Wetland Biological Conditions EA Report

Project Name	H-600 Pipeline Spread D	AFE	124300132	Spread	H-600 Pipeline Spread D
Contractor	Precision	Report #	34		
Environmental Auditor	Alex Miller			Date/Time	8/27/2023 10:27 AM
Wetland ID	W-IJ50	Crossing Start Date	8/27/2023	Crossing Completion Date	9/1/2023
Milepost	111.72	Pre-Con Assessment Date	8/19/2023	Post-Con Assessment Date	9/1/2023
Station	5898+82	Cowardin Classification	PEM	Wetland Impact Area(acs)	0.0528
State	WV				
County	Nicholas

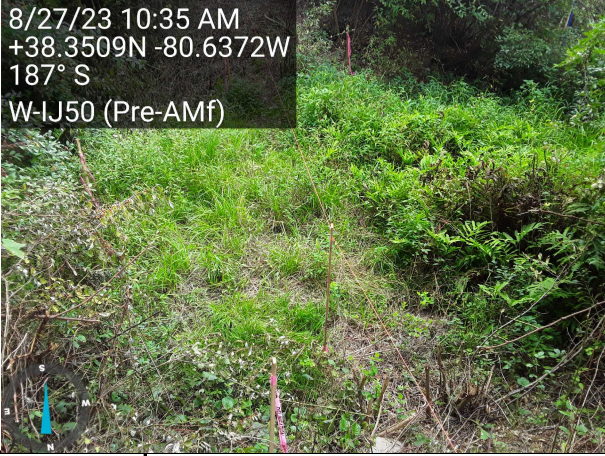
<p>8/27/23 10:35 AM +38.3509N -80.6372W 187° S W-IJ50 (Pre-AMf)</p>

GPS Location	See Photo	GPS Location	See Photo
Description	View of permitted resource impact area during pre-construction assessment. View of wetland pre construction from CIS on pipe centerline.	Description	At edge of LOD, view of unimpacted resource area conditions during pre-construction assessment. View off left side of LOD taken from LOD Edge pre construction
<p>9/1/23 17:12:39 +38.3507N -80.6372W 177° S W-IJ50 (Post-AM)</p>

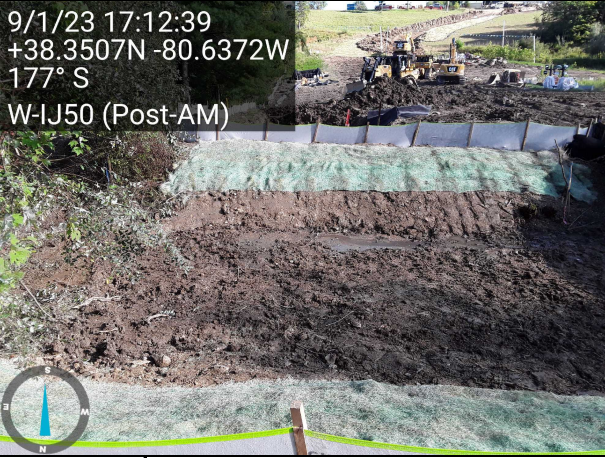
Conditions 18 and 19 were given a rating of 4 due to the lack of vegetation in the disturbed permitted impact area following completion of the crossing and restoration efforts. The W-IJ50 PEM topsoil has been properly stabilized and the disturbed area has been seeded with the appropriate permanent seed mix in accordance with Appendix B: Restoration Work Plan of the Mountain Valley Pipeline Comprehensive Stream and Wetland Monitoring, Restoration and Mitigation Framework.

GPS Location	See Photo	GPS Location	See Photo
Description	View of permitted resource impact area during post-construction assessment. View of wetland post construction from CIS of Pipe centerline.	Description	At edge of LOD, view of unimpacted resource area conditions during post-construction assessment. View off left side of LOD taken from LOD edge post construction.

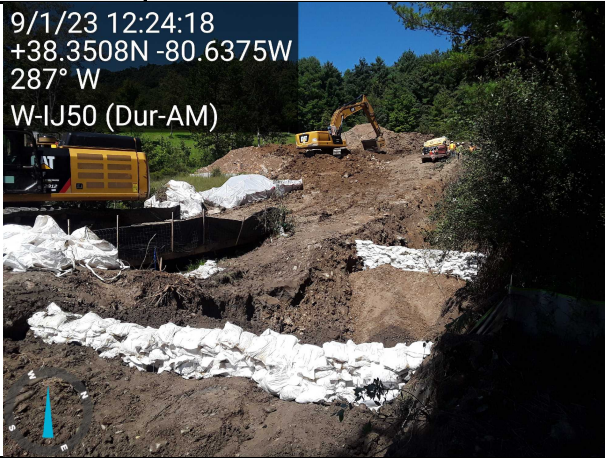
<p>9/1/23 12:24:18 +38.3508N -80.6375W 287° W W-IJ50 (Dur-AM)</p>

GPS Location	See Photo	GPS Location	See Photo
Description	Trench breakers constructed just past the 10 ft buffer of W-IJ50. Located within the 25ft buffer.	Description	Excavator replacing and grading wetland topsoil in W-IJ50.

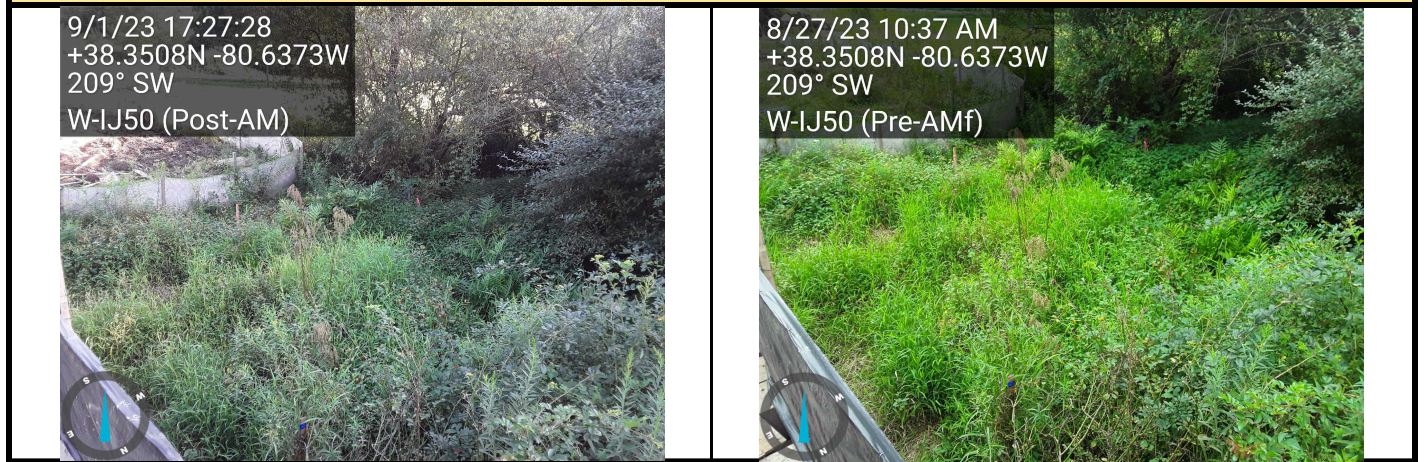
GPS Location	See Photo	GPS Location	See Photo
Description	Unimpacted area of W-IJ50 within LOD taken from bridge, facing right side of LOD. Post construction	Description	Unimpacted area of W-IJ50 within LOD taken from bridge, facing right side of LOD, Pre construction.
