Wetland Biological Conditions EA Report

Project Name	H-600 Pipeline Spread F	A/E	124300135	Spread	H-600 Pipeline Spread F
Contractor	Price Gregory	Report #	25		
Environmental Auditor	Beth Burdette			Date/Time	8/21/2023 5:49 PM
Wetland ID	W-K2-PEM	Crossing Start Date	8/29/2023	Crossing Completion Date	9/6/2023
Milepost	172.73	Pre-Con Assessment Date	8/22/2023	Post-Con Assessment Date	9/6/2023
Station	9120+14	Cowardin Classification	PEM	Wetland Impact Area(acs)	0.0104
State	WV				
County	Summers

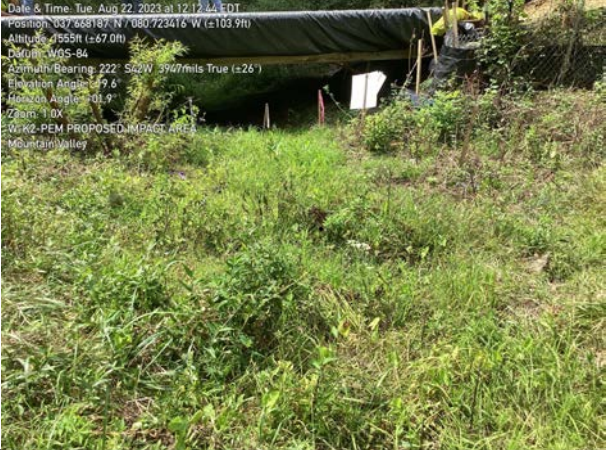
<p>Date & Time: Tue, Aug 22, 2023 at 12:12:44 EDT Position: 037.668187 N / 080.723416 W (+103.9ft) Altitude: 1055ft (+67.0ft) Datum: WGS-84 Azimuth/Bearing: 222° S42W 3947mils True (+26°) Elevation Angle: -9.6° Horizon Angle: -01.8° Zoom: 1.0X W-K2-PEM PROPOSED IMPACT AREA Mountain Valley</p>

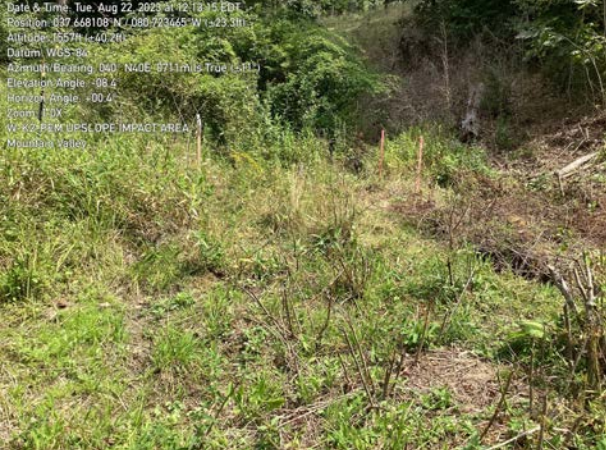
<p>Date & Time: Tue, Aug 22, 2023 at 12:19:16 EDT Position: 037.668188 N / 080.723465 W (+23.3ft) Altitude: 1057ft (+67.0ft) Datum: WGS-84 Azimuth/Bearing: 090° N06E 0711mils True (+01°) Elevation Angle: -08.8° Horizon Angle: -00.4° Zoom: 1.0X W-K2-PEM UPSLOPE OF IMPACT AREA Mountain Valley</p>	
GPS Location	See Photo	GPS Location	See Photo
Description	View of permitted resource impact area during pre-construction assessment. Overview of W-K2-PEM proposed trench location facing downslope.	Description	At edge of LOD, view of unimpacted resource area conditions during pre-construction assessment. Overview of W-K2-PEM upslope of proposed trench location (No Impact).

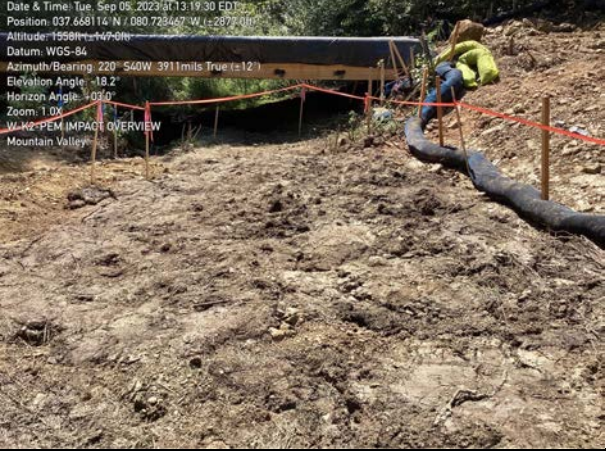
<p>Date & Time: Tue, Sep 05, 2023 at 13:19:30 EDT Position: 037.668114 N / 080.723467 W (+267.7ft) Altitude: 1058ft (+67.0ft) Datum: WGS-84 Azimuth/Bearing: 220° S40W 3911mils True (+12°) Elevation Angle: -18.2° Horizon Angle: -03.0° Zoom: 1.0X W-K2-PEM IMPACT OVERVIEW Mountain Valley</p>

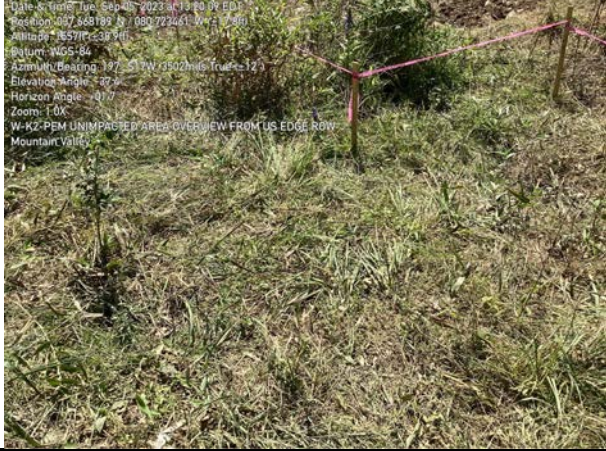
<p>Date & Time: Tue, Sep 05, 2023 at 13:20:09 EDT Position: 037.668189 N / 080.723461 W (+23.3ft) Altitude: 1057ft (+67.0ft) Datum: WGS-84 Azimuth/Bearing: 187° S11W 3802mils True (+12°) Elevation Angle: -07.2° Horizon Angle: -01.0° Zoom: 1.0X W-K2-PEM UNIMPACTED AREA OVERVIEW FROM US EDGE ROW Mountain Valley</p>	
GPS Location	See Photo	GPS Location	See Photo
Description	View of permitted resource impact area during post-construction assessment. Overview of W-K2-PEM restored trench location facing downslope.	Description	At edge of LOD, view of unimpacted resource area conditions during post-construction assessment. Overview of unimpacted resource from US edge of ROW facing downslope.

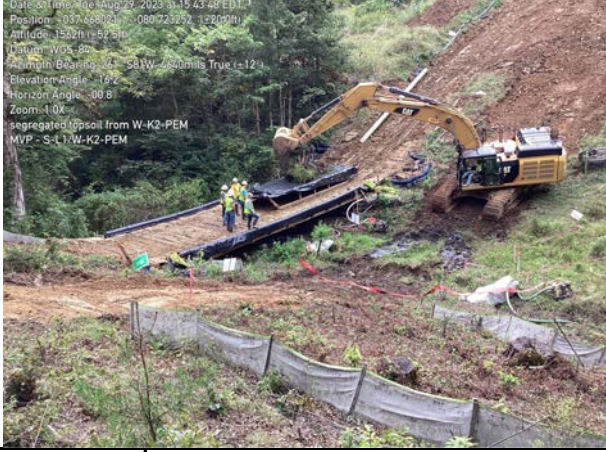
Day 1 (8/29/2023)
 Rain yesterday/overnight. Vegetation trimmed and wetland topsoil removed (Photo1). Wetland topsoil was then segregated and stored in upland area (Photo 2).

<p>Date & Time: Tue, Aug 29, 2023 at 15:43:48 EDT Position: 037.668302 N / 080.723392 W (+280.9ft) Altitude: 1039ft (+67.0ft) Datum: WGS-84 Azimuth/Bearing: 45° S8W 3800mils True (+12°) Elevation Angle: -12° Horizon Angle: -08.8° Zoom: 1.0X Segregated topsoil from W-K2-PEM MVP - S-L1-W-K2-PEM</p>

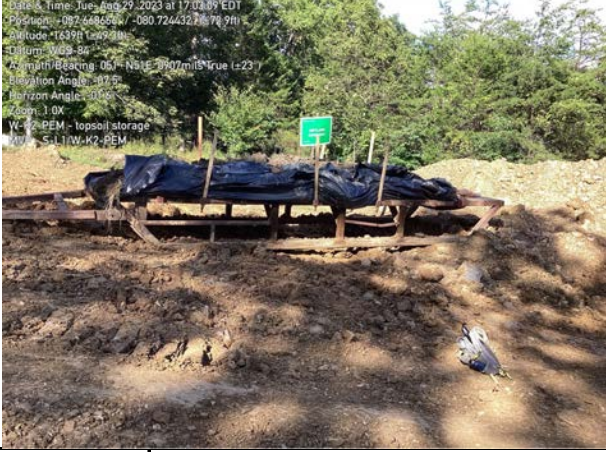
<p>Date & Time: Tue, Aug 29, 2023 at 17:03:09 EDT Position: 037.668564 N / 080.724432 W (+76.9ft) Altitude: 1163ft (+67.0ft) Datum: WGS-84 Azimuth/Bearing: 051° N01E 3807mils True (+23°) Elevation Angle: -01.1° Horizon Angle: -00.6° Zoom: 1.0X W-K2-PEM - topsoil storage S-L1-W-K2-PEM</p>	
GPS Location	See Photo	GPS Location	See Photo
Description	Photo 1. Wetland 12" topsoil excavation and segregation onto sled.	Description	Photo 2. Wetland 12" topsoil stock pile.

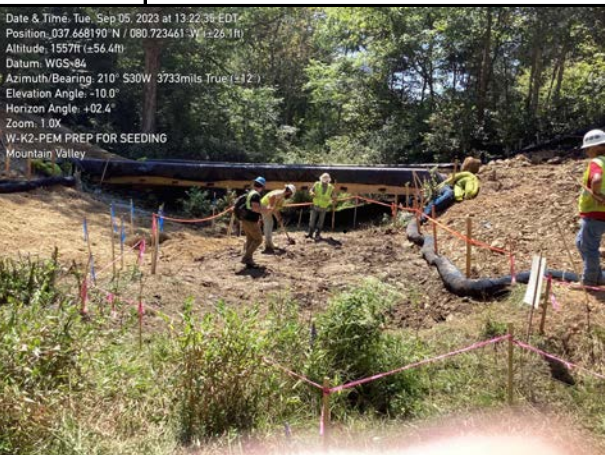
Day 7 (9/5/2023)
 Survey completed for final contouring of resource (Photo 7). Hand shoveling and raking to contour wetland. Additional backfilling of trench outside of resource area (in the riparian buffer). Hand tools used to minimize compaction of wetland soils. Post Construction Assessment began.

<p style="font-size: small; margin-top: 5px;">Date & Time: Tue, Sep 05, 2023 at 13:22:36 EDT Position: +037.668190° N / -080.723461° W (+11.2 9ft) Altitude: 1557ft (+48.4ft) Datum: WGS-84 Azimuth/Bearing: 210° S30W 3733mils True (+12°) Elevation Angle: -10.0° Horizon Angle: +02.4° Zoom: 1.0X W-K2-PEM PREP FOR SEEDING Mountain Valley</p>	  <p style="font-size: small; margin-top: 5px;">Date & Time: Wed, Sep 06, 2023 at 10:44:58 EDT Position: +037.668159° N / -080.723774° W (+11.2 9ft) Altitude: 1568ft (+42.0ft) Datum: WGS-84 Azimuth/Bearing: 220° S36W 4177mils True (+12°) Elevation Angle: -18.6° Horizon Angle: -02.7° Zoom: 1.0X W-K2-PEM SEEDING Mountain Valley</p>		
GPS Location	See Photo	GPS Location	See Photo
Description	Photo 7. Final contouring of wetland soil and prep for seeding.	Description	Photo 8. Seeded wetland.
