Wetland Biological Conditions EA Report

Project Name	H-600 Pipeline Spread A	AFE	124300129	Spread	H-600 Pipeline Spread A
Contractor	Precision	Report #	53		
Environmental Auditor	Devin Jen			Date/Time	9/11/2023 8:57 AM
Wetland ID	W-K45	Crossing Start Date	9/11/2023	Crossing Completion Date	9/16/2023
Milepost	32.41	Pre-Con Assessment Date	9/11/2023	Post-Con Assessment Date	9/16/2023
Station	1711+25	Cowardin Classification	PEM	Wetland Impact Area(acres)	0.0401
State	WV				
County	Doddridge

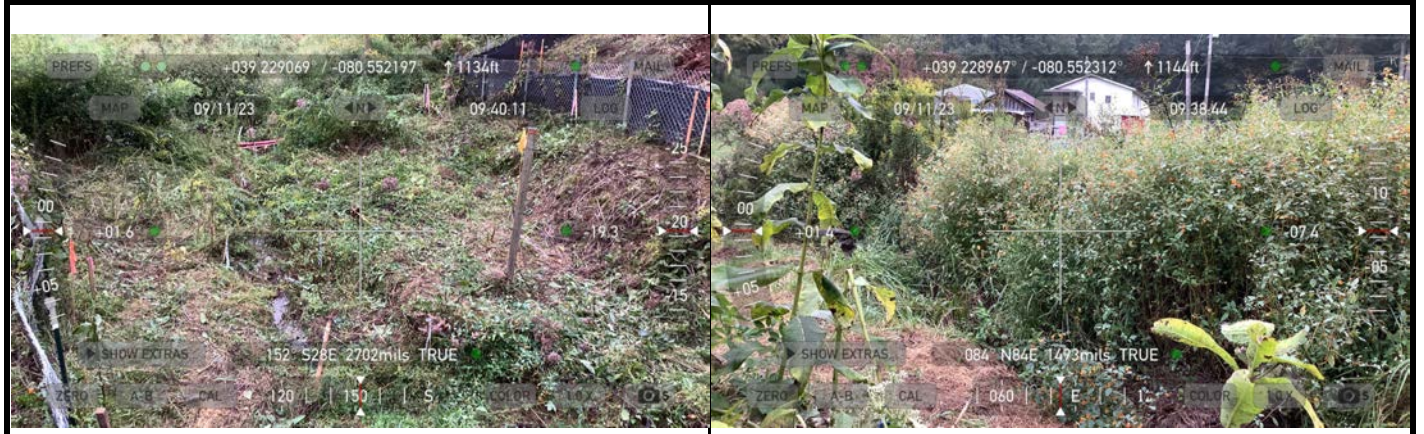
GPS Location	See photograph.	GPS Location	See photograph.
Description	View of permitted resource impact area during pre-construction assessment.	Description	At edge of LOD, view of unimpacted resource area conditions during pre-construction assessment.

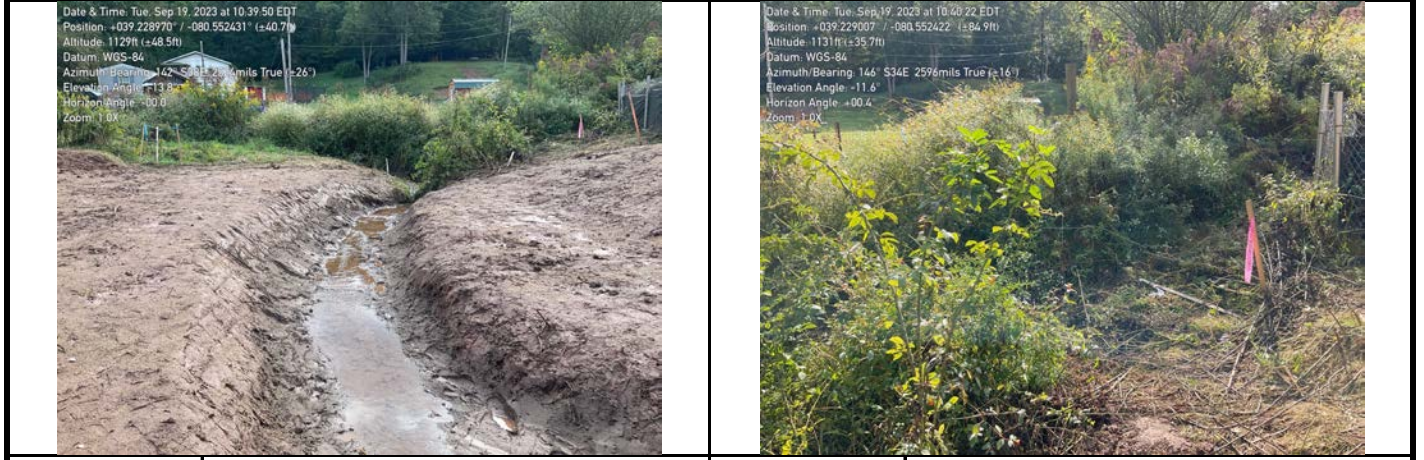
9/16/2023
 The weather on 9/16/2023 had a high of 75 °F and was clear, however, the weather fluctuated throughout the day. The contractor completed restoration of the wetland after backfilling and replacing segregated wetland topsoil. Conditions 18 and 19 were given a rating of 4 during the post-construction assessment due to the lack of vegetation in the disturbed permitted impact area following the completion of the crossing and restoration efforts. The W-K45 PEM wetland topsoils have been properly stabilized and the disturbed area has been seeded with the appropriate permanent seed mix in accordance with Appendix B: Restoration Work Plan of the Mountain Valley Pipeline Comprehensive Stream and Wetland Monitoring, Restoration and Mitigation Framework.

GPS Location	See photograph	GPS Location	See photograph
Description	View of permitted resource impact area during post-construction assessment.	Description	At edge of LOD, view of unimpacted resource area conditions during post-construction assessment.

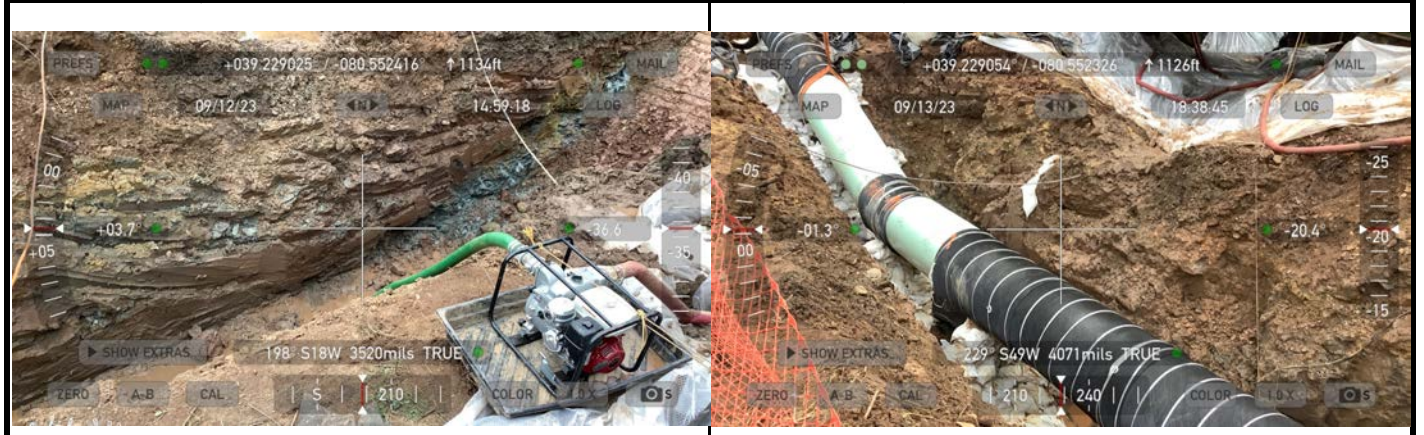
GPS Location	See photograph.	GPS Location	See photograph.
Description	The photo taken on 9/12/2023 shows the progress of the trench excavation.	Description	The photo shows the pipe and sandbags placed in the area of the wetland crossing at the end of the workday on 9/13/2023.

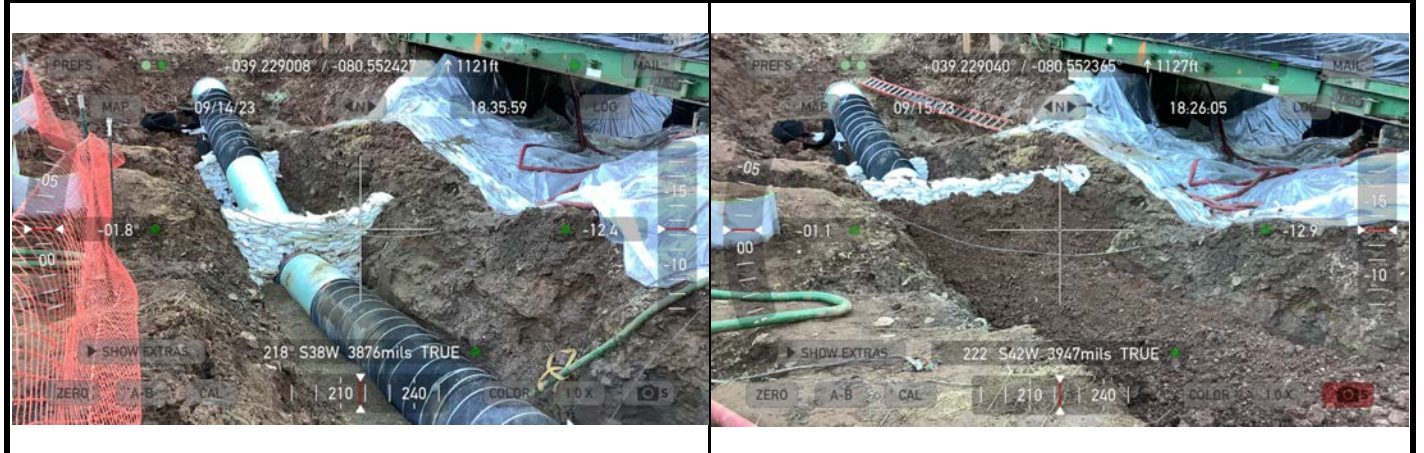
Description	The photo shows the trench breakers and pea gravel in the area of the wetland crossing on 9/14/2023.	Description	The photo shows the progress of backfilling towards the end of the day on 9/15/2023.
--------------------	--	--------------------	--
