# Wetland Biological Conditions EA Report

<b>Project Name</b>	H-600 Pipeline Spread E	<b>A/E</b>	124300134	<b>Spread</b>	H-600 Pipeline Spread E
<b>Contractor</b>	Price Gregory	<b>Report #</b>	27		
<b>Environmental Auditor</b>	Tim Ferguson			<b>Date/Time</b>	8/22/2023 8:28 AM
<b>Wetland ID</b>	W-L16	<b>Crossing Start Date</b>	8/24/2023	<b>Crossing Completion Date</b>	9/13/2023
<b>Milepost</b>	144.36	<b>Pre-Con Assessment Date</b>	8/22/2023	<b>Post-Con Assessment Date</b>	9/13/2023
<b>Station</b>	7622+21	<b>Cowardin Classification</b>	PEM	<b>Wetland Impact Area(acres)</b>	0.0247
<b>State</b>	WV				
<b>County</b>	Greenbrier

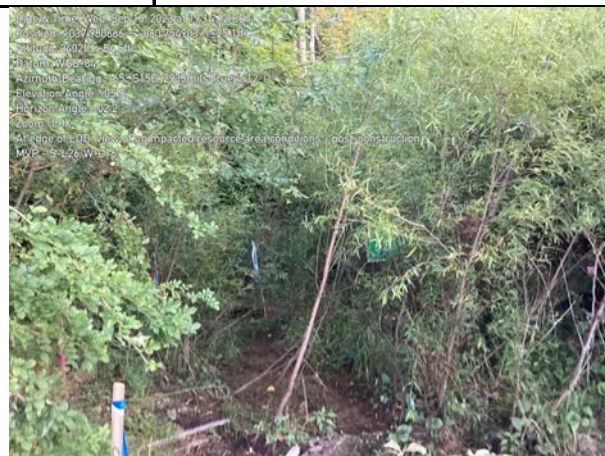
<b>GPS Location</b> See Photo	<b>GPS Location</b> See Photo
<b>Description</b> View of permitted resource impact area during post-construction assessment.	<b>Description</b> At edge of LOD, view of unimpacted resource area conditions during post-construction assessment.

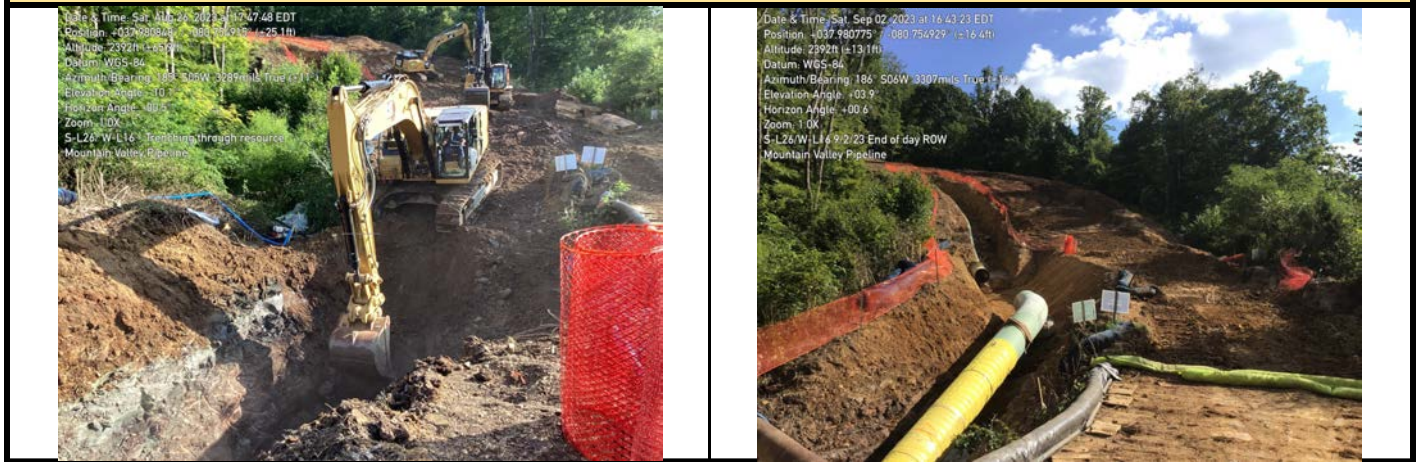
Day 3 and Day 4 (8/26/2023 and 8/27/2023)  
 Trenching began in aquatic resources (Photo 3).

Day 9 and Day 10 (9/1/2023 and 9/2/2023)  
 Trench prepared for pipe installation and pipe lowered into trench in aquatic resources (Photo 4). Welding and x-ray ongoing in trench.

<b>GPS Location</b> See Photo	<b>GPS Location</b> See Photo
<b>Description</b> Photo 3: Trenching through aquatic resources.	<b>Description</b> Photo 4: Pipe lowered into aquatic resources.

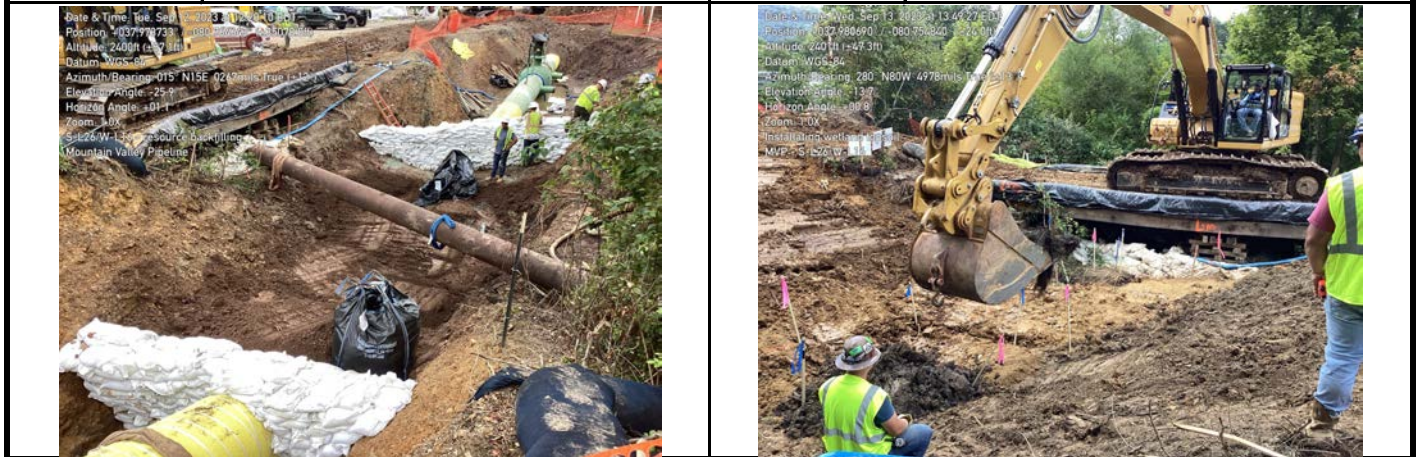
Day 17 (9/12/2023)  
 Finished installing trench breakers (Photo 5) and filling resource. Site graded. Survey work began.

Day 18 (9/13/2023)  
 Survey staked out stream boundary and elevations. Wetland topsoil was placed in resource area (Photo 6) and then restored using hand tools (Photo 7). Curlex installed (Photo 8). Resource crossing complete. Post Construction Form completed.

<b>GPS Location</b> See Photo	<b>GPS Location</b> See Photo
<b>Description</b> Photo 5: Constructing trench breaks.	<b>Description</b> Photo 6: Restoring Wetland Soil.

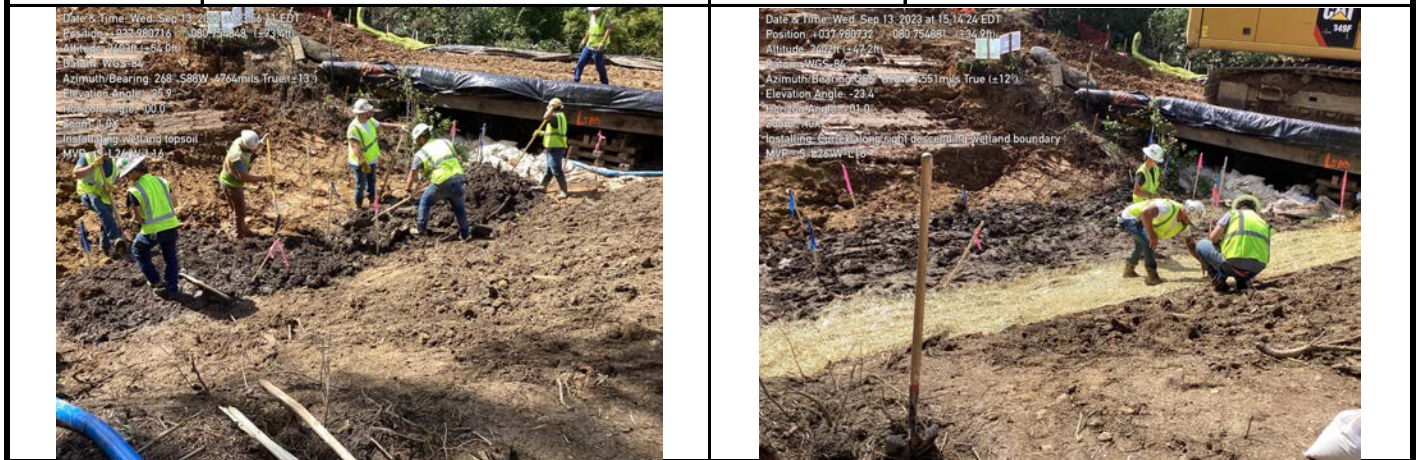
<b>GPS Location</b> See Photo	<b>GPS Location</b> See Photo
<b>Description</b> Photo 7: Distributing wetland soil by hand.	<b>Description</b> Photo 8: Installing Curlex.
