Wetland Biological Conditions EA Report

Project Name	H-600 Pipeline Spread B	A/E	124300130	Spread	H-600 Pipeline Spread B
Contractor	Precision	Report #	22		
Environmental Auditor	Mathew Huber			Date/Time	8/20/2023 7:10 AM
Wetland ID	W-VV3 PEM	Crossing Start Date	8/20/2023	Crossing Completion Date	8/27/2023
Milepost	65.62	Pre-Con Assessment Date	8/20/2023	Post-Con Assessment Date	8/27/2023
Station	3464+49	Cowardin Classification	PEM	Wetland Impact Area(acs)	0.0447
State	WV				
County	Lewis

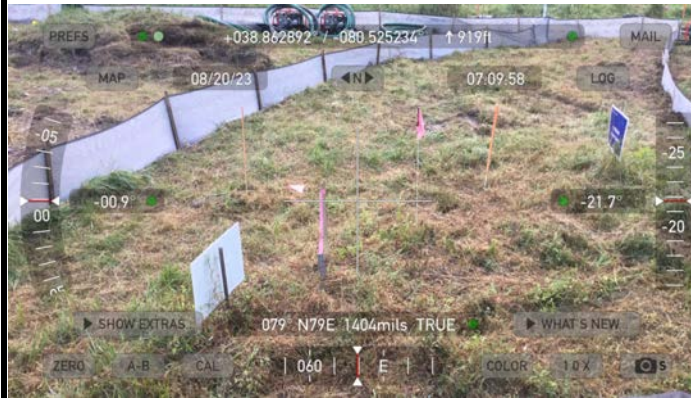
Pre-construction
 Densely vegetated emergent wetland along the north bank of stream S-VV2 and adjacent to AR 27. No standing water or rocky or woody debris was observed in the wetland. Temporary bridge crossing on W-VV3 PEM runs north to south. W-VV3 PEM extends west along S-VV2 well off of LOD. - M. Huber

GPS Location See Photograph.
Description View of permitted resource impact area during pre-construction assessment.

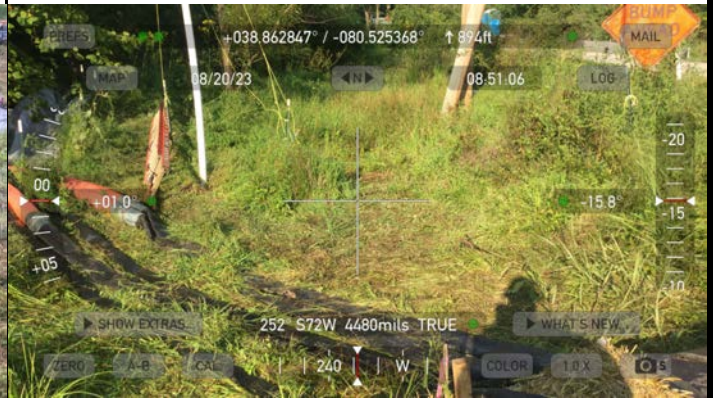
GPS Location See Photograph.
Description At edge of LOD, view of unimpacted resource area conditions during pre-construction assessment.

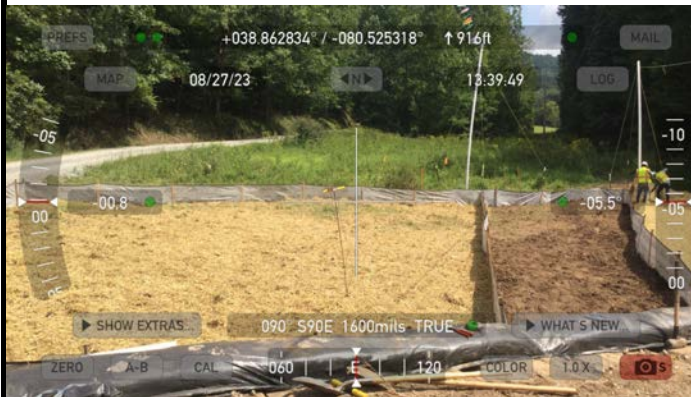
08/27/2023 Post-construction assessment
 Todays weather was sunny with a high off 82 degrees Fahrenheit. Wetland restoration was completed. Conditions 18 and 19 were given a rating of 4 during the post-construction assessment due to lack of vegetation in the disturbed permitted impact area following the completion of the crossing and restoration efforts. The W-VV3 PEM wetland topsoils have been properly stabilized and the disturbed area has been seeded with the appropriate permanent seed mix in accordance with Appendix B: Restoration Work Plan of the Mountain Valley Pipeline Comprehensive Stream and Wetland Monitoring, Restoration and Mitigation Framework. - A. Dunn

GPS Location See Photograph.
Description View of permitted resource impact area during post-construction assessment.

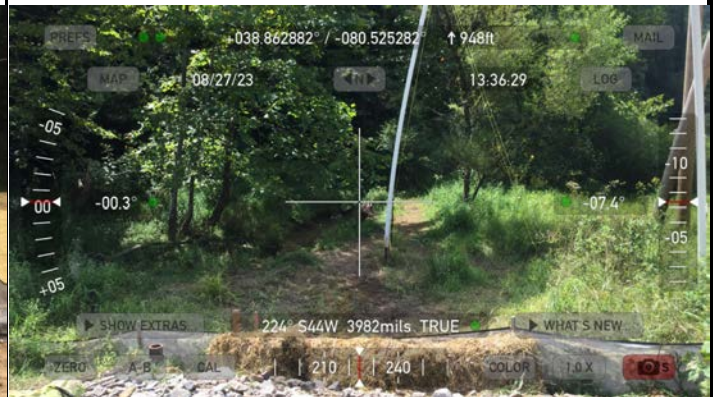
GPS Location See Photograph.
Description At edge of LOD, view of unimpacted resource area conditions during post-construction assessment.

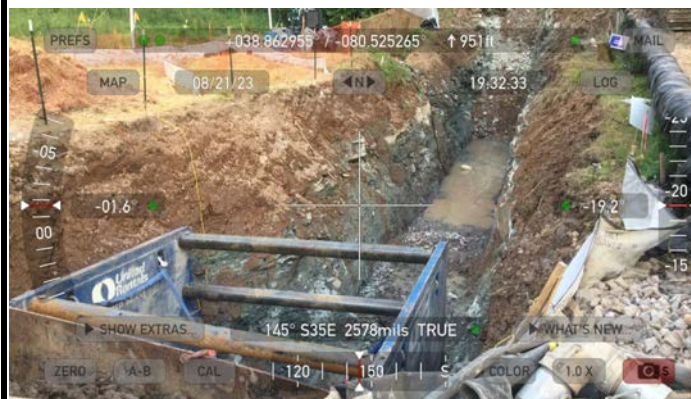
08/21/2023
 Weather sunny with a high of 89 degrees Fahrenheit. Crew continued to dig ditch wetland crossing. - M. Huber

GPS Location See Photograph
Description Wetland crossing at end of day 08/21/2023

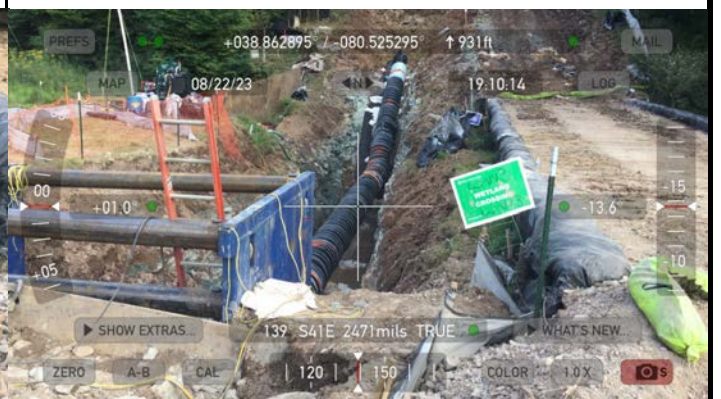
08/22/2023
 Weather sunny with a with a high of 82 degrees Fahrenheit. Crew finished digging the ditch and successfully installed the stream/wetland crossing section of pipe. - M. Huber

GPS Location See Photograph
Description Wetland crossing at end of day 08/22/2023

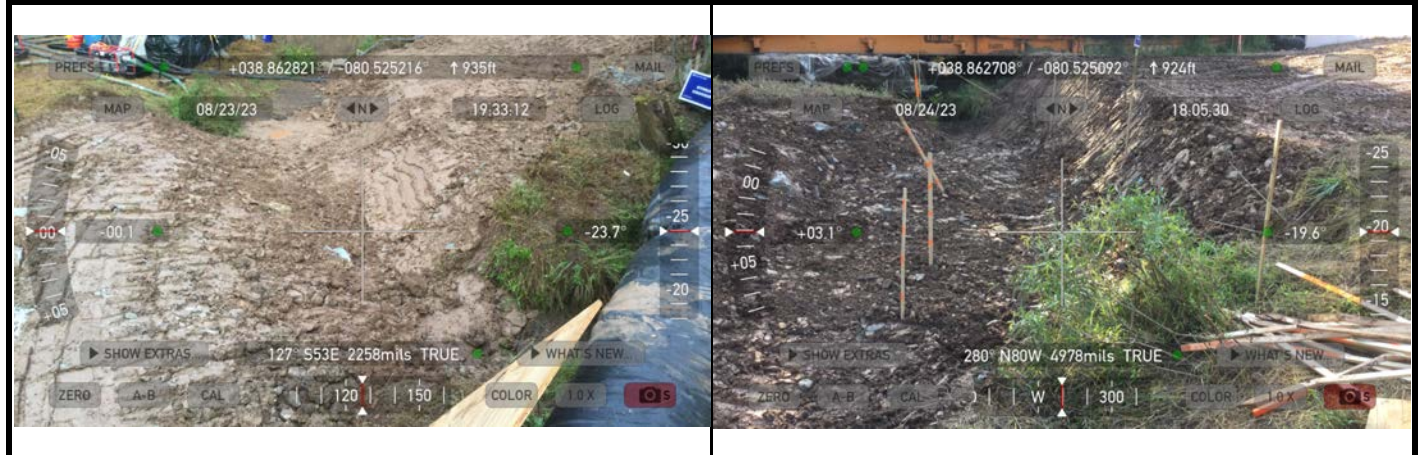
GPS Location	See Photograph.	GPS Location	See Photograph
Description	Wetland crossing at end of day 08/23/2023	Description	Wetland crossing at end of day 08/24/2023

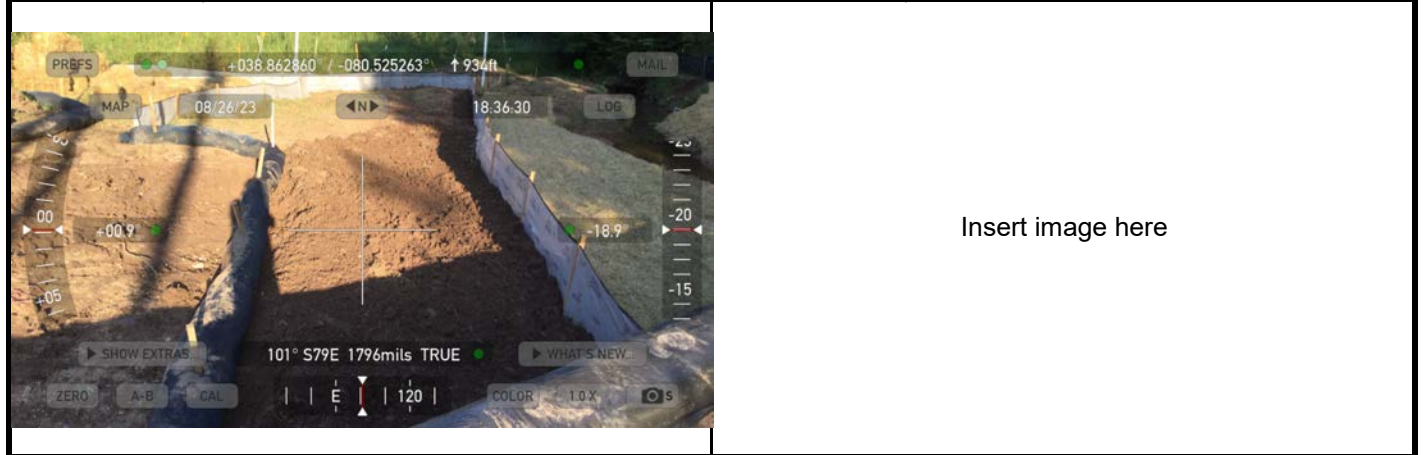
08/26/2023
 Todays weather was sunny with a high of 84 degrees Fahrenheit. Wetland restoration began but is not yet complete. A portion of wetland topsoil was backfilled today. - M. Huber

GPS Location	See Photograph	GPS Location	
Description	Wetland crossing at end of day 08/26/2023	Description
