Wetland Biological Conditions EA Report

Project Name	H-600 Pipeline Spread B	AFE	124300130	Spread	H-600 Pipeline Spread B
Contractor	Precision	Report #	33		
Environmental Auditor	Mathew Huber			Date/Time	8/20/2023 7:00 AM
Wetland ID	W-VV3 PFO	Crossing Start Date	8/20/2023	Crossing Completion Date	8/27/2023
Milepost	65.62	Pre-Con Assessment Date	8/20/2023	Post-Con Assessment Date	8/27/2023
Station	3464+49	Cowardin Classification	PFO	Wetland Impact Area(acres)	0.0160
State	WV				
County	Braxton

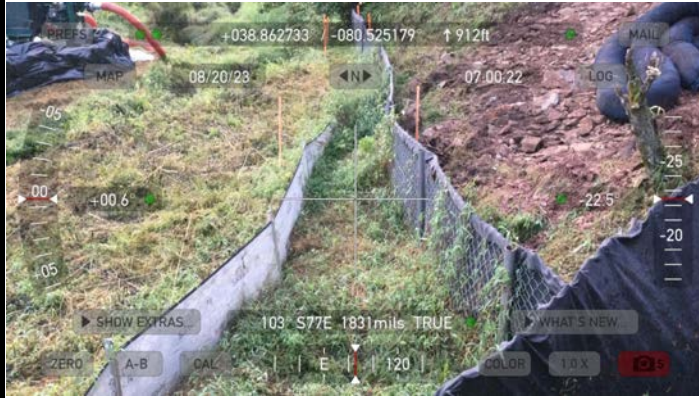
Pre-construction assessment
 Small section of densely vegetated forested wetland. W-VV3 PFO runs along the southern bank of S-VV2, continuing off of LOD. No rocks, woody debris, or standing water observed within wetland. 17 received a 2 because any trees with the forested wetland have been removed prior to construction. - M. Huber

GPS Location See photograph.
Description View of permitted resource impact area during pre-construction assessment.

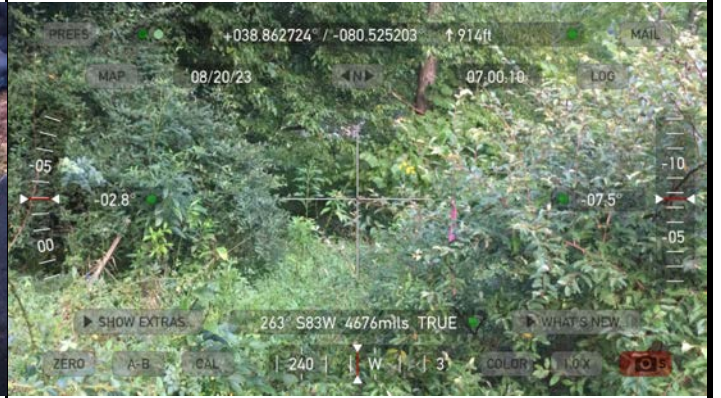
GPS Location See photograph.
Description At edge of LOD, view of unimpacted resource area conditions during pre-construction assessment.

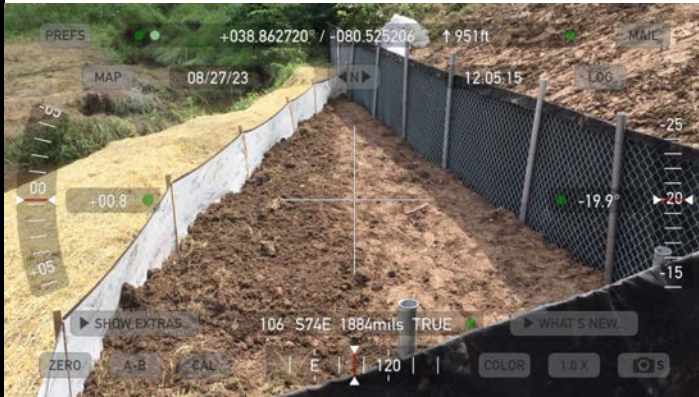
08/27/2023 Post Construction Assessment
 The weather was sunny with a high of 84 degrees Fahrenheit. Conditions 18 and 19 were given a rating of 4 during post-construction assessment due to lack of vegetation in the disturbed permitted impact area following the completion of the crossing and restoration efforts. The W-VV3 PFO wetland topsoils have been properly stabilized and the disturbed area has been seeded with the appropriate permanent seed mix in accordance with Appendix B: Restoration Work Plan of the Mountain Valley Pipeline Comprehensive Stream and Wetland Monitoring Restoration and Mitigation Framework.

GPS Location See photograph.
Description View of permitted resource impact area during post-construction assessment.

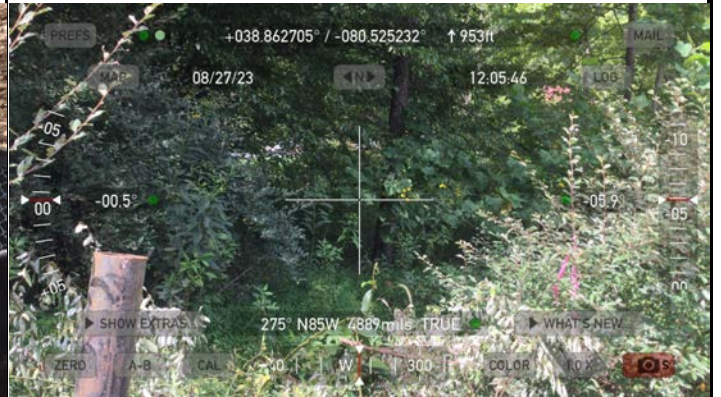
GPS Location See photograph.
Description At edge of LOD, view of unimpacted resource area conditions during post-construction assessment.

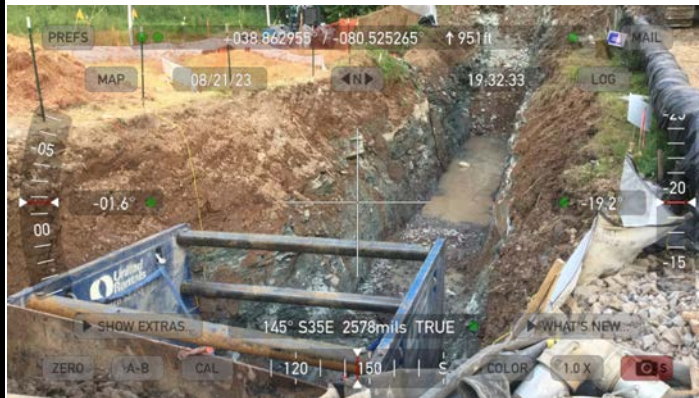
08/21/2023
 The weather was sunny with a high of 89 degrees Fahrenheit. Crew continued to dig ditch for stream/wetland crossing. - M. Huber

GPS Location See photograph.
Description Photo of crossing at the end of the day on 8/21/2023

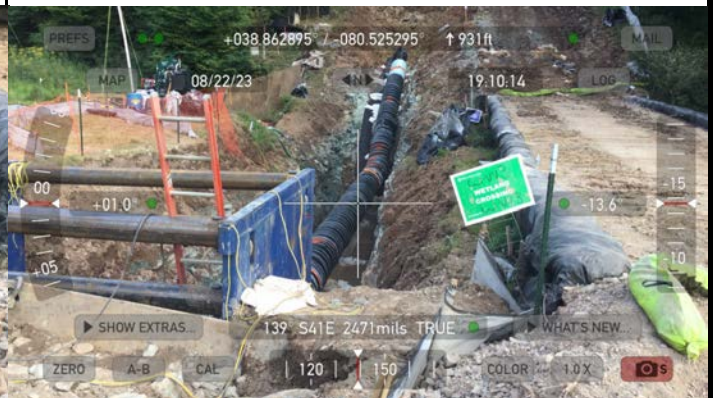
08/22/2023
 The weather was sunny with a high of 82 degrees Fahrenheit. Crew finished digging the ditch and successfully installed the stream/wetland crossing section of pipe. - M. Huber

GPS Location See photograph.
Description Photo of crossing at the end of the day on 8/22/2023

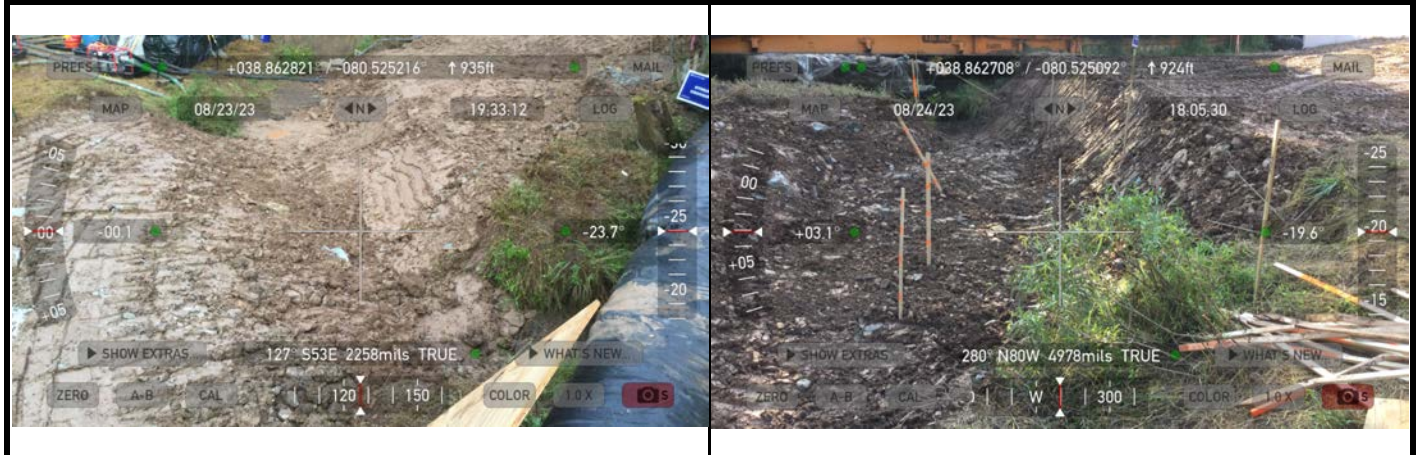
08/23/2023
 The weather was sunny with a high of 87 degrees Fahrenheit. The ditch was successfully backfilled. Wetland restoration did not start. - M. Huber

08/24/2023
 The weather was sunny with a high of 86 degrees Fahrenheit. The crew began restoration of S-VV2. No wetland restoration occurred today. - M. Huber

GPS Location	See photograph.	GPS Location	See photograph.
Description	Photo of crossing at the end of the day on 8/23/2023	Description	Photo of crossing at the end of the day on 8/24/2023

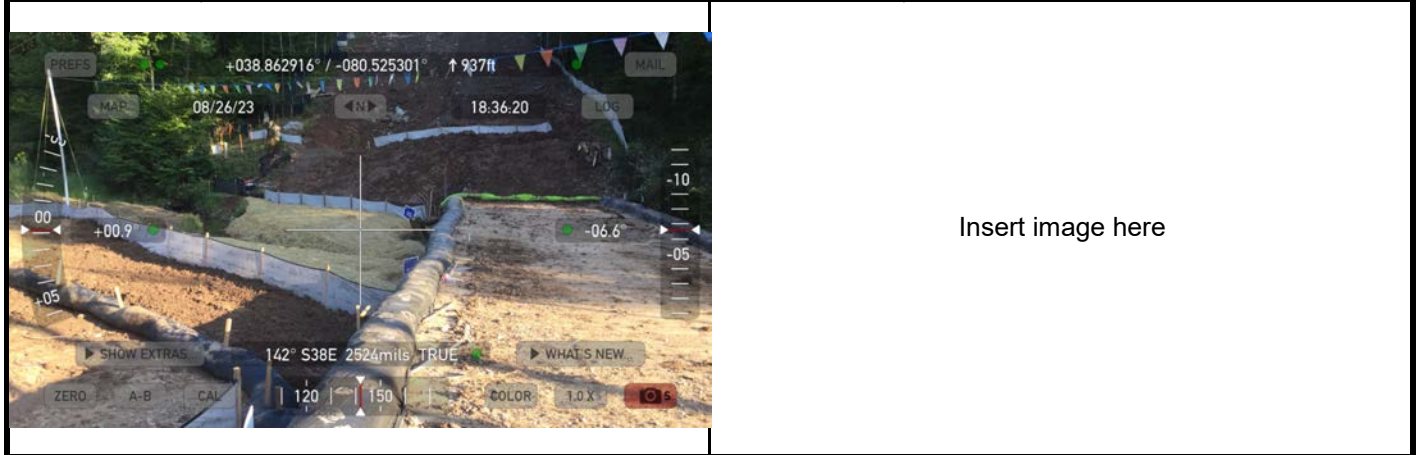
08/26/2023
 The weather was sunny with a high of 84 degrees Fahrenheit. After restoring S-VV2 to completion, W-VV3 PFO was partially restored. Most of the wetland topsoil was successfully back filled into the wetland. Restoration will continue tomorrow. - M. Huber

GPS Location	See photograph.	GPS Location	
Description	Photo of crossing at the end of the day on 8/26/2023	Description
