# Stream Biological Conditions EA Report

<b>Project Name</b>	H-600 Pipeline Spread A	<b>AFE</b>	124300129	<b>Spread</b>	H-600 Pipeline Spread A
<b>Contractor</b>	Precision	<b>Report #</b>	285		
<b>Environmental Auditor</b>	Elyse Johnston	<b>Date/Time</b>	10/4/2023 12:05 PM		
<b>Stream ID</b>	S-A110/K62	<b>Crossing Start Date</b>	10/4/2023	<b>Crossing Completion Date</b>	10/13/2023
<b>Milepost</b>	34.96	<b>Pre-Con Assessment Date</b>	10/4/2023	<b>Post-Con Assessment Date</b>	10/16/2023
<b>Station</b>	1845+95	<b>Bankfull Width (ft.)</b>	1.0	<b>Riffle:Pool Complexes Present?</b>	No
<b>State</b>	WV	<b>Stream Classification</b>	Intermittent		
<b>County</b>	Doddridge	<b>303(d) Impairment Listing</b>	No

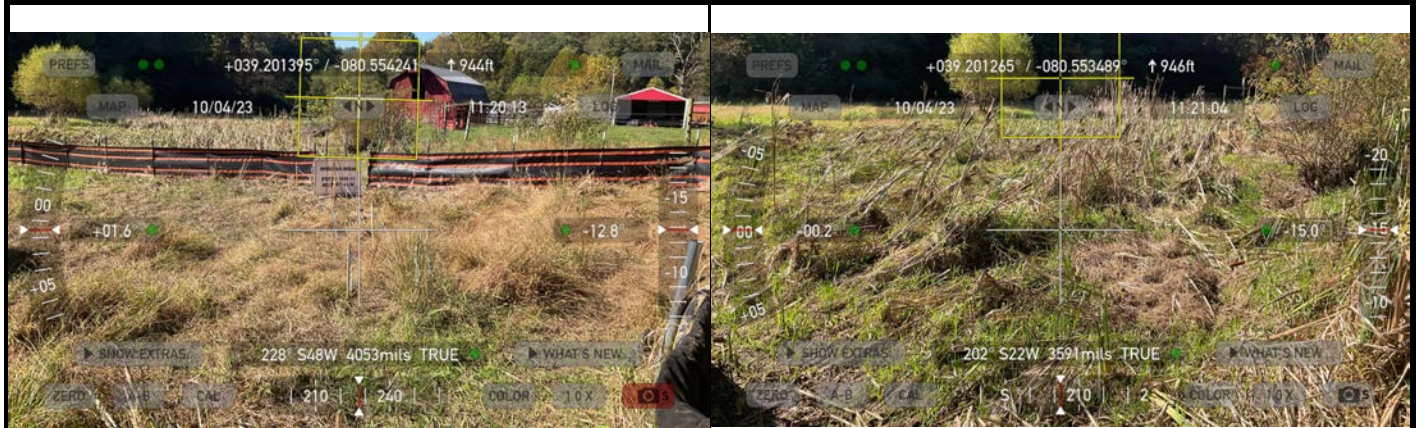
<b>GPS Location</b>	See photo	<b>GPS Location</b>	See photo
<b>Description</b>	Downstream view of permitted impact area during pre-construction assessment.	<b>Description</b>	Downstream view of unimpacted area during pre-construction assessment.

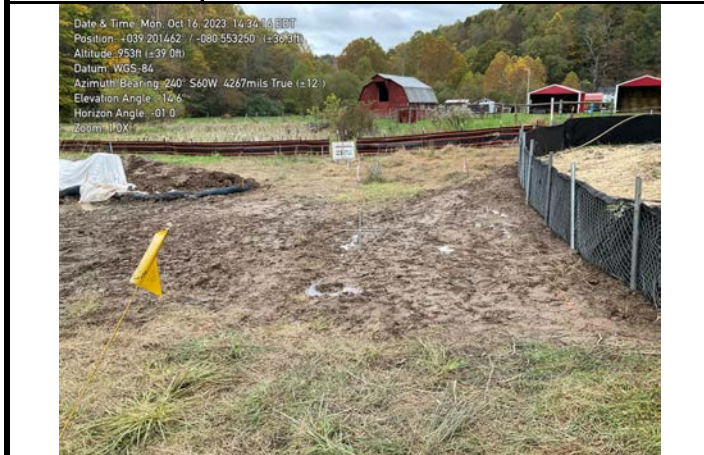
<b>GPS Location</b>	See photo	<b>GPS Location</b>	See photo
<b>Description</b>	Downstream view of permitted impact area during post-construction assessment.	<b>Description</b>	Downstream view of unimpacted area during post-construction assessment.

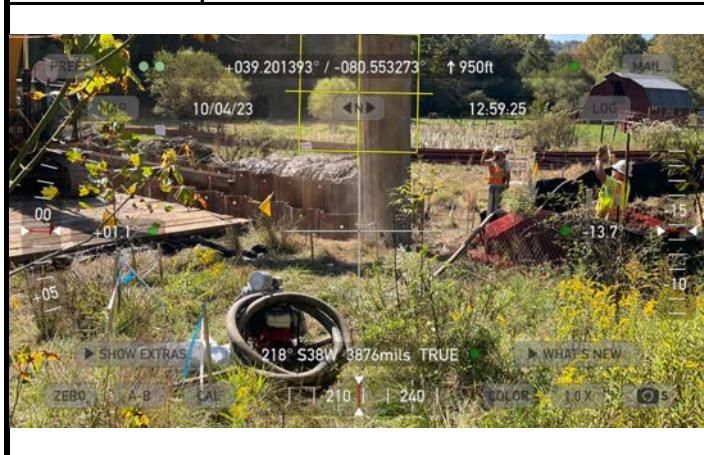
<b>GPS Location</b>	See photo	<b>GPS Location</b>	See photo
<b>Description</b>	View of sheet piling & pump and dam.	<b>Description</b>	View of topsoil.

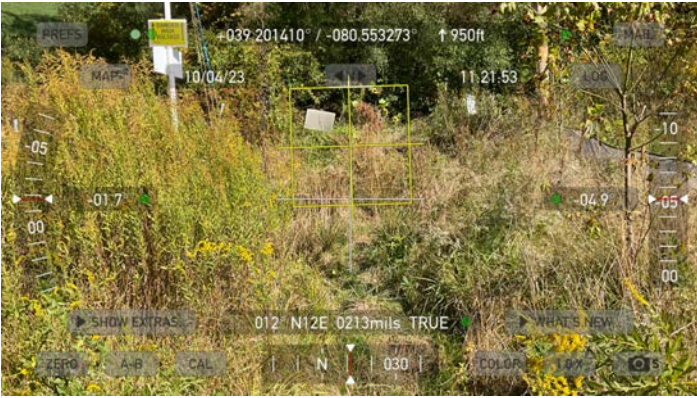
<b>GPS Location</b>	See photo	<b>GPS Location</b>	See photo
<b>Description</b>	View of culverted stream (upstream of crossing) vegetative conditions pre-construction.	<b>Description</b>	View of culverted stream (upstream of crossing) vegetative conditions post-restoration.

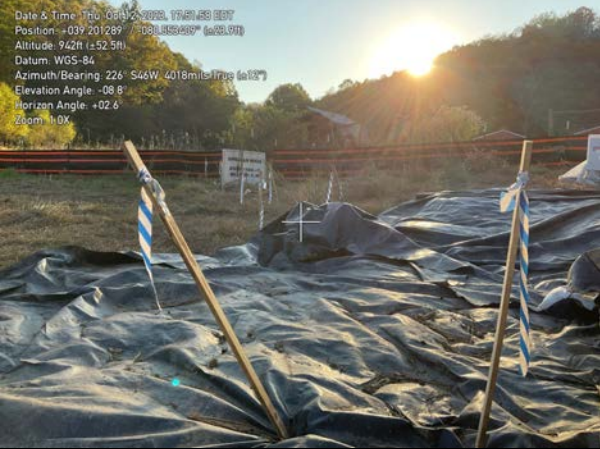
<b>GPS Location</b>	See photo	<b>GPS Location</b>	See photo
<b>Description</b>	View of stream covered with plastic tarp to prevent discharge from equipment moving dirt.	<b>Description</b>	View of sheet pile removal.

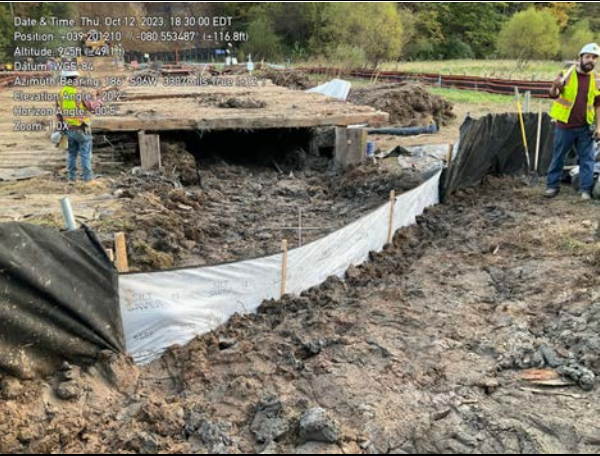
<b>GPS Location</b>	See photo	<b>GPS Location</b>	See photo
<b>Description</b>	View of silt fence added to protect resource overnight prior to adding topsoil (stream officially restored 10/13).	<b>Description</b>	View of area post-restoration.
