Stream Biological Conditions EA Report

Project Name	H-600 Pipeline Spread A	AFE	124300129	Spread	H-600 Pipeline Spread A
Contractor	Precision	Report #	282		
Environmental Auditor	Samantha Felix	Date/Time	10/9/2023 4:00 PM		
Stream ID	S-A11a Braid 2	Crossing Start Date	10/4/2023	Crossing Completion Date	10/9/2023
Milepost	21.77	Pre-Con Assessment Date	9/30/2023	Post-Con Assessment Date	10/9/2023
Station	1149+20	Bankfull Width (ft.)	6.0	Riffle:Pool Complexes Present?	No
State	WV	Stream Classification	Intermittent		
County	Harrison	303(d) Impairment Listing	Iron, Fecal

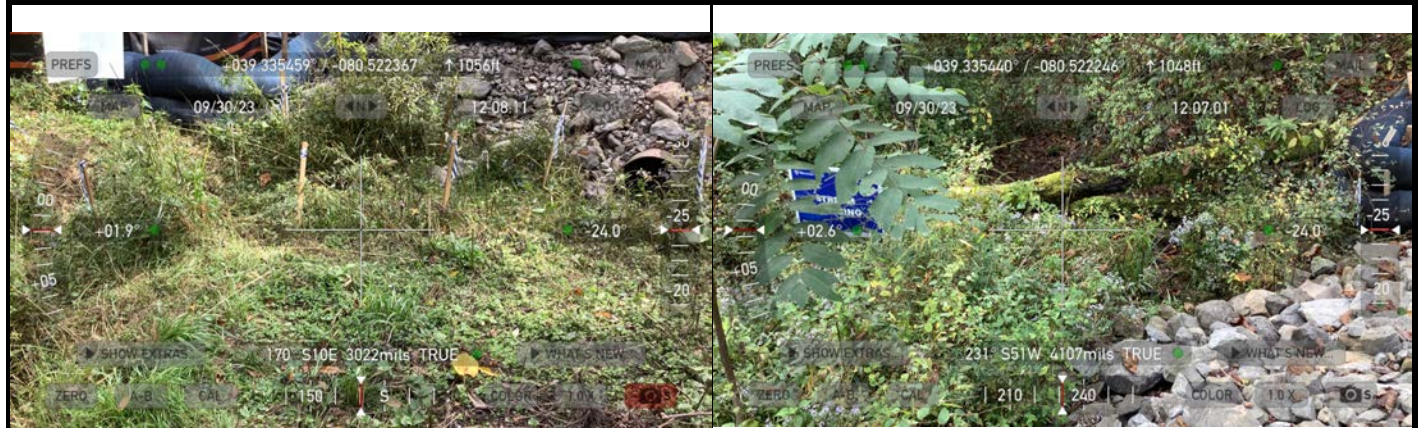
GPS Location	See above.	GPS Location	See above.
Description	Downstream view of permitted impact area during pre-construction assessment.	Description	Downstream view of unimpacted area during pre-construction assessment.

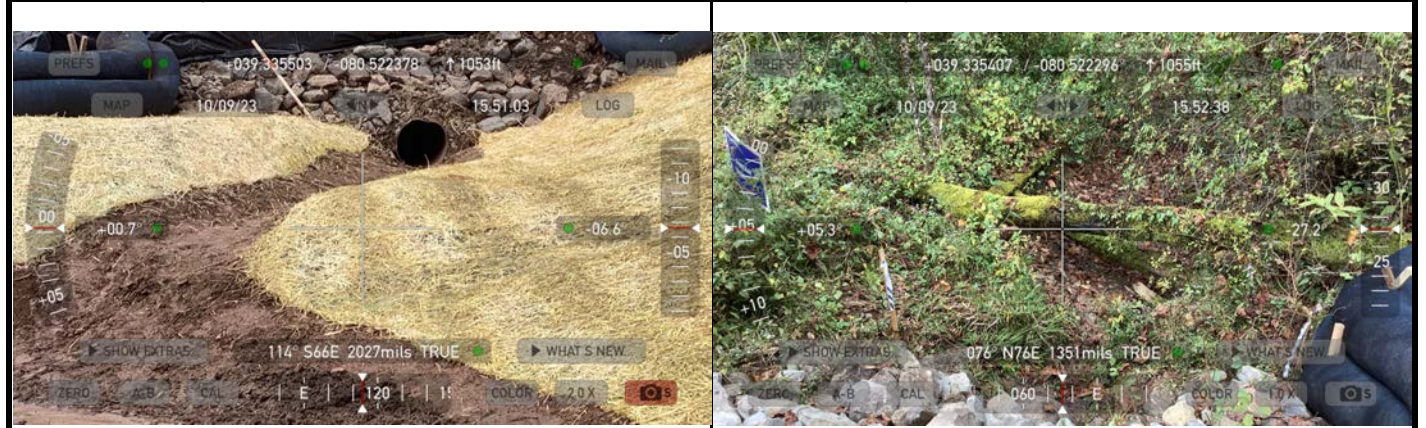
GPS Location	See above.	GPS Location	See above.
Description	Downstream view of permitted impact area during post-construction assessment.	Description	Downstream view of unimpacted area during post-construction assessment.

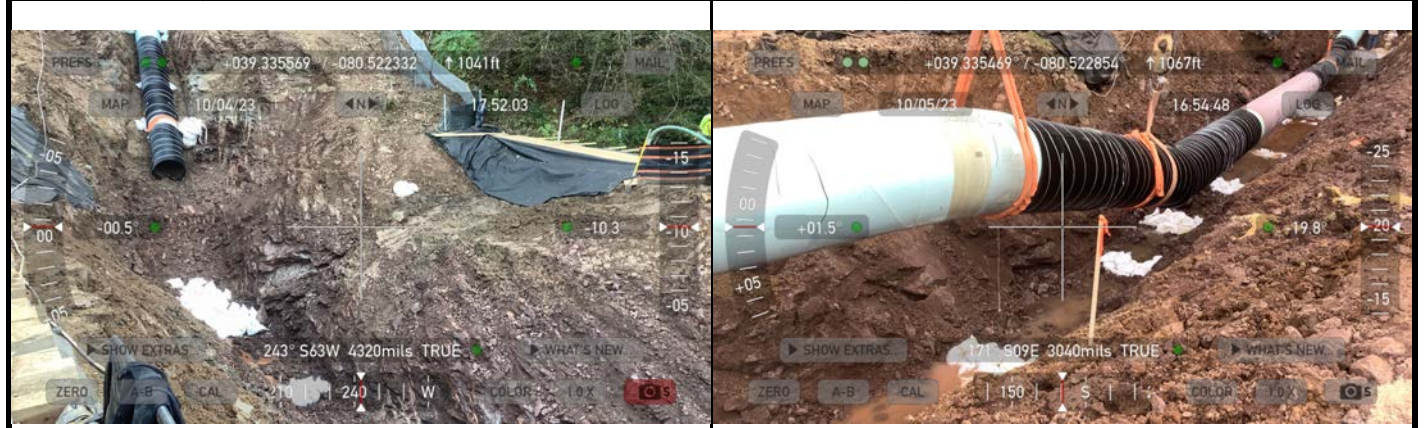
GPS Location	See above.	GPS Location	See above.
Description	In the process of excavating the pit	Description	The pipe was lowered into the trench and welded.

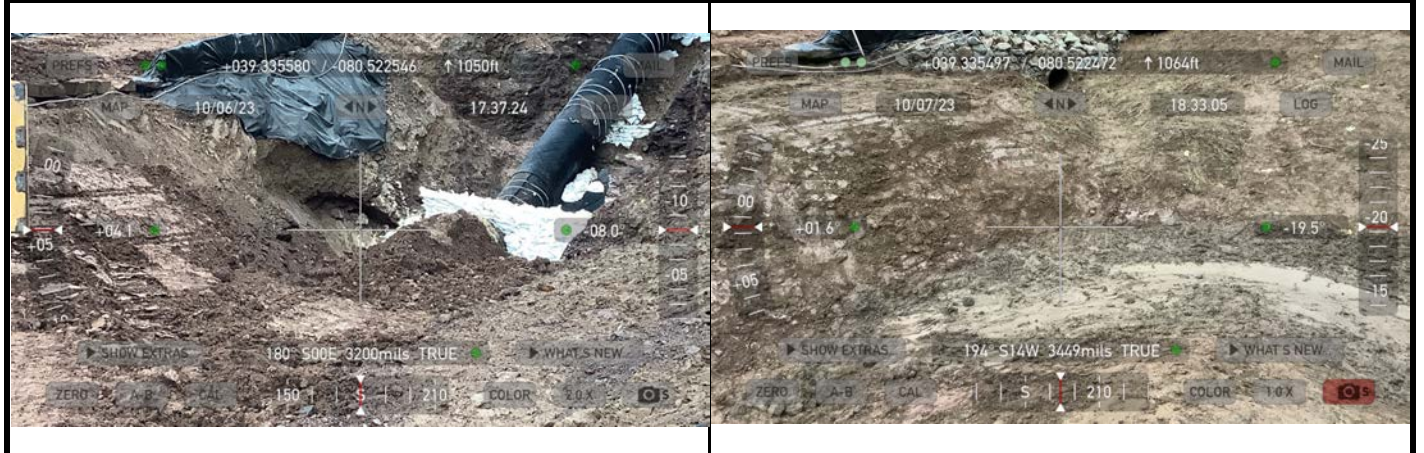
Description	Trench being filled with substrate.	Description	Adding waterbody substrate.
--------------------	-------------------------------------	--------------------	-----------------------------
