Stream Biological Conditions EA Report

Project Name	H-600 Pipeline Spread A	AFE	124300129	Spread	H-600 Pipeline Spread A
Contractor	Precision	Report #	266		
Environmental Auditor	Samantha Felix	Date/Time	10/4/2023 7:12 AM		
Stream ID	S-A11a	Crossing Start Date	10/4/2023	Crossing Completion Date	10/9/2023
Milepost	21.77	Pre-Con Assessment Date	9/30/2023	Post-Con Assessment Date	10/9/2023
Station	1149+23	Bankfull Width (ft.)	12.0	Riffle:Pool Complexes Present?	No
State	WV	Stream Classification	Perennial		
County	Harrison	303(d) Impairment Listing	Fecal, Iron

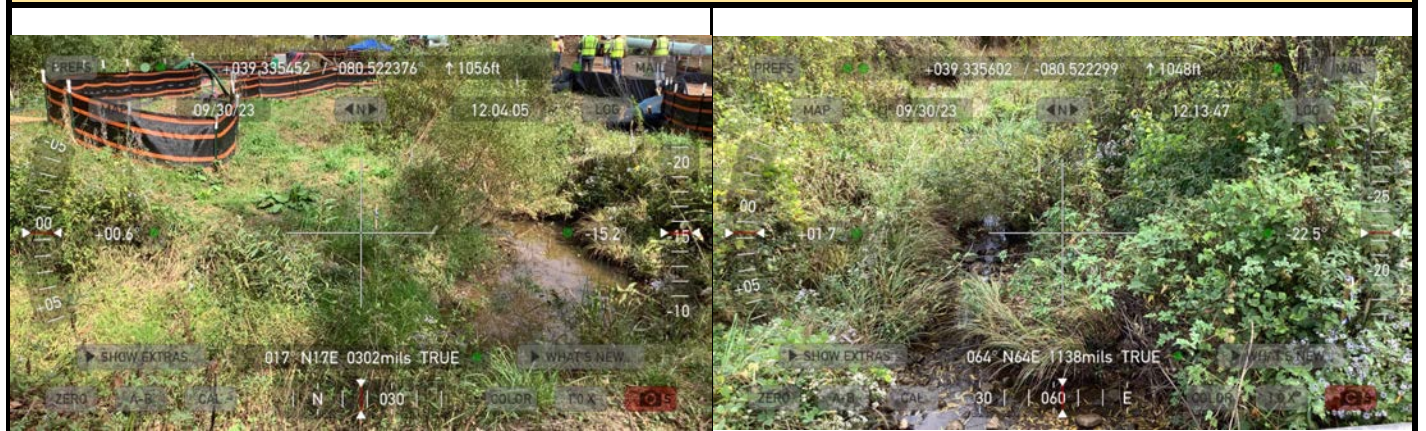
GPS Location	See Photo	GPS Location	See Photo
Description	Downstream view of permitted impact area during pre-construction assessment.	Description	Downstream view of unimpacted area during pre-construction assessment.

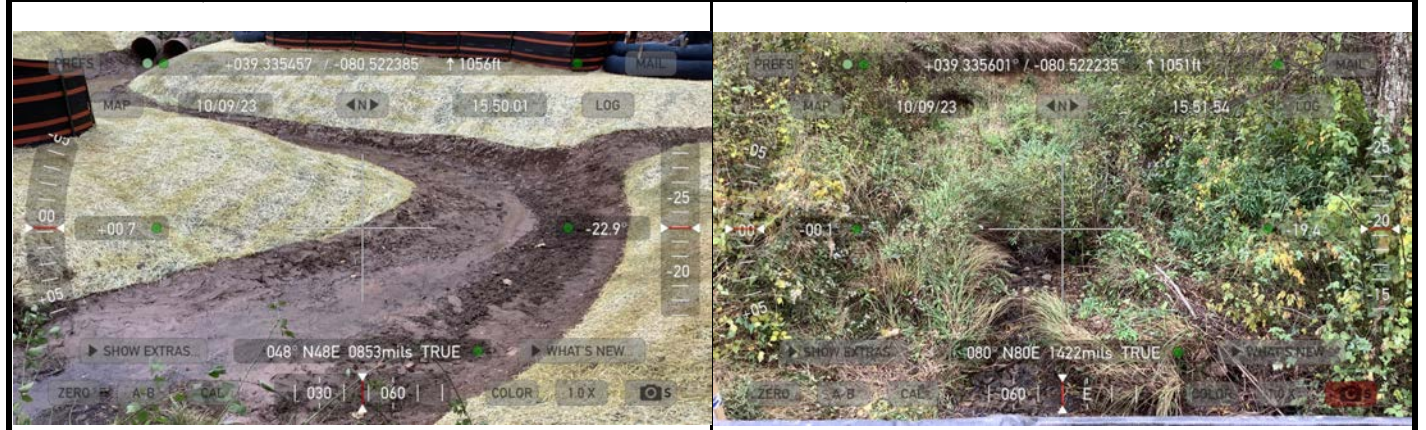
GPS Location	See Photo	GPS Location	See Photo
Description	Downstream view of permitted impact area during post-construction assessment.	Description	Downstream view of unimpacted area during post-construction assessment.

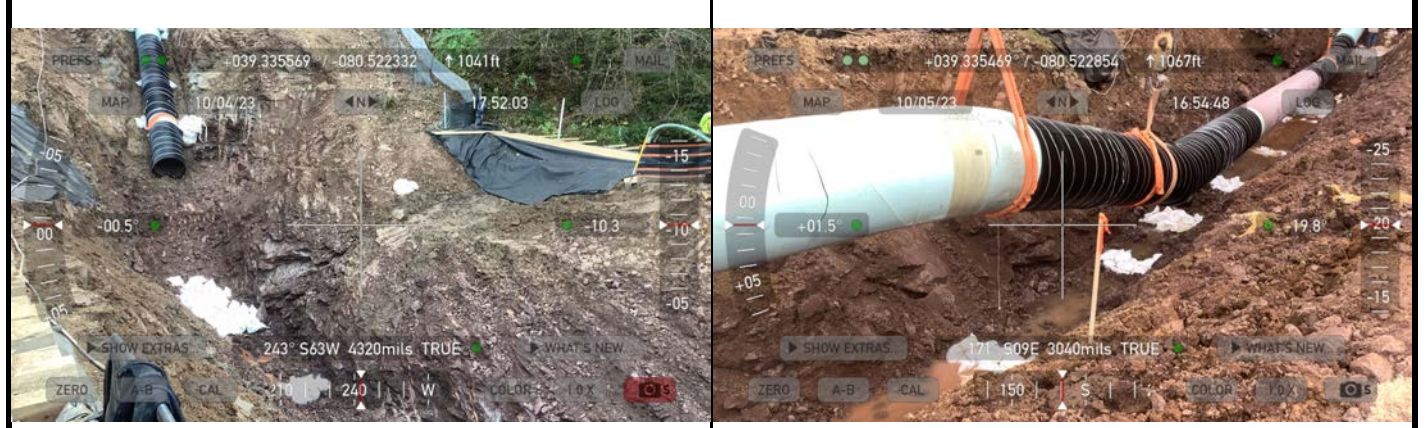
GPS Location	See above.	GPS Location	See above.
Description	In the process of excavating the pit.	Description	The pipe was lowered into the trench and welded.
