# Stream Biological Conditions EA Report

<b>Project Name</b>	H-600 Pipeline Spread A	<b>AFE</b>	124300129	<b>Spread</b>	H-600 Pipeline Spread A
<b>Contractor</b>	Precision	<b>Report #</b>	258		
<b>Environmental Auditor</b>	Scott Wessel	<b>Date/Time</b>	9/25/2023 7:33 AM		
<b>Stream ID</b>	S-A83/A91	<b>Crossing Start Date</b>	9/25/2023	<b>Crossing Completion Date</b>	9/30/2023
<b>Milepost</b>	92.57	<b>Pre-Con Assessment Date</b>	9/18/2023	<b>Post-Con Assessment Date</b>	9/30/2023
<b>Station</b>	4887+84	<b>Bankfull Width (ft.)</b>	10.9	<b>Riffle:Pool Complexes Present?</b>	No
<b>State</b>	WV	<b>Stream Classification</b>	Perennial		
<b>County</b>	Webster	<b>303(d) Impairment Listing</b>	No

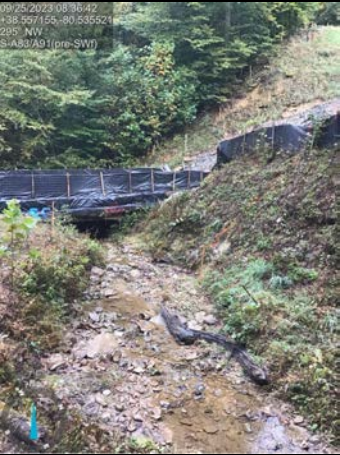
<b>GPS Location</b>	See GPS in attached photo.
<b>Description</b>	Downstream view of permitted impact area during pre-construction assessment.	<b>Description</b>	Downstream view of unimpacted area during pre-construction assessment.

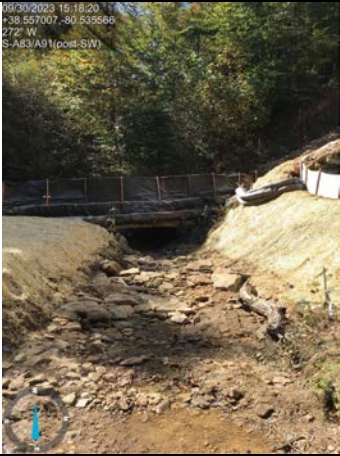
<b>GPS Location</b>	See GPS in attached photo.	<b>GPS Location</b>	See GPS in attached photo.	<b>Description</b>	Downstream view of permitted impact area during post-construction assessment.

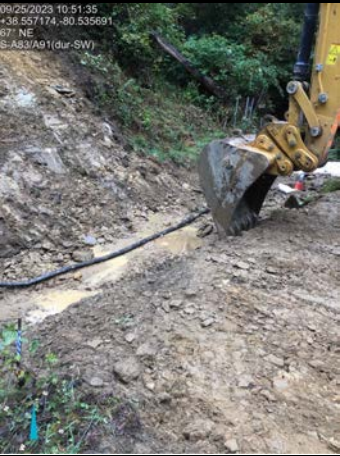
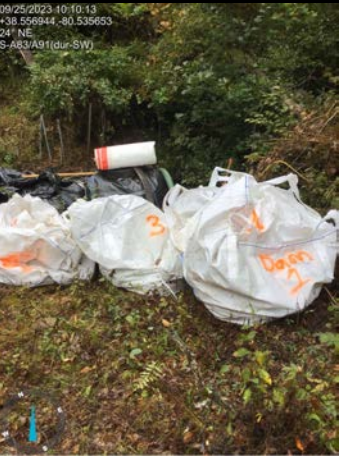
<b>GPS Location</b>	See GPS in attached photo.
<b>Description</b>	Removing topsoil from riparian buffer zone area.	<b>Description</b>	Substrate material being labeled in super sacks.	<b>GPS Location</b>	See GPS in attached photo.

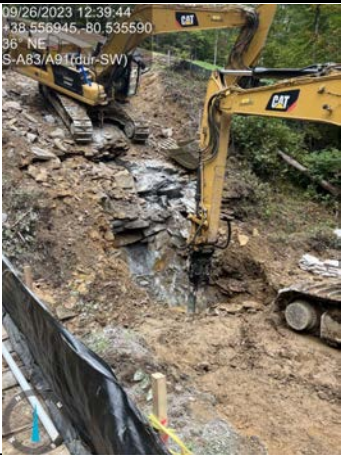
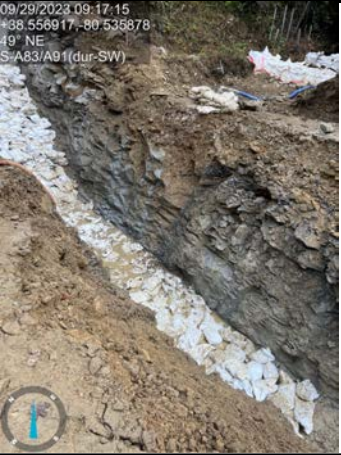
GPS Location	See GPS in attached photo.		GPS Location	See GPS in attached photo.	
Description	Contractor using hammer attachment to break up solid rock.		Description	Trench being lined with sandbags before pipe is installed.

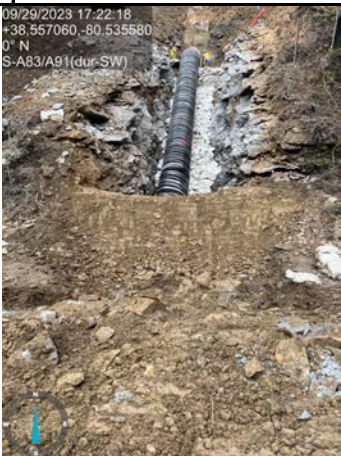
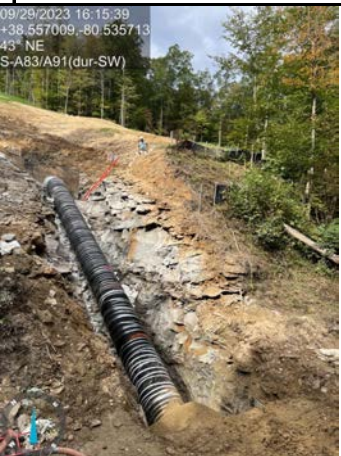
GPS Location	See GPS in attached photo.		GPS Location	See GPS in attached photo.	
Description	Sub soil being used to build up streambed, banks, and buffer zone.		Description	Pipe installed and being backfilled.

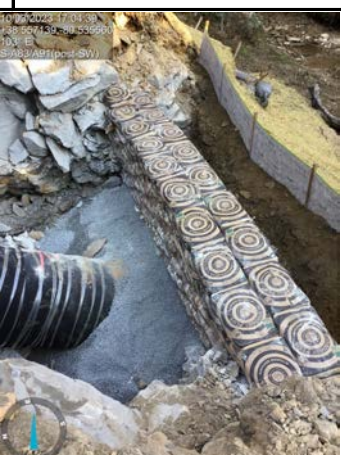
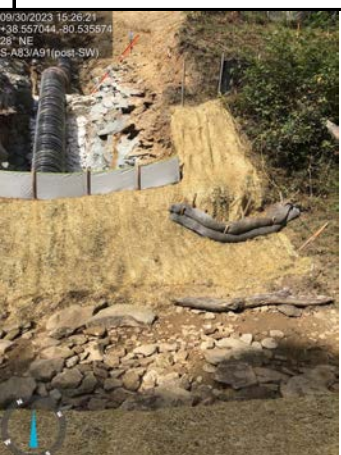
GPS Location	See GPS in attached photo.		GPS Location	See GPS in attached photo.	
Description	Aquablok and bentonite trench breaker being installed on the CIS of stream crossing.		Description	Riparian buffer zones restored with erosion control blanket, compost filter sock, and proper seed after pipe installation.
