# Stream Biological Conditions EA Report

<b>Project Name</b>	H-600 Pipeline Spread C	<b>AFE</b>	124300131	<b>Spread</b>	H-600 Pipeline Spread C
<b>Contractor</b>	Precision	<b>Report #</b>	256		
<b>Environmental Auditor</b>	Kyle Gillow	<b>Date/Time</b>	9/27/2023 2:04 PM		
<b>Stream ID</b>	S-A96/A103	<b>Crossing Start Date</b>	9/27/2023	<b>Crossing Completion Date</b>	10/2/2023
<b>Milepost</b>	80.88	<b>Pre-Con Assessment Date</b>	9/26/2023	<b>Post-Con Assessment Date</b>	10/5/2023
<b>Station</b>	4270+42	<b>Bankfull Width (ft.)</b>	5.0	<b>Riffle:Pool Complexes Present?</b>	No
<b>State</b>	WV	<b>Stream Classification</b>	Ephemeral		
<b>County</b>	Webster	<b>303(d) Impairment Listing</b>	No

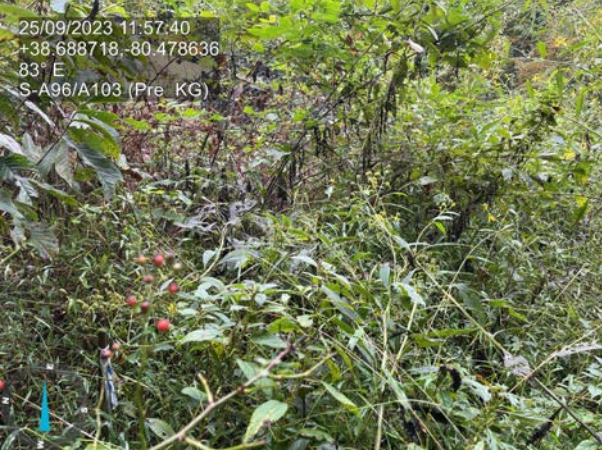
<b>GPS Location</b>	See caption in photo.	<b>GPS Location</b>	See caption in photo.
<b>Description</b>	Downstream view of permitted impact area during pre-construction assessment.	<b>Description</b>	Downstream view of unimpacted area during pre-construction assessment.

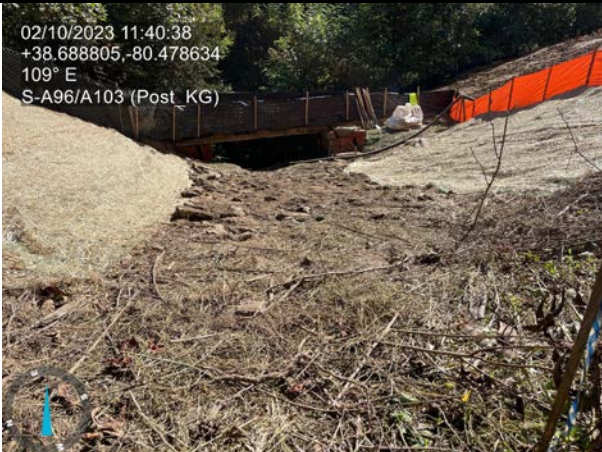
<b>GPS Location</b>	See caption in photo.	<b>GPS Location</b>	See caption in photo.
<b>Description</b>	Downstream view of permitted impact area during post-construction assessment.	<b>Description</b>	Downstream view of unimpacted area during post-construction assessment.

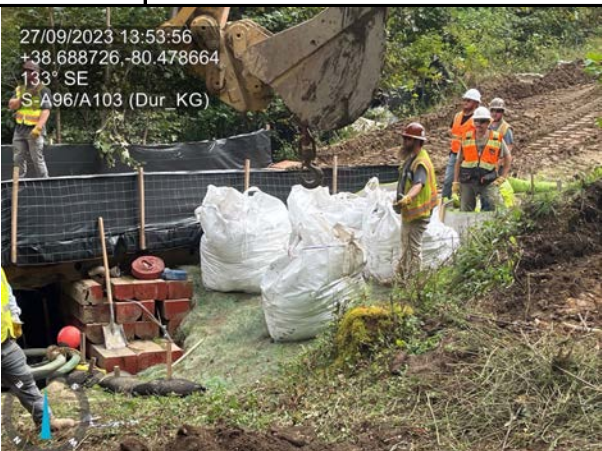
<b>GPS Location</b>	See caption in photo.	<b>GPS Location</b>	See caption in photo.
<b>Description</b>	Segregated stream substrate.	<b>Description</b>	Crew beginning to dig on coming in side of feature.
