Stream Biological Conditions EA Report

Project Name	H-600 Pipeline Spread C	AFE	124300131	Spread	H-600 Pipeline Spread C
Contractor	Precision	Report #	269		
Environmental Auditor	Kyle Gillow	Date/Time	10/4/2023 11:28 AM		
Stream ID	S-A97	Crossing Start Date	10/4/2023	Crossing Completion Date	10/10/2023
Milepost	80.91	Pre-Con Assessment Date	9/26/2023	Post-Con Assessment Date	10/12/2023
Station	4271+79	Bankfull Width (ft.)	8.0	Riffle:Pool Complexes Present?	No
State	WV	Stream Classification	Intermittent		
County	Webster	303(d) Impairment Listing	No

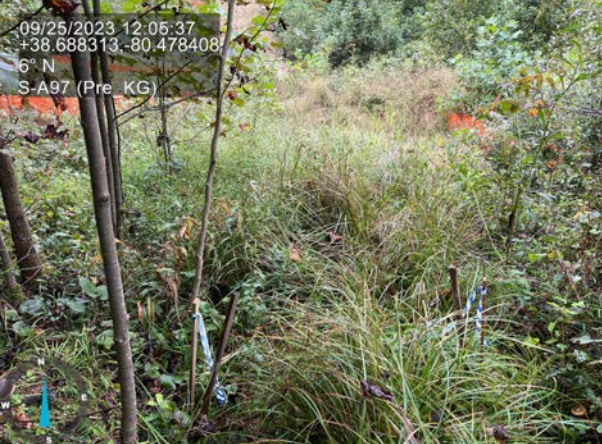
GPS Location See caption in photo.	GPS Location See caption in photo.
Description Downstream view of permitted impact area during pre-construction assessment.	Description Downstream view of unimpacted area during pre-construction assessment.

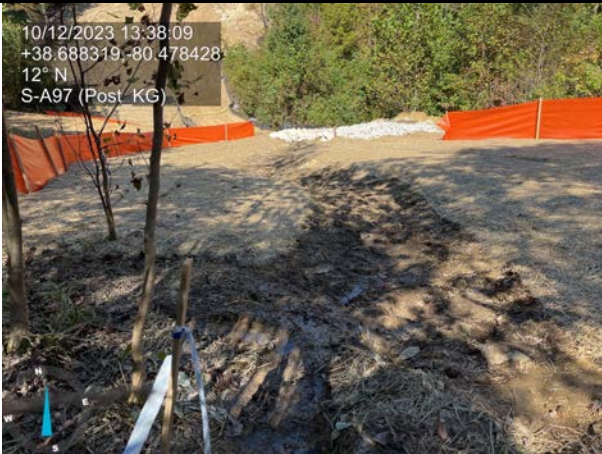
GPS Location See caption in photo.	GPS Location See caption in photo.
Description Downstream view of permitted impact area during post-construction assessment.	Description Downstream view of unimpacted area during post-construction assessment.

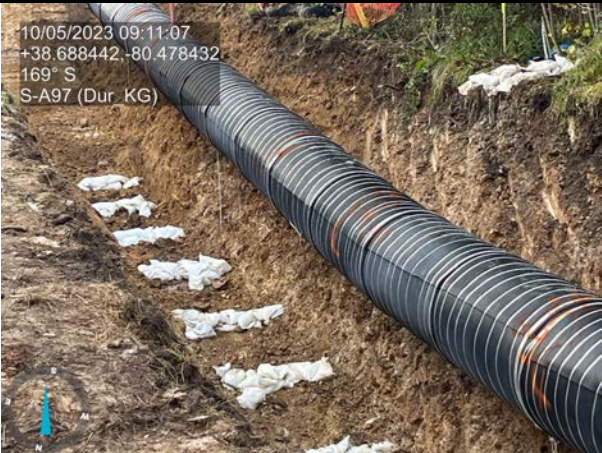
GPS Location See caption in photo.	GPS Location See caption in photo.
Description Lowering pipe in trench through feature.	Description Carrying section to be lowered in through feature.
