Stream Biological Conditions EA Report

Project Name	H-600 Pipeline Spread C	AFE	124300131	Spread	H-600 Pipeline Spread C
Contractor	Precision	Report #	279		
Environmental Auditor	Kyle Gillow	Date/Time	10/5/2023 12:13 PM		
Stream ID	S-A98S	Crossing Start Date	10/5/2023	Crossing Completion Date	10/10/2023
Milepost	80.94	Pre-Con Assessment Date	9/26/2023	Post-Con Assessment Date	10/12/2023
Station	4273+70	Bankfull Width (ft.)	7.0	Riffle:Pool Complexes Present?	No
State	WV	Stream Classification	Intermittent		
County	Webster	303(d) Impairment Listing	No

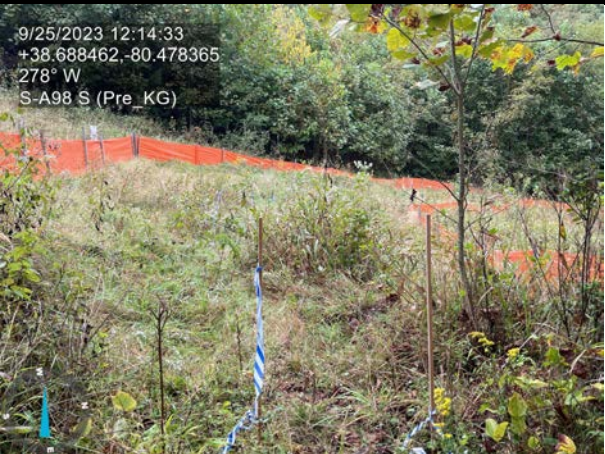
<p>9/25/2023 12:14:33 +38.688462,-80.478365 278° W S-A98 S (Pre_KG)</p>

GPS Location	See caption in photo.	GPS Location	See caption in photo.
Description	Downstream view of permitted impact area during pre-construction assessment.	Description	Downstream view of unimpacted area during pre-construction assessment.
<p>10/12/2023 13:45:19 +38.687866,-80.478011 301° NW S-A98 S (Post_KG)</p>

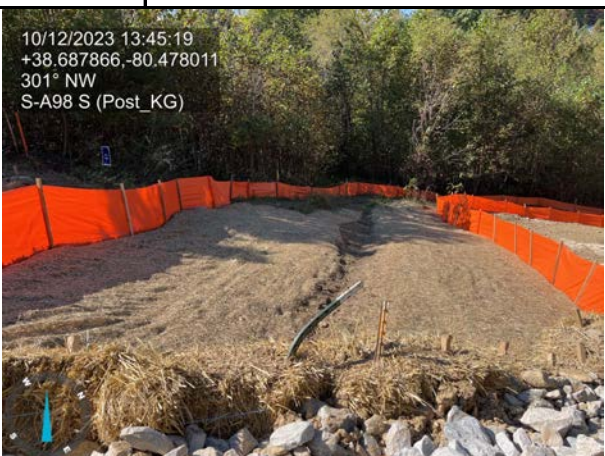
GPS Location	See caption in photo.	GPS Location	See caption in photo.
Description	Downstream view of permitted impact area during post-construction assessment.	Description	Downstream view of unimpacted area during post-construction assessment.
<p>10/06/2023 10:06:24 +38.687903,-80.478168 31° NE S-A98 S (Dur_KG)</p>

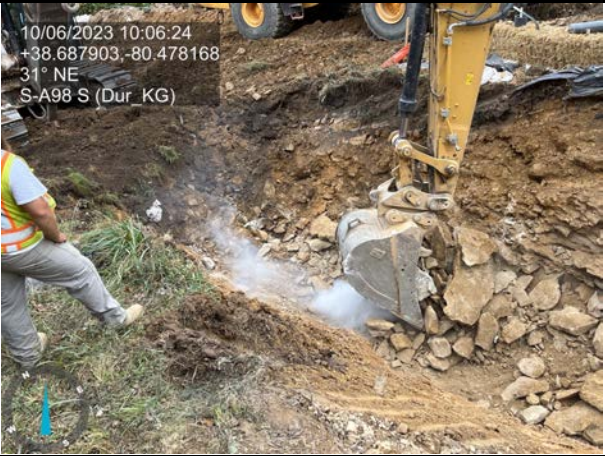
GPS Location	See caption in photo.	GPS Location	See caption in photo.
Description	Trenching through feature S-A98s.	Description	Lowering in final section getting ready to tie in section at feature.
