Stream Biological Conditions EA Report

Project Name	H-600 Pipeline Spread E	AFE	124300134	Spread	H-600 Pipeline Spread E
Contractor	Price Gregory	Report #	30		
Environmental Auditor	Charles Haden	Date/Time	8/8/2023 10:04 AM		
Stream ID	S-EF41	Crossing Start Date	8/8/2023	Crossing Completion Date	9/20/2023
Milepost	133.20	Pre-Con Assessment Date	8/8/2023	Post-Con Assessment Date	9/20/2023
Station	7032+84	Bankfull Width (ft.)	4.6	Riffle:Pool Complexes Present?	No
State	WV	Stream Classification	Intermittent		
County	Nicholas	303(d) Impairment Listing	No

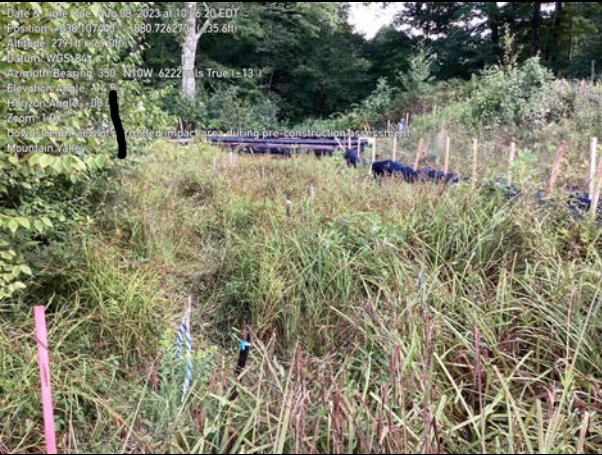
GPS Location	See Photo	GPS Location	See Photo		
Description	Downstream view of permitted impact area during pre-construction assessment.	Description	Downstream view of unimpacted area during pre-construction assessment.

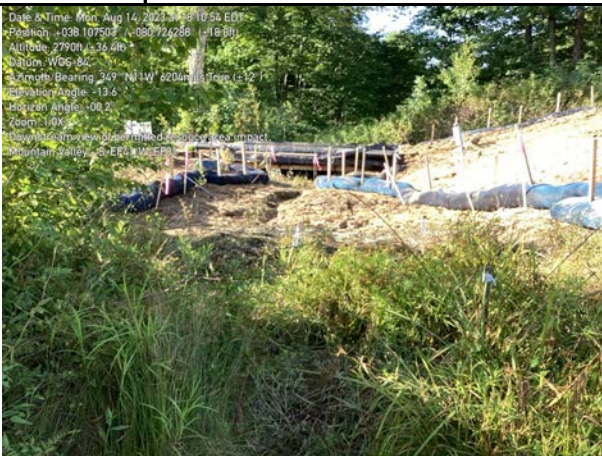
GPS Location	See Photo	GPS Location	See Photo		
Description	Downstream view of permitted impact area during post-construction assessment. Original Post Construction Photo	Description	Downstream view of unimpacted area during post-construction assessment. Original Post Construction Photo

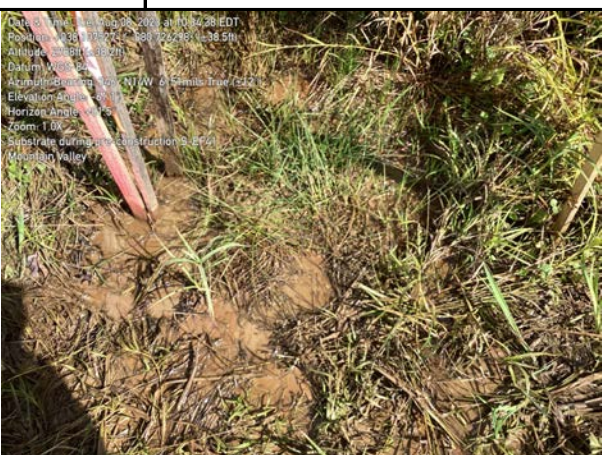
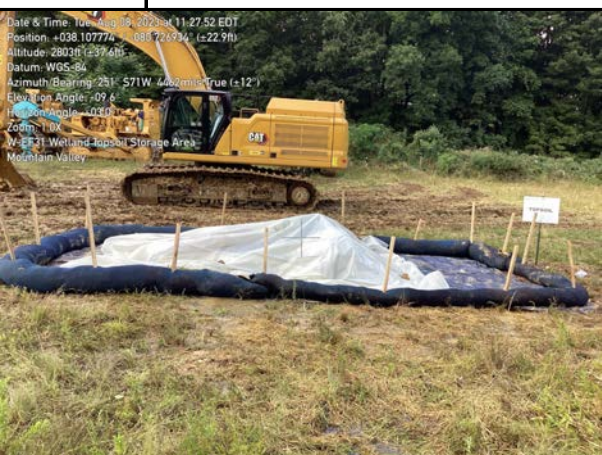
GPS Location	See Photo	GPS Location	See Photo		
Description	Photo 1: Pre-construction stream substrate.	Description	Photo 2: Segregated stream substrate.

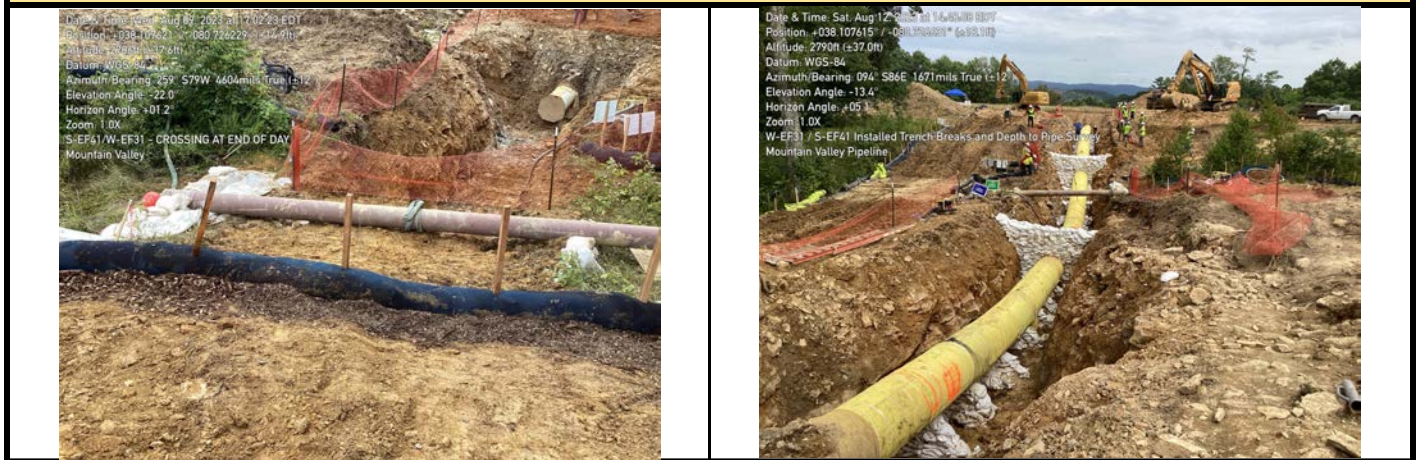
GPS Location See Photo	GPS Location See Photo
Description Photo 3: Trench on LDB	Description Photo 4: Trench breaks installed.

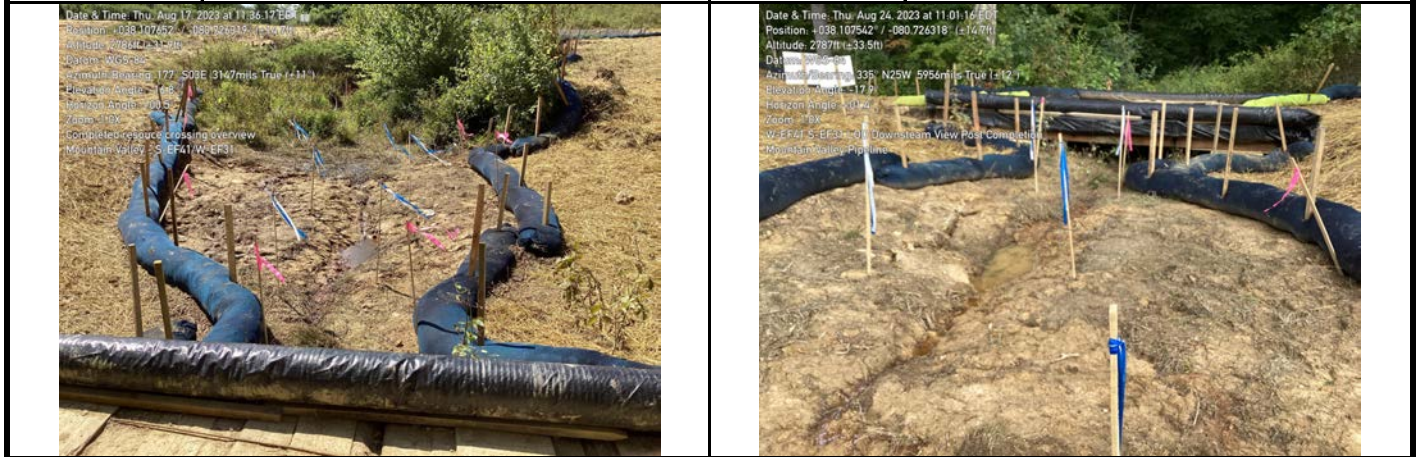
GPS Location See Photo	GPS Location See Photo
Description Photo 5: Surveyed and restored stream.	Description Photo 6: Sinking stream (8/24/2023)

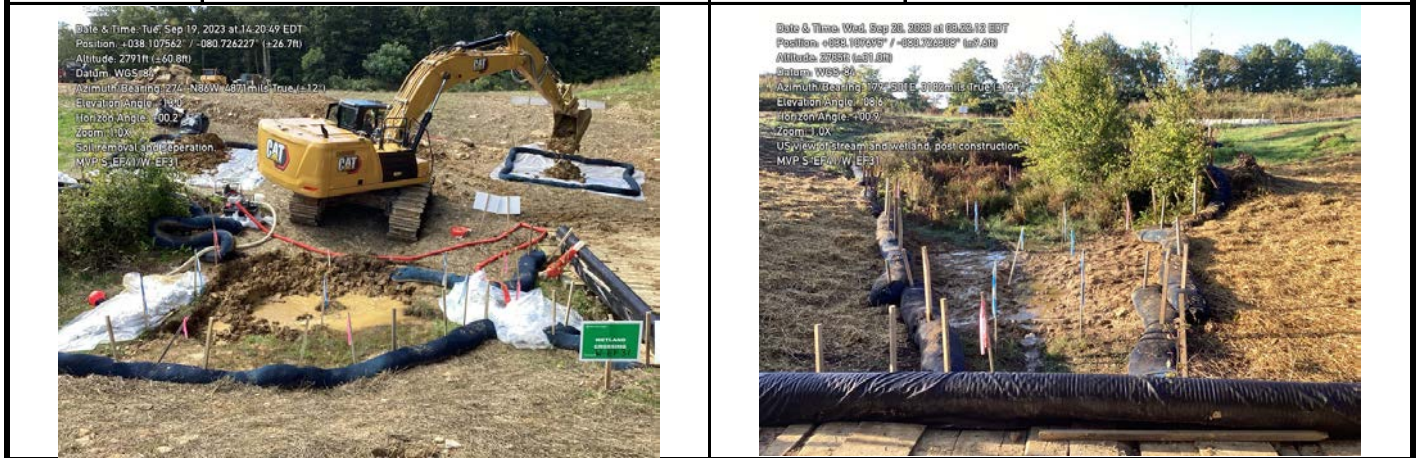
GPS Location See Photo	GPS Location See Photo
Description Photo 7: Stream substrate removed and segregated (9/19/2023).	Description Photo 8: Stream surveyed and restored (9/20/2023).

Additional Notes						
<p>Pre-Construction Notes</p> <p>*Bankfull width measured at OHWM stakes</p> <p>15. Substrate is primarily composed of silt and clay (Photo 1).</p> <p>18. Pre-Con - Timber mat present (travel lane)</p> <p>Day 1 (8/8/2023)</p> <p>Pre-Construction meeting at 0900. EI for crossing is Johnny Graham. 0.69" of precipitation recorded in previous 24-hours. Both wetland topsoil and stream substrate were removed to upland area and segregated separately (Photo 2).</p> <p>Day 2 (8/9/2023)</p> <p>Crossing location prepped and marked for trenching. Trenching to crossing on LDB (Photo 3).</p> <p>Day 3 (8/10/2023)</p> <p>Continuation of trench hammering and soil/rock removal. Trench completed, additional soil removal around pipe ends, and end plate cut and pipe end grinded/cleaned. Intermittent heavy rain all day.</p> <p>Day 4 (8/11/2023)</p> <p>Move and lower pipe into trench.</p> <p>Day 5 (8/14/2023)</p> <p>Light Rain Pipe is installed with appropriate trench breakers. Trench backfilled (Photo 6). Upland areas have been backfilled and brought to grade. Top 12" of stream substrate was replaced and graded to original stream topography. Permanent seed was applied.</p> <p>Post Construction Notes</p> <p>16., 17. Crossing and riparian areas have been recently restored. These areas will be monitored until 80% vegetative coverage has been achieved and areas that do not have 80% vegetative cover within 30 days will be reseeded. 19. Does not include timber mats that remain in place for travel lane.</p> <p>Discovered stream and wetland have sunken, yet flow was still present (8/24/2023).</p> <p>9/19/2023</p> <p>Stream substrate was removed stream above trenched area and placed in an upland area for storage (Photo 7). Some vegetative growth was noted. Additional fill placed in stream. Stream surveyed and restored with original substrate.</p> <p>9/20/2023</p> <p>Area seeded and riparian zone completed (Photo 8). Post Construction Assessment completed.</p>
