# Stream Biological Conditions EA Report

<b>Project Name</b>	H-600 Pipeline Spread D	<b>AFE</b>	124300132	<b>Spread</b>	H-600 Pipeline Spread D
<b>Contractor</b>	Precision	<b>Report #</b>	248		
<b>Environmental Auditor</b>	Roderick Grills	<b>Date/Time</b>	9/22/2023 6:29 PM		
<b>Stream ID</b>	S-E49	<b>Crossing Start Date</b>	9/15/2023	<b>Crossing Completion Date</b>	9/21/2023
<b>Milepost</b>	110.00	<b>Pre-Con Assessment Date</b>	9/8/2023	<b>Post-Con Assessment Date</b>	9/21/2023
<b>Station</b>	5808+20	<b>Bankfull Width (ft.)</b>	3.3	<b>Riffle:Pool Complexes Present?</b>	No
<b>State</b>	WV	<b>Stream Classification</b>	Ephemeral		
<b>County</b>	Webster	<b>303(d) Impairment Listing</b>	No

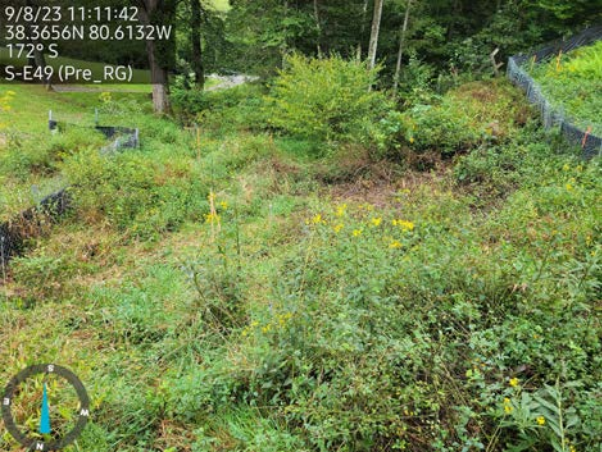
<p>9/8/23 11:11:42 38.3656N 80.6132W 172° S S-E49 (Pre_RG)</p>

<b>GPS Location</b>	See caption in photo	<b>GPS Location</b>	See caption in photo
<b>Description</b>	Downstream view of permitted impact area during pre-construction assessment. Looking downstream from bridge of impact area pre-construction.	<b>Description</b>	Downstream view of unimpacted area during pre-construction assessment. Looking downstream from LOD edge of unimpacted area pre-construction.
<p>9/21/23 15:46:25 38.36557083N 80.61322276W 131° SE S-E49 (Post_RG)</p>

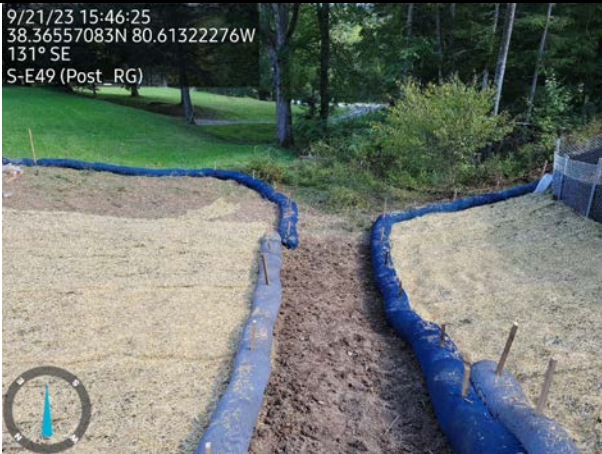
<b>GPS Location</b>	See caption in photo	<b>GPS Location</b>	See caption in photo
<b>Description</b>	Downstream view of permitted impact area during post-construction assessment. Looking downstream from bridge of impact area post-construction.	<b>Description</b>	Downstream view of unimpacted area during post-construction assessment. Looking downstream from LOD edge of unimpacted area post-construction.

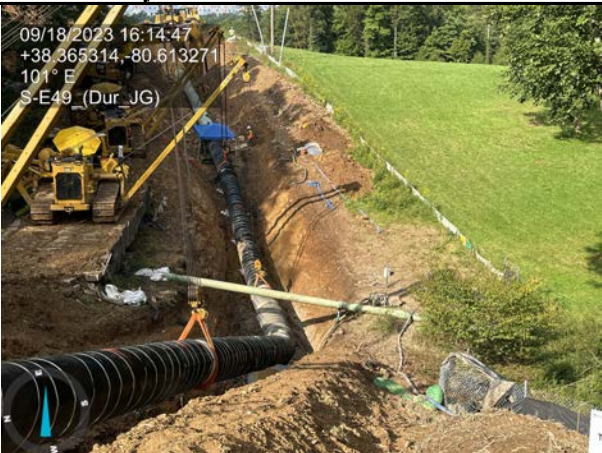
<p>09/18/2023 16:14:47 +38.365314,-80.613271 101° E S-E49 (Dur_JG)</p>

<b>GPS Location</b>	See caption in photo	<b>GPS Location</b>	See caption in photo
<b>Description</b>	Pipe has been lowered in and weld started on CIS.	<b>Description</b>	Flume pipe installed for potential flow.
