Stream Biological Conditions EA Report

Project Name	H-600 Pipeline Spread C	AFE	124300131	Spread	H-600 Pipeline Spread C
Contractor	Precision	Report #	281		
Environmental Auditor	Jeffrey Arbogast	Date/Time	10/9/2023 8:37 AM		
Stream ID	S-H105	Crossing Start Date	10/9/2023	Crossing Completion Date	10/13/2023
Milepost	93.22	Pre-Con Assessment Date	9/11/2023	Post-Con Assessment Date	10/13/2023
Station	4922+19	Bankfull Width (ft.)	3.4	Riffle:Pool Complexes Present?	No
State	WV	Stream Classification	Perennial		
County	Webster	303(d) Impairment Listing	No

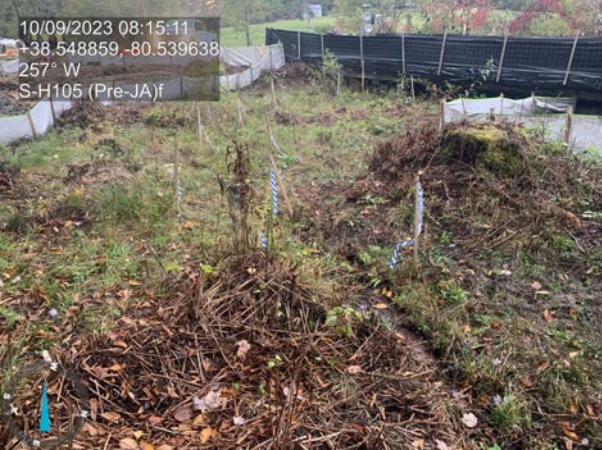
GPS Location	See Caption in Photo	GPS Location	See Caption in Photo
Description	Downstream view of permitted impact area during pre-construction assessment.	Description	Downstream view of unimpacted area during pre-construction assessment.

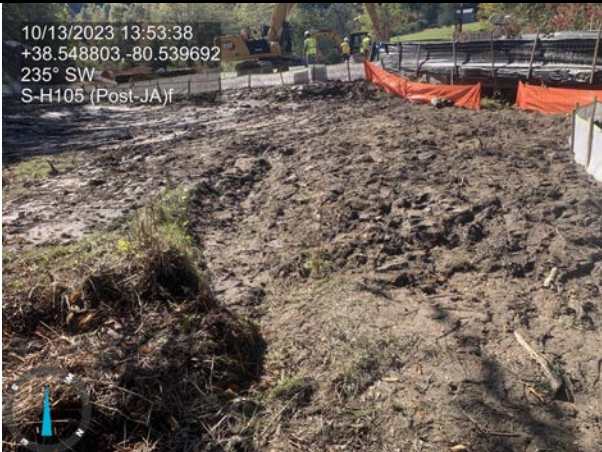
GPS Location	See Caption in Photo	GPS Location	See Caption in Photo
Description	Downstream view of permitted impact area during post-construction assessment.	Description	Downstream view of unimpacted area during post-construction assessment.

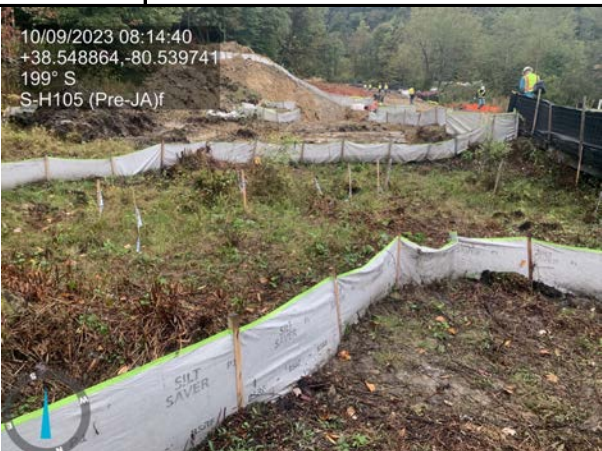
GPS Location	See Caption in Photo	GPS Location	See Caption in Photo
Description	View from CIS standing on the center line pre-construction.	Description	View from GAS standing on the centerline pre-construction.
