# Stream Biological Conditions EA Report

<b>Project Name</b>	H-600 Pipeline Spread C	<b>AFE</b>	124300131	<b>Spread</b>	H-600 Pipeline Spread C
<b>Contractor</b>	Precision	<b>Report #</b>	257		
<b>Environmental Auditor</b>	Jeffrey Arbogast	<b>Date/Time</b>	9/28/2023 2:47 PM		
<b>Stream ID</b>	S-H107	<b>Crossing Start Date</b>	9/28/2023	<b>Crossing Completion Date</b>	10/6/2023
<b>Milepost</b>	93.26	<b>Pre-Con Assessment Date</b>	9/11/2023	<b>Post-Con Assessment Date</b>	10/6/2023
<b>Station</b>	4923+89	<b>Bankfull Width (ft.)</b>	1.8	<b>Riffle:Pool Complexes Present?</b>	No
<b>State</b>	WV	<b>Stream Classification</b>	Intermittent		
<b>County</b>	Webster	<b>303(d) Impairment Listing</b>	No

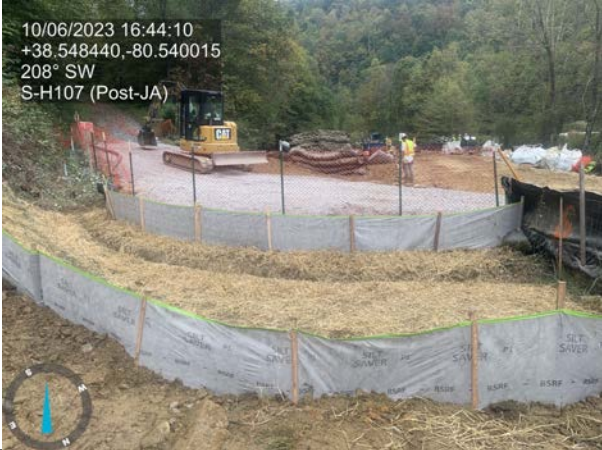
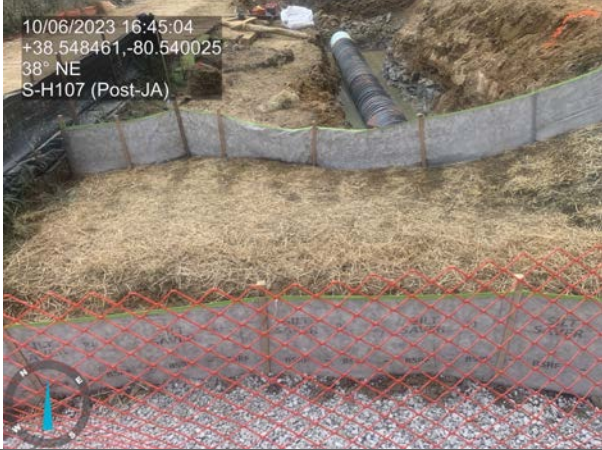
<b>GPS Location</b>	See Caption in Photo	<b>GPS Location</b>	See Caption in Photo
<b>Description</b>	Standing on the CIS of the crossing on the centerline post-construction.	<b>Description</b>	Standing on the GAS of the crossing on the centerline post-construction.

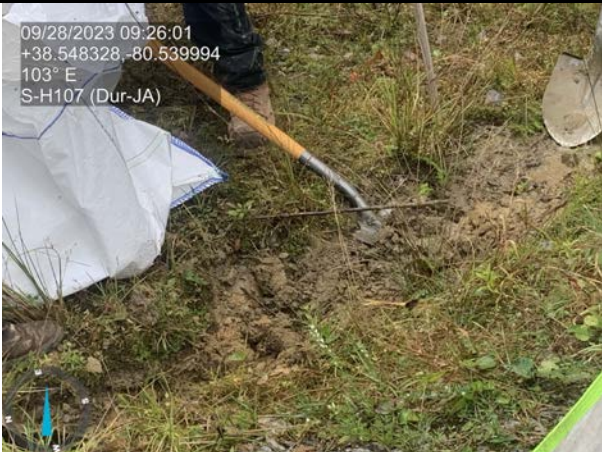
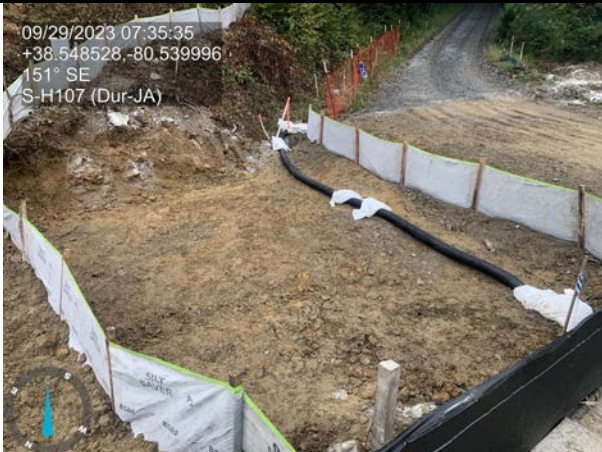
<b>GPS Location</b>	See Caption in Photo	<b>GPS Location</b>	See Caption in Photo
<b>Description</b>	The top 12" of stream substrate being removed by hand and segregated into super sacks.	<b>Description</b>	ECDs returned to stream after blasting has been completed.

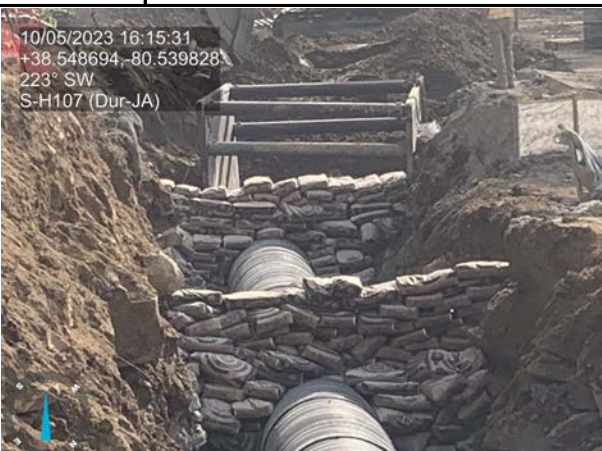
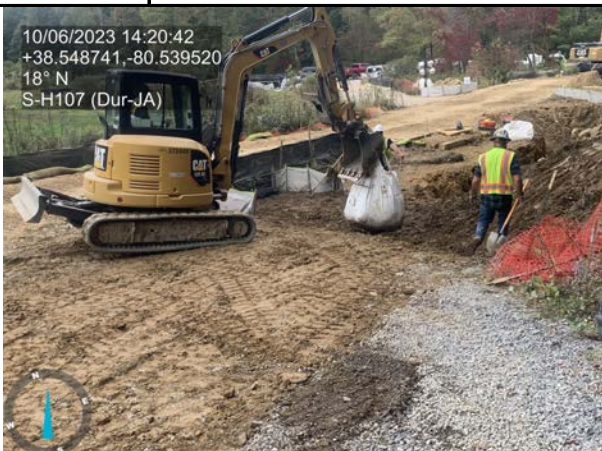
<b>GPS Location</b>	See Caption in Photo	<b>GPS Location</b>	See Caption in Photo
<b>Description</b>	Bentonite trench breakers.	<b>Description</b>	Stream substrate being placed in the channel.
