Stream Biological Conditions EA Report

Project Name	H-600 Pipeline Spread C	AFE	124300131	Spread	H-600 Pipeline Spread C
Contractor	Precision	Report #	299		
Environmental Auditor	Jeffrey Arbogast	Date/Time	10/16/2023 1:04 PM		
Stream ID	S-H108	Crossing Start Date	10/16/2023	Crossing Completion Date	10/19/2023
Milepost	93.18	Pre-Con Assessment Date	9/11/2023	Post-Con Assessment Date	10/20/2023
Station	4919+79	Bankfull Width (ft.)	6.3	Riffle:Pool Complexes Present?	No
State	WV	Stream Classification	Perennial		
County	Webster	303(d) Impairment Listing	No

AFE 124300131		Date/Time	10/16/2023 1:04 PM	Report #	299
Required Photos

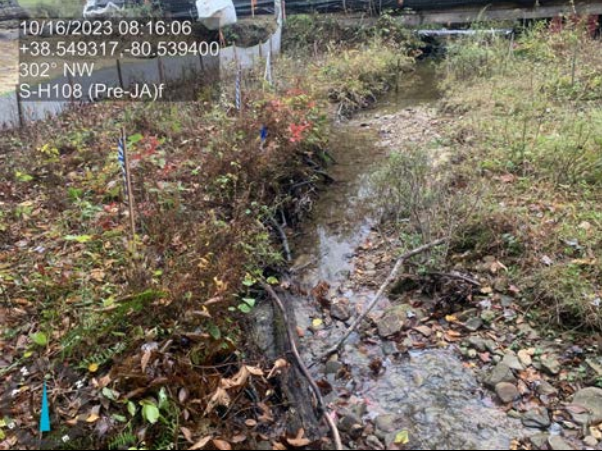
<p>10/16/2023 08:16:06 +38.549317,-80.539400 302° NW S-H108 (Pre-JA)f</p>

<p>10/16/2023 08:19:17 +38.549508,-80.539597 269° W S-H108 (Pre-JA)f</p>			
GPS Location	See caption in photo		GPS Location	See caption in photo	
Description	Downstream view of permitted impact area during pre-construction assessment. Photo taken standing on left side of LOD facing downstream.		Description	Downstream view of unimpacted area during pre-construction assessment. Photo taken standing on right side of LOD facing downstream.

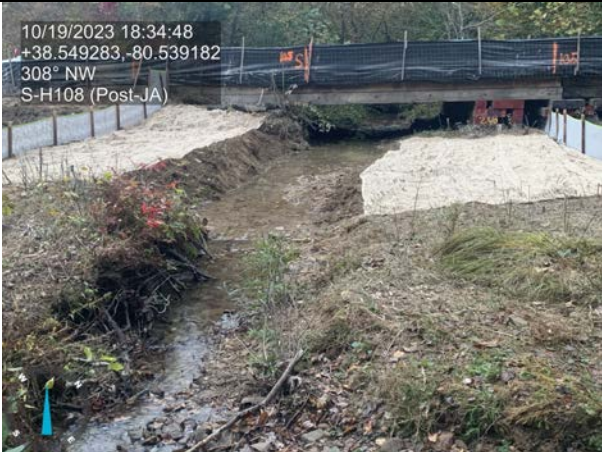
<p>10/19/2023 18:34:48 +38.549283,-80.539182 308° NW S-H108 (Post-JA)</p>

<p>10/20/2023 15:27:58 +38.549393,-80.539407 271° W S-H108 (Post-JA)</p>			
GPS Location	See caption in photo		GPS Location	See caption in photo	
Description	Downstream view of permitted impact area during post-construction assessment. Photo taken standing on left side of LOD facing downstream.		Description	Downstream view of unimpacted area during post-construction assessment. Photo taken standing on right side of LOD facing downstream.

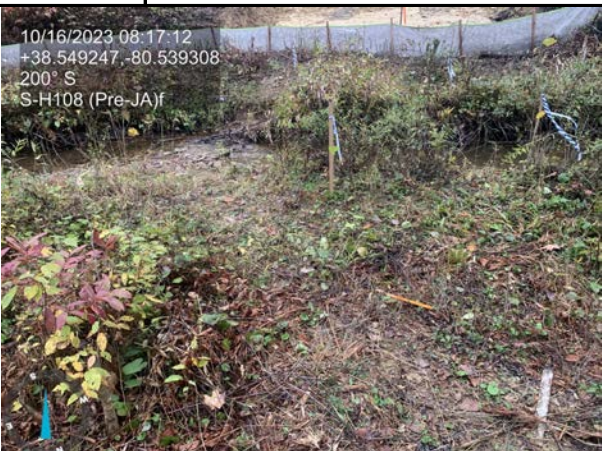
<p>10/16/2023 08:17:12 +38.549247,-80.539308 200° S S-H108 (Pre-JA)f</p>

<p>10/16/2023 08:14:48 +38.549258,-80.539209 41° NE S-H108 (Pre-JA)f</p>			
GPS Location	See caption in photo		GPS Location	See caption in photo	
Description	View from CIS of crossing, facing SSW. Pre-Construction.		Description	View from GAS of crossing, facing NE. Pre-Construction.
