Stream Biological Conditions EA Report

Project Name	H-600 Pipeline Spread C	AFE	124300131	Spread	H-600 Pipeline Spread C
Contractor	Precision	Report #	252		
Environmental Auditor	Josh Guy	Date/Time	9/14/2023 9:41 PM		
Stream ID	S-I57	Crossing Start Date	9/14/2023	Crossing Completion Date	9/20/2023
Milepost	79.89	Pre-Con Assessment Date	9/6/2023	Post-Con Assessment Date	9/20/2023
Station	4218+17	Bankfull Width (ft.)	32.6	Riffle:Pool Complexes Present?	No
State	WV	Stream Classification	Perennial		
County	Braxton	303(d) Impairment Listing	No

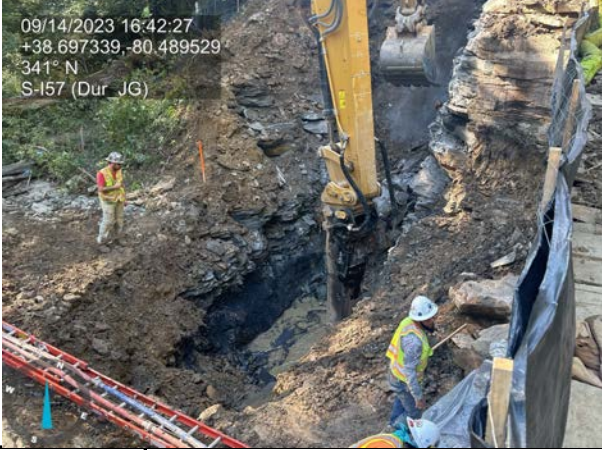
GPS Location	In photo above	GPS Location	In photo above
Description	Viewing downstream of mat bridge of contractor ditching/hammering ditch line after blasting efforts.	Description	View of stream section lowered in and contractor preparing to make a weld in upland area.

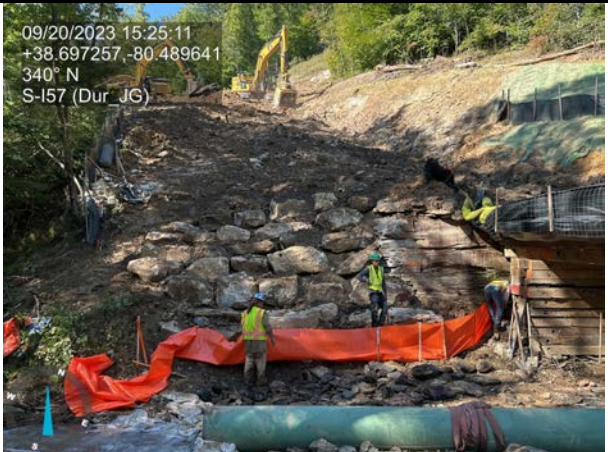
GPS Location	In photo above	GPS Location	In photo above
Description	Viewing upstream from LOD of contractor having restored stream bed within high water marks and backfilling C.I.S. buffer zone.	Description	View from G.A.S. stream bank of contractor stabilizing C.I.S. stream buffer soils with large stones/boulders.
Insert image here		Insert image here	
GPS Location		GPS Location	
Description		Description
