# Stream Biological Conditions EA Report

<b>Project Name</b>	H-600 Pipeline Spread D	<b>AFE</b>	124300132	<b>Spread</b>	H-600 Pipeline Spread D
<b>Contractor</b>	Precision	<b>Report #</b>	288		
<b>Environmental Auditor</b>	Gary Cruz	<b>Date/Time</b>	10/2/2023 8:13 PM		
<b>Stream ID</b>	S-J28	<b>Crossing Start Date</b>	10/2/2023	<b>Crossing Completion Date</b>	10/11/2023
<b>Milepost</b>	119.93	<b>Pre-Con Assessment Date</b>	10/2/2023	<b>Post-Con Assessment Date</b>	10/11/2023
<b>Station</b>	6332+09	<b>Bankfull Width (ft.)</b>	5.0	<b>Riffle:Pool Complexes Present?</b>	No
<b>State</b>	WV	<b>Stream Classification</b>	Intermittent		
<b>County</b>	Nicholas	<b>303(d) Impairment Listing</b>	No

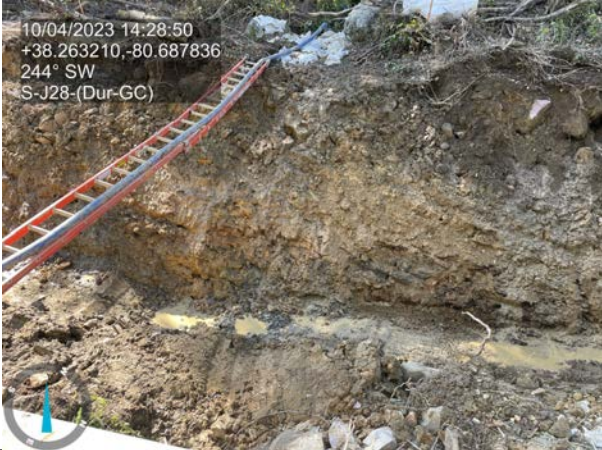
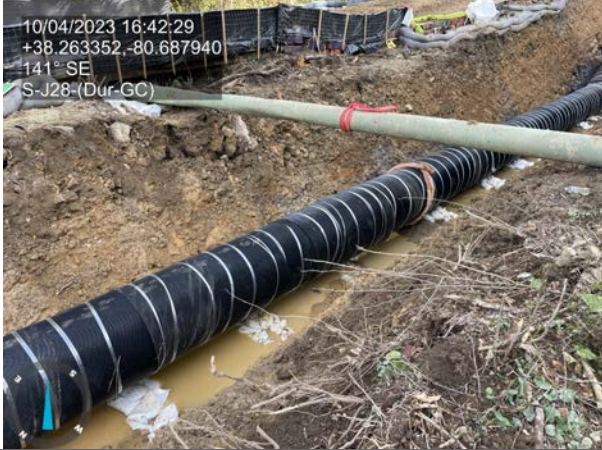
<b>GPS Location</b>	See photo above	<b>GPS Location</b>	See photo above
<b>Description</b>	Contractor excavated ditch line within the stream.	<b>Description</b>	Section of pipe has been laid within the ditch line of stream.

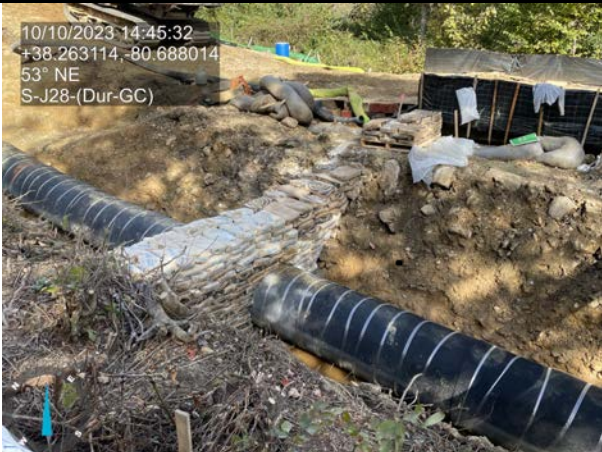
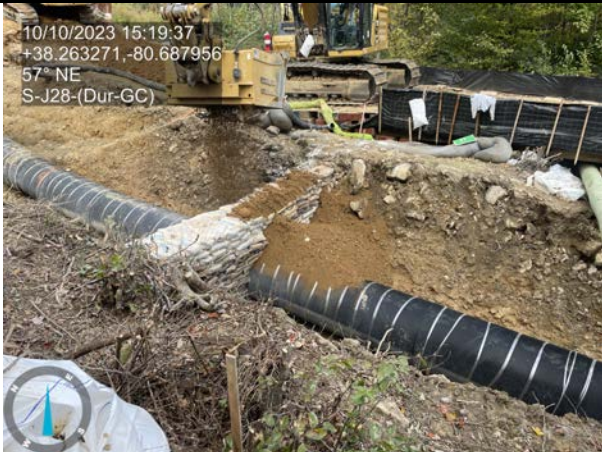
<b>GPS Location</b>	See photo above	<b>GPS Location</b>	See photo above
<b>Description</b>	Impervious trench breaker has been installed at 6331+95.	<b>Description</b>	Operator padding the ditch line within the feature.

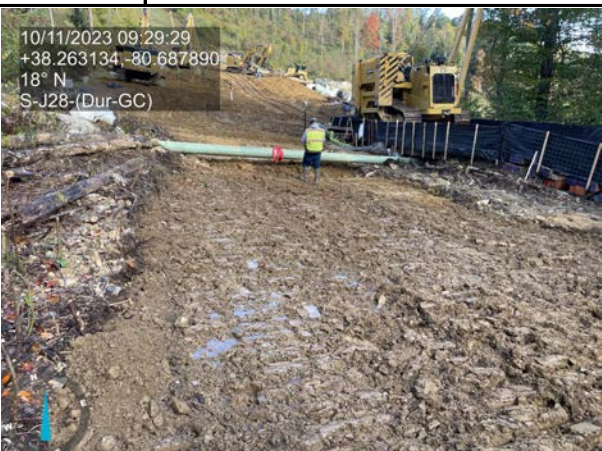
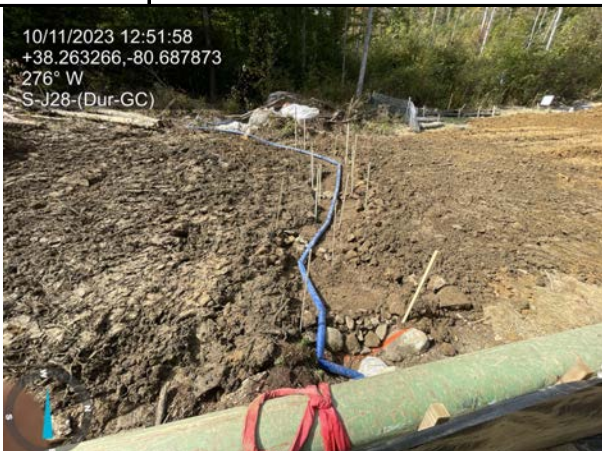
<b>GPS Location</b>	See photo above	<b>GPS Location</b>	See photo above
<b>Description</b>	Survey shooting the grade of stream to original elevation.	<b>Description</b>	Contractor has finished building the contours to its original state according to survey.
