Stream Biological Conditions EA Report

Project Name	H-600 Pipeline Spread F	AFE	124300135	Spread	H-600 Pipeline Spread F
Contractor	Price Gregory	Report #	226		
Environmental Auditor	Beth Burdette	Date/Time	9/9/2023 8:11 PM		
Stream ID	S-J5	Crossing Start Date	9/19/2023	Crossing Completion Date	10/6/2023
Milepost	172.86	Pre-Con Assessment Date	9/11/2023	Post-Con Assessment Date	10/6/2023
Station	9127+20	Bankfull Width (ft.)	16.3	Riffle:Pool Complexes Present?	No
State	WV	Stream Classification	Perennial		
County	Summers	303(d) Impairment Listing	No

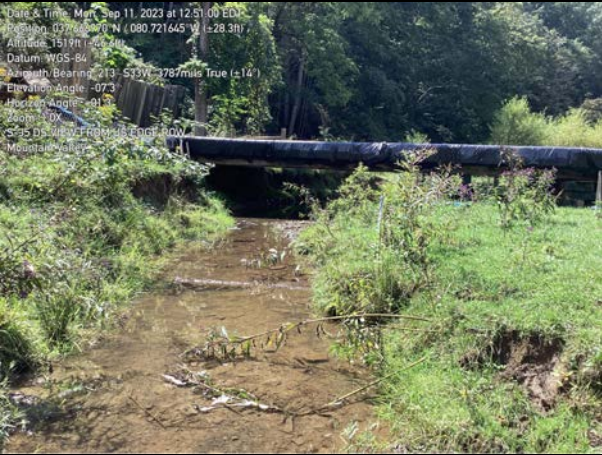
GPS Location	See Photo	GPS Location	See Photo		
Description	Downstream view of permitted impact area during pre-construction assessment. DS View of resource from US edge of ROW	Description	Downstream view of unimpacted area during pre-construction assessment. DS View of resource from DS edge of ROW

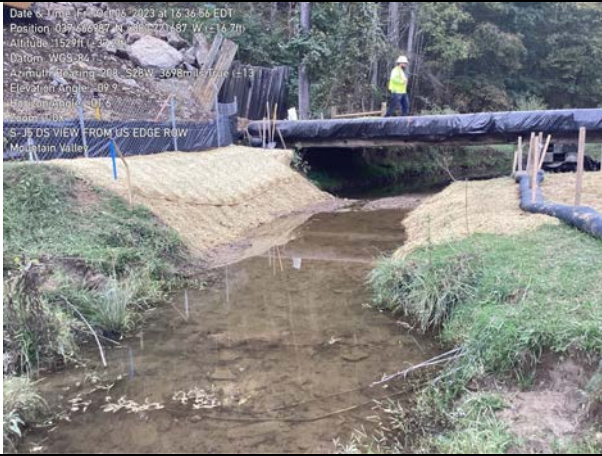
GPS Location	See Photo	GPS Location	See Photo		
Description	Downstream view of permitted impact area during post-construction assessment. DS View of resource from US edge of ROW	Description	Downstream view of unimpacted area during post-construction assessment. DS View of resource from DS edge of ROW

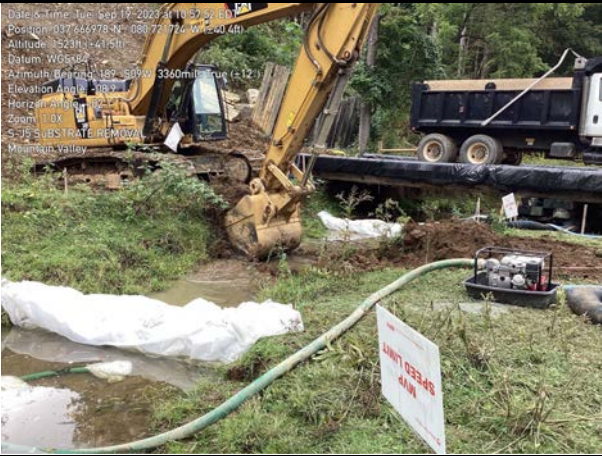
GPS Location	See Photo	GPS Location	See Photo		
Description	Photo 1: Removal of stream substrate.	Description	Photo 2: Stream substrate segregated in an upland area.

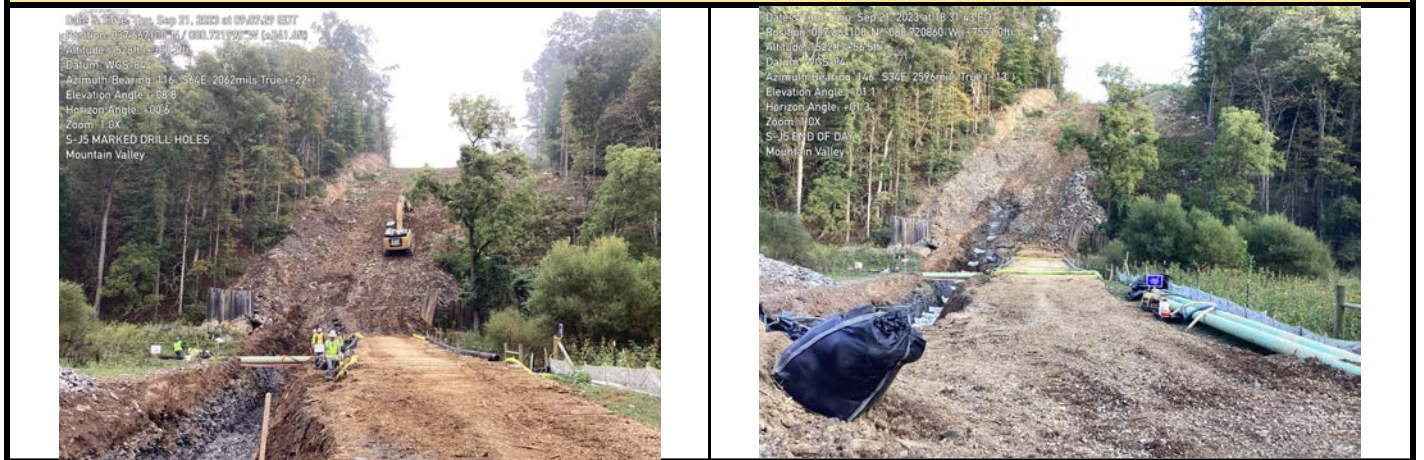
GPS Location See Photo	GPS Location See Photo
Description Photo 3: Trench through aquatic resource.	Description Photo 4: Bedding placed in trench in aquatic resource.

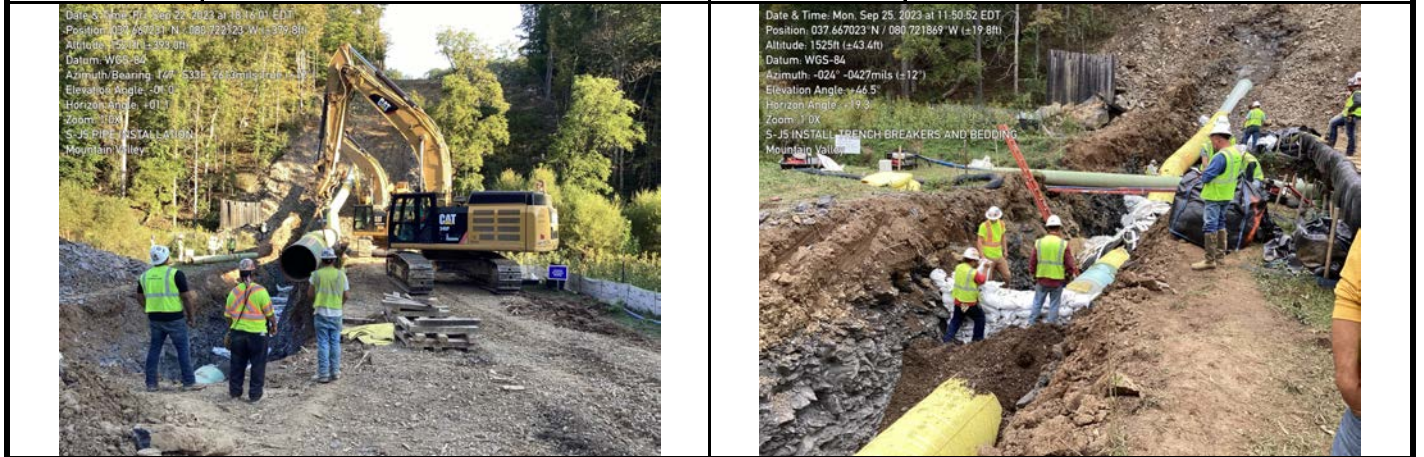
GPS Location See Photo	GPS Location See Photo
Description Photo 5: Lowering pipe into aquatic resource.	Description Photo 6: River weights and trench breaks installed in aquatic resource area.

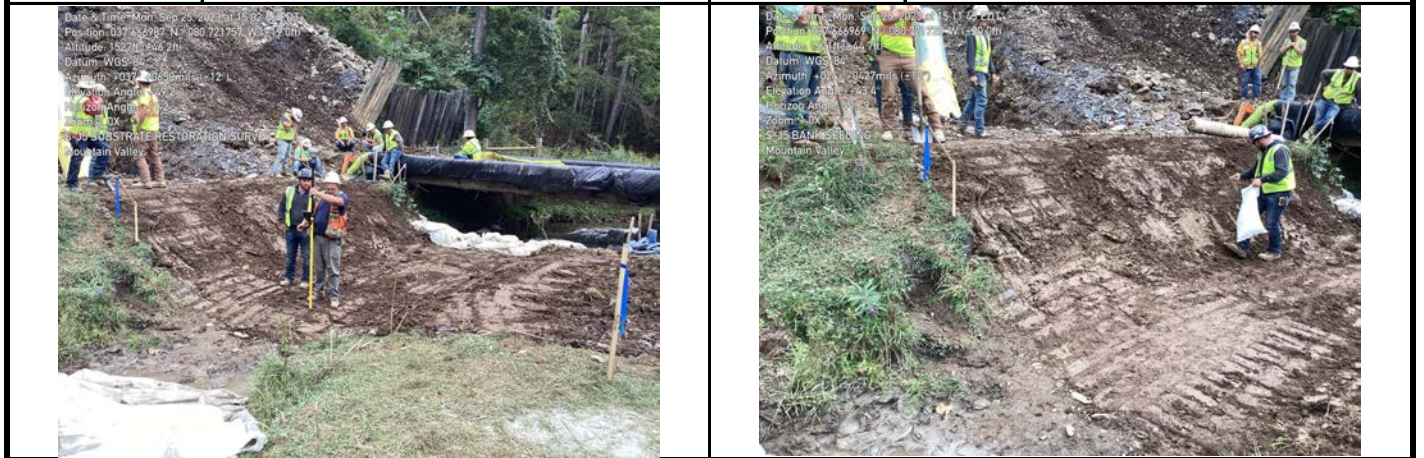
GPS Location See Photo	GPS Location See Photo
Description Photo 7: Substrate restoration and survey.	Description Photo 8: Seeding of banks.
