Stream Biological Conditions EA Report

Project Name	H-600 Pipeline Spread C	AFE	124300131	Spread	H-600 Pipeline Spread C
Contractor	Precision	Report #	223		
Environmental Auditor	Scott Wessel	Date/Time	9/5/2023 8:54 AM		
Stream ID	S-J70	Crossing Start Date	9/5/2023	Crossing Completion Date	9/24/2023
Milepost	72.40	Pre-Con Assessment Date	9/2/2023	Post-Con Assessment Date	9/24/2023
Station	3822+72	Bankfull Width (ft.)	26.8	Riffle:Pool Complexes Present?	No
State	WV	Stream Classification	Perennial		
County	Braxton	303(d) Impairment Listing	No

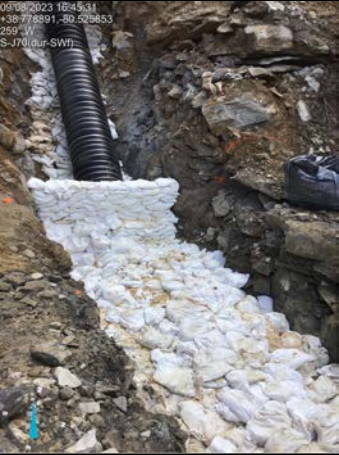
AFE	124300131	Date/Time	9/5/2023 8:54 AM	Report #	223
Optional Photos					
	  <p>09/05/2023 08:04:47 +38.778275, -80.525818 219° SW S-J70(dur-SW)</p>

<p>09/05/2023 08:45:31 +38.778991, -80.525853 259° W S-J70(dur-SW)</p>	
GPS Location	See gps in attached photo		GPS Location	See gps in attached photo	
Description	Pipe lowered in ditch and pumps dewatering.		Description	Sandbag breakers being built.

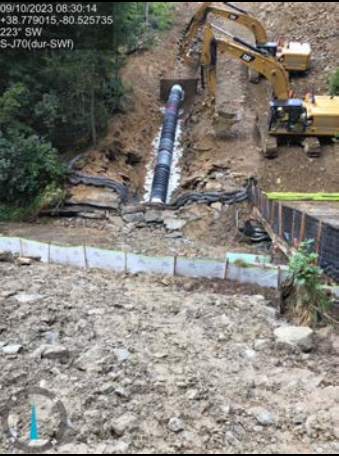
<p>09/05/2023 14:38:00 +38.779162, -80.525947 180° S S-J70(dur-SW)</p>

<p>09/10/2023 08:30:14 +38.779015, -80.525735 223° SW S-J70(dur-SW)</p>	
GPS Location	See gps in attached photo		GPS Location	See gps in attached photo	
Description	Substrate material being put back after pipe installation.		Description	Filter sock and silt fence in place until backfill and stream crossig is complete.
