Stream Biological Conditions EA Report

| Project Name | H-600 Pipeline Spread A | AFE | 124300129 | Spread | H-600 Pipeline Spread A |
| Stream ID | S-K65 | Crossing Start Date | 10/2/2023 | Crossing Completion Date | 10/9/2023 |
| Milepost | 34.33 | Pre-Con Assessment Date | 10/2/2023 | Post-Con Assessment Date | 10/9/2023 |

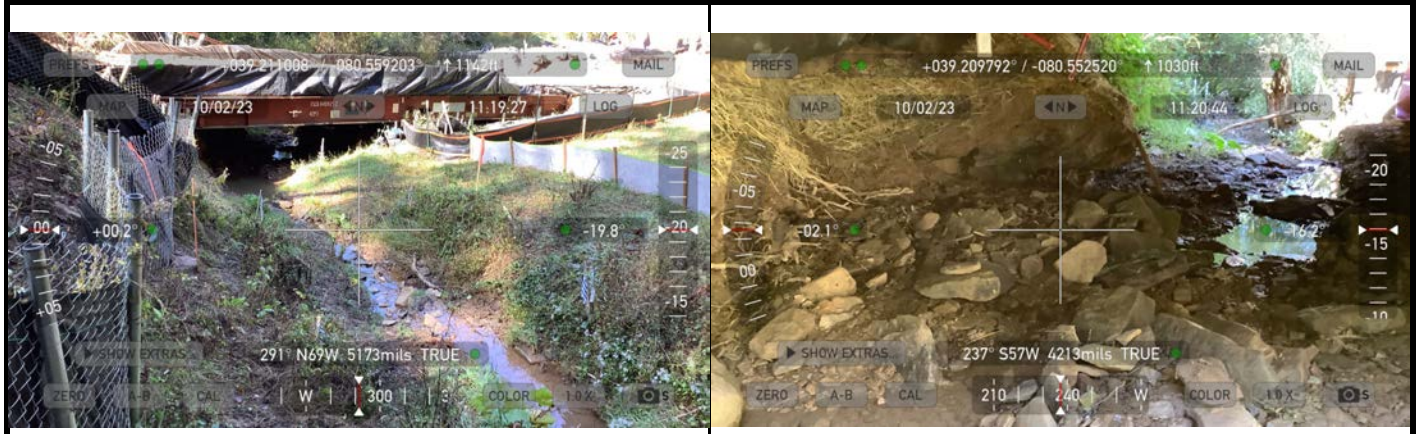
| Description | Downstream view of permitted impact area during pre-construction assessment. | Description | Downstream view of unimpacted area during pre-construction assessment. |

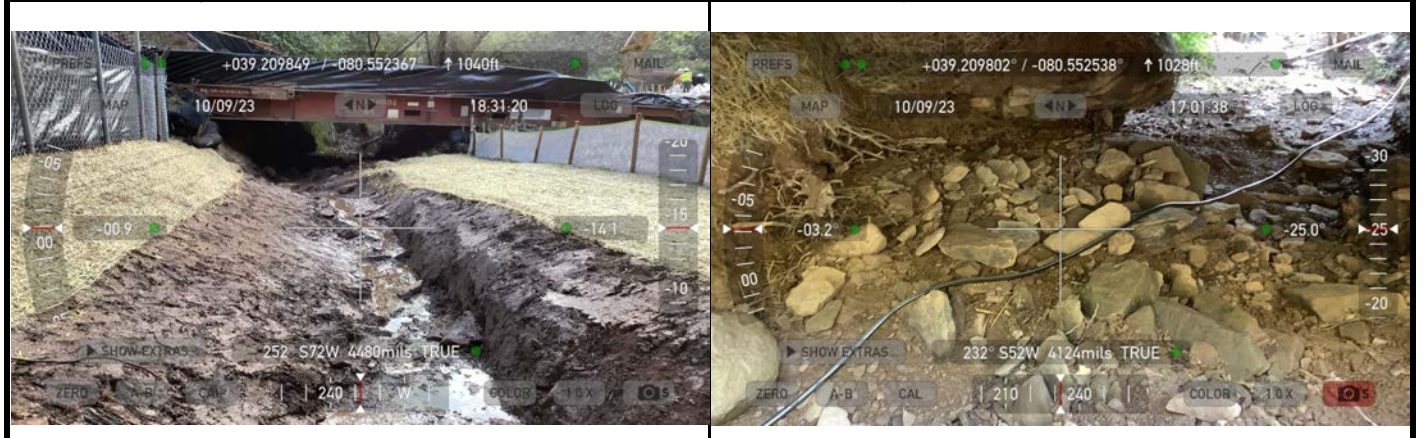
| | | Pre-Con | Post-Con |
|---|--|---|---|
| 16 | Channel Conditions: Rating: 1-Optimal (80-100% stable banks), 2-Sub-optimal (60-80% stable banks), 3-Marginal (40-60% stable banks), 4-Poor (20-40% stable banks), 5-Severe (0-20% stable banks, highly eroded or unvegetated banks) | 3 | 5 |
| 17 | Riparian Buffer Zone within ROW and ≤50 ft. from Stream Top-of-Bank: Rating: 1-Optimal (60-100% heavy vegetative cover), 2-Sub-optimal (30-60% mixed vegetated coverage), 3-Marginal (<30% vegetative coverage), 4-Poor (Mowed/maintained area or farmland, impervious area, sparsely vegetated coverage, etc.) | 1 | 4 |

| Description | Downstream view of permitted impact area during post-construction assessment. | Description | Downstream view of unimpacted area during post-construction assessment. |

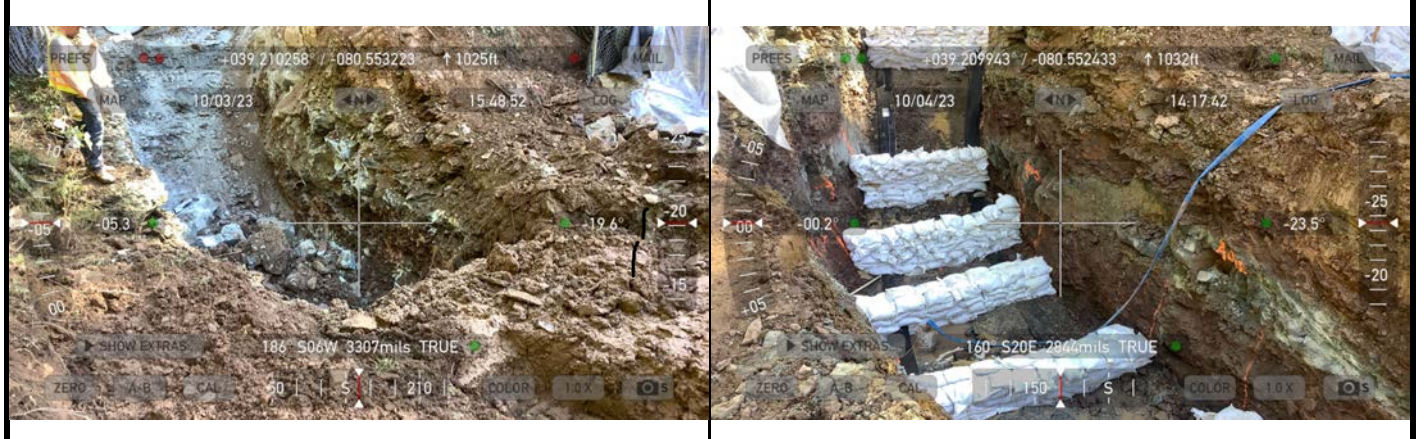
| Description | The photo shows the progress of the trench excavation on 10/3/2023. | Description | The photo shows the progress of construction on 9/4/2023. |

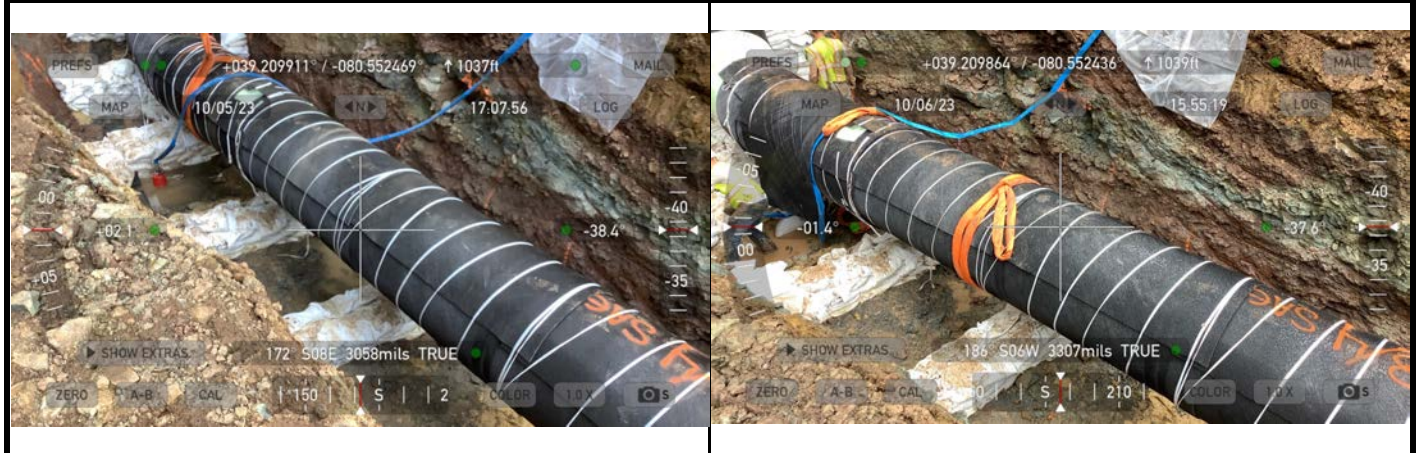
| Description | The photo shows the progress of construction on 9/5/2023. | Description | The photo shows the progress of construction on 9/6/2023. |

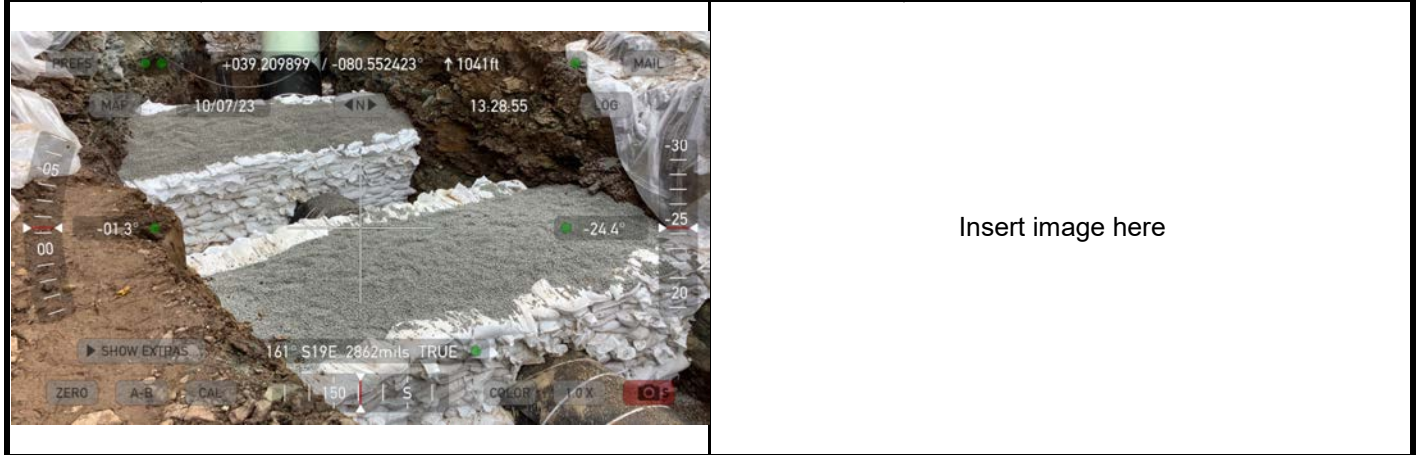
| Description | The photo shows the progress of construction on 9/7/2023. | Description | |
