Stream Biological Conditions EA Report

Project Name	H-600 Pipeline Spread A	AFE	124300129	Spread	H-600 Pipeline Spread A
Contractor	Precision	Report #	260		
Environmental Auditor	Devin Jen	Date/Time	9/25/2023 1:15 PM		
Stream ID	S-K67	Crossing Start Date	9/25/2023	Crossing Completion Date	9/30/2023
Milepost	34.28	Pre-Con Assessment Date	9/25/2023	Post-Con Assessment Date	9/30/2023
Station	1809+87	Bankfull Width (ft.)	10.0	Riffle:Pool Complexes Present?	No
State	WV	Stream Classification	Intermittent		
County	Doddridge	303(d) Impairment Listing	N/A

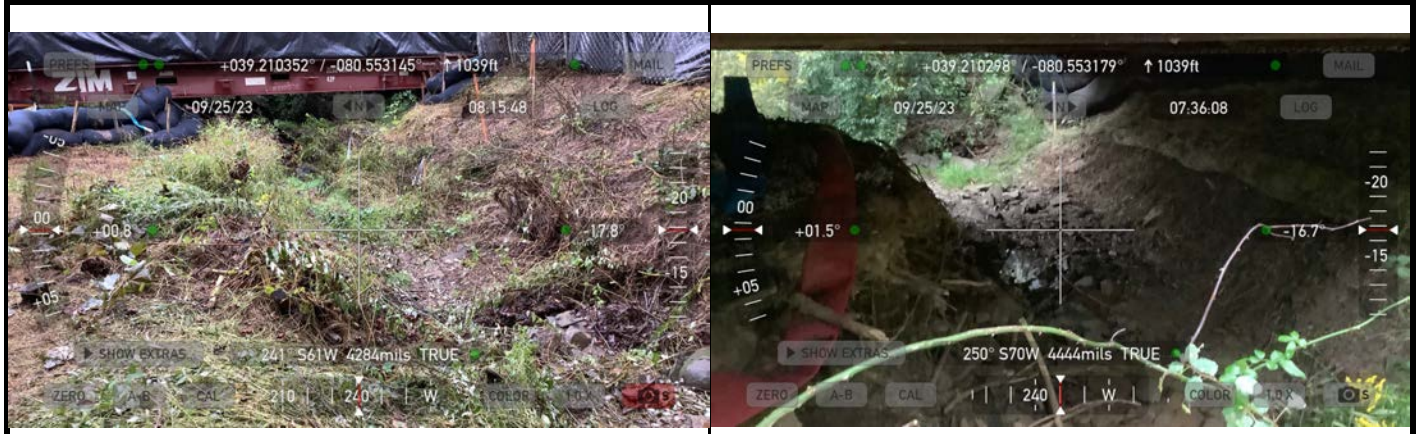
GPS Location	See photo.	GPS Location	See photo.
Description	Downstream view of permitted impact area during pre-construction assessment.	Description	Downstream view of unimpacted area during pre-construction assessment.

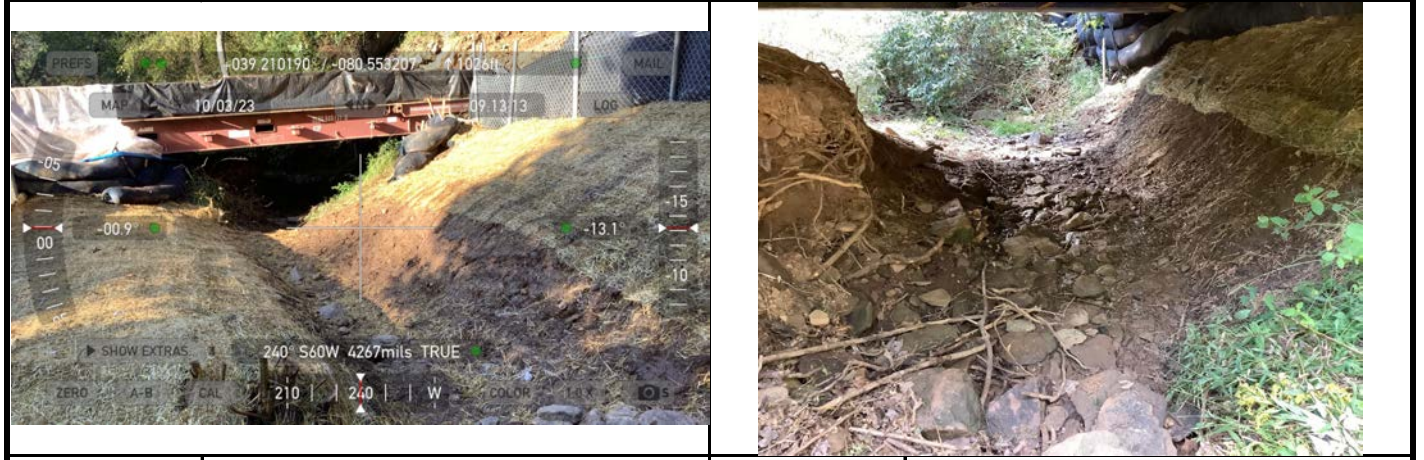
GPS Location	See photo.	GPS Location	See photo.
Description	Downstream view of permitted impact area during post-construction assessment.	Description	Downstream view of unimpacted area during post-construction assessment.

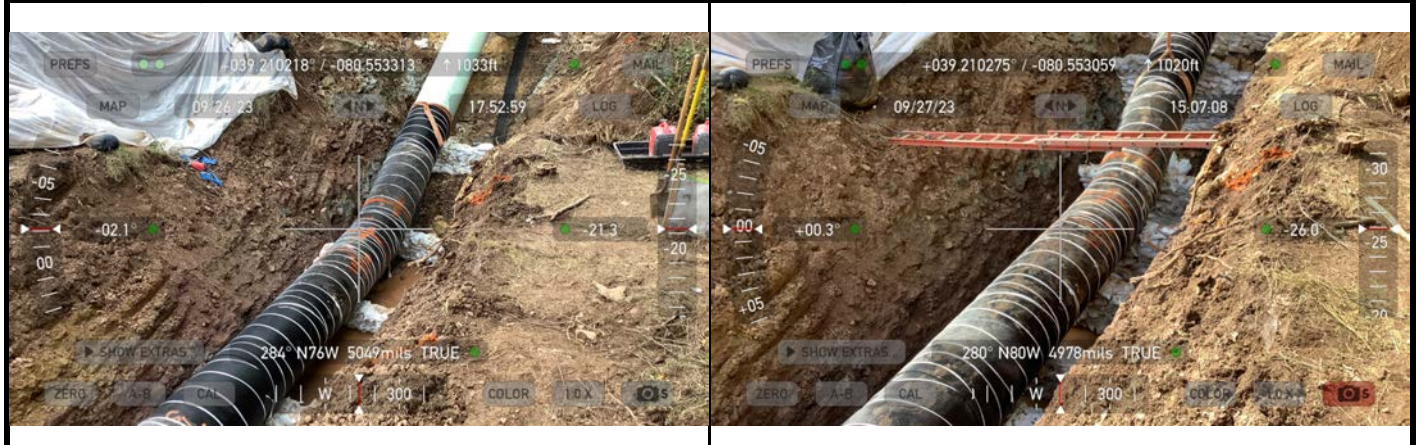
GPS Location	See photo.	GPS Location	See photo.
Description	The photo shows the progress of the construction on 9/26/2023.	Description	The photo shows the progress of the construction on 9/27/2023.

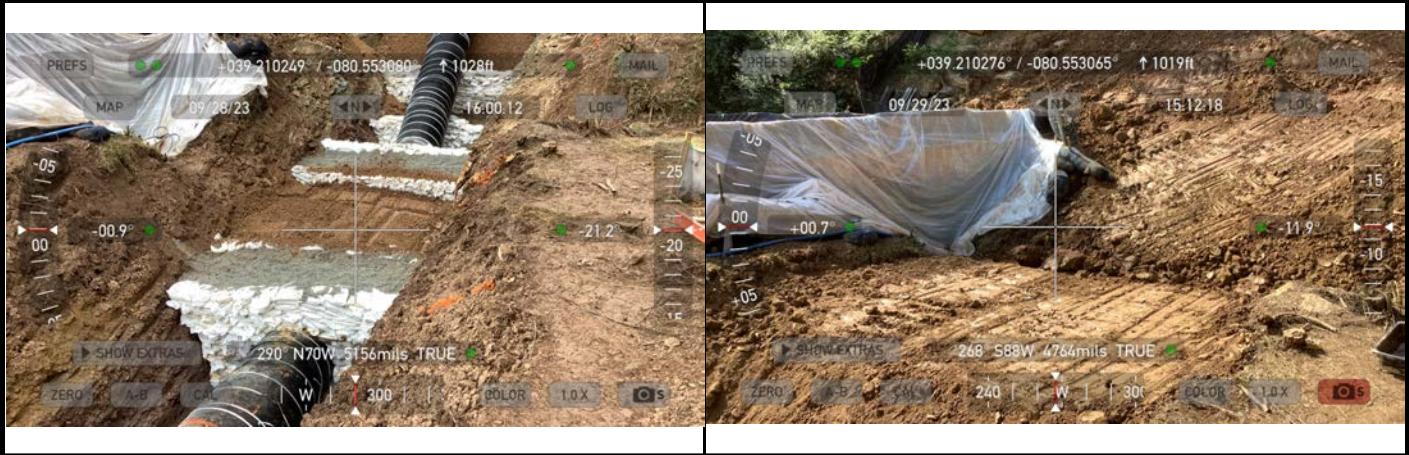
Description The photo shows the progress of the construction on 9/28/2023.	Description The photo shows the progress of the construction on 9/29/2023.
---	---
