Stream Biological Conditions EA Report

Project Name	H-600 Pipeline Spread E	AFE	124300134	Spread	H-600 Pipeline Spread E
Contractor	Price Gregory	Report #	274		
Environmental Auditor	Dan Miller	Date/Time	10/6/2023 9:06 AM		
Stream ID	S-L20	Crossing Start Date	10/6/2023	Crossing Completion Date	10/14/2023
Milepost	147.53	Pre-Con Assessment Date	10/6/2023	Post-Con Assessment Date	10/14/2023
Station	7789+40	Bankfull Width (ft.)	8.5	Riffle:Pool Complexes Present?	No
State	WV	Stream Classification	Perennial		
County	Greenbrier	303(d) Impairment Listing	N/A

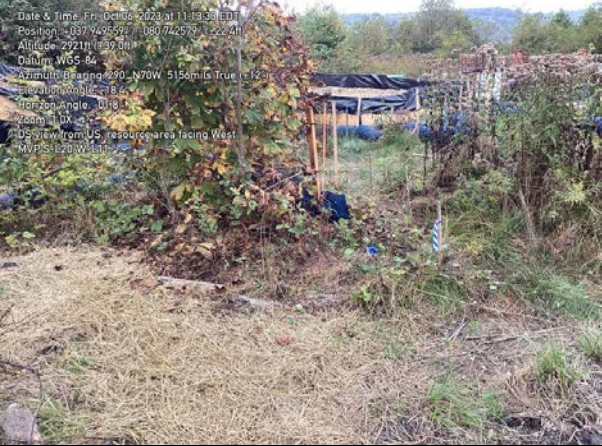
<p><small>Date & Time: Fri, Oct 06, 2023 at 11:33:51 EDT Position: +037.949597 / -080.742577 (+22.24) Altitude: 2911ft (+89.6m) Datum: WGS-84 Azimuth/Bearing: 290° N70W 515mils True (+13) Elevation Angle: -0.8° Horizon Angle: -0.8° Zoom: 1.0X DS view from US resource area facing West MVP S-L20/W-L11</small></p>

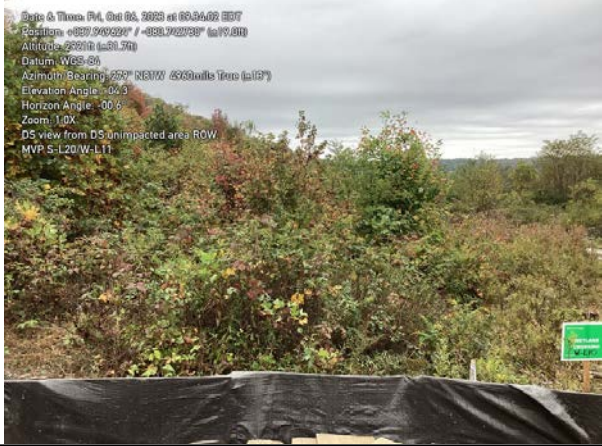
<p><small>Date & Time: Fri, Oct 06, 2023 at 09:56:02 EDT Position: +037.949297 / -080.742587 (+19.84) Altitude: 2920ft (+89.5m) Datum: WGS-84 Azimuth/Bearing: 299° N67W 430mils True (+19°) Elevation Angle: -0.3° Horizon Angle: -0.6° Zoom: 1.0X DS view from DS unimpacted area ROW MVP S-L20/W-L11</small></p>			
GPS Location	See Photo	GPS Location	See Photo		
Description	Downstream view of permitted impact area during pre-construction assessment.	Description	Downstream view of unimpacted area during pre-construction assessment.

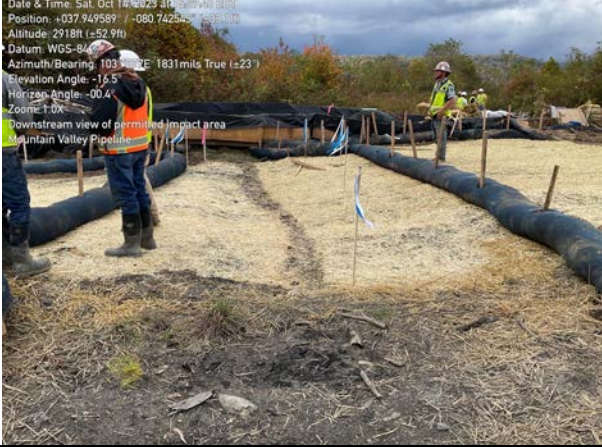
<p><small>Date & Time: Sat, Oct 14, 2023 at 09:44:44 EDT Position: +037.949589 / -080.742547 (+22.10) Altitude: 2918ft (+89.9m) Datum: WGS-84 Azimuth/Bearing: 103° E 1831mils True (+23) Elevation Angle: -1.5° Horizon Angle: -0.4° Zoom: 1.0X Downstream view of permitted impact area Mountain Valley Pipeline</small></p>

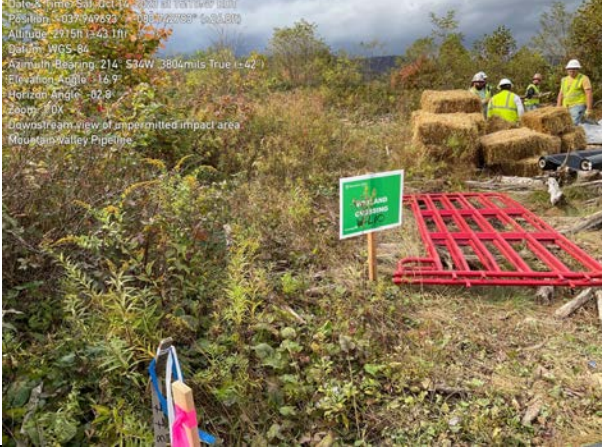
<p><small>Date & Time: Sat, Oct 14, 2023 at 09:16:47 EDT Position: +037.949632 / -080.742687 (+23.10) Altitude: 2919ft (+89.8m) Datum: WGS-84 Azimuth/Bearing: 214° S94W 3804mils True (+42) Elevation Angle: +18.9° Horizon Angle: -3.8° Zoom: 1.0X Downstream view of unimpacted area Mountain Valley Pipeline</small></p>			
GPS Location	See Photo	GPS Location	See Photo		
Description	Downstream view of permitted impact area during post-construction assessment.	Description	Downstream view of unimpacted area during post-construction assessment.

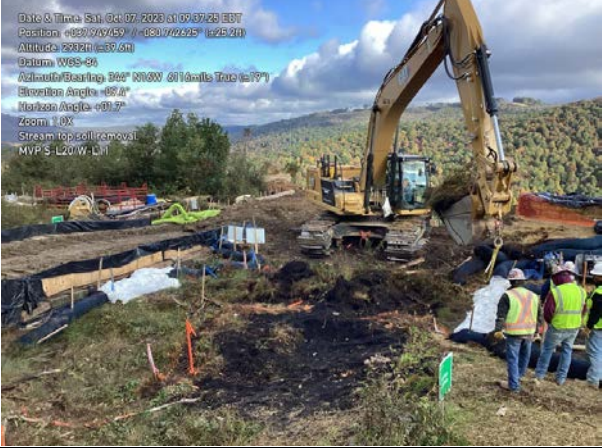
<p><small>Date & Time: Sat, Oct 07, 2023 at 09:57:25 EDT Position: +037.949450 / -080.742625 (+22.24) Altitude: 2927ft (+89.6m) Datum: WGS-84 Azimuth/Bearing: 042° N42W 6014mils True (+19°) Elevation Angle: -0.2° Horizon Angle: -01.7° Zoom: 1.0X Stream top soil removal MVP S-L20/W-L11</small></p>

GPS Location	See Photo	GPS Location	See Photo		
Description	Photo 1: Removing first 12 inches of stream substrate.	Description	Photo 2: Stream substrate segregated and stored in upland area.

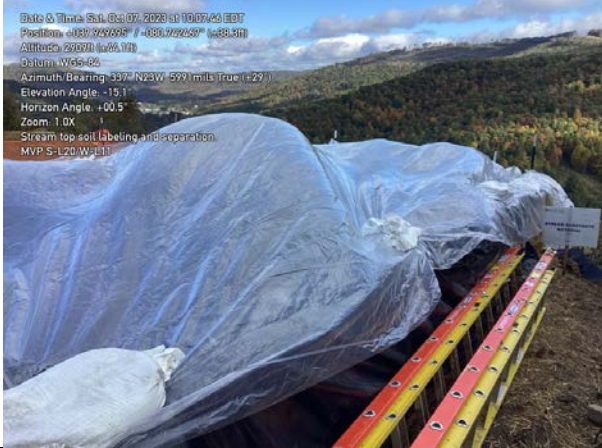
<p><small>Date & Time: Sat, Oct 07, 2023 at 10:07:43 EDT Position: +037.949495 / -080.742627 (+22.24) Altitude: 2920ft (+89.6m) Datum: WGS-84 Azimuth/Bearing: 337° N23W 5991mils True (+29) Elevation Angle: -10.1° Horizon Angle: +00.5° Zoom: 1.0X Stream top soil labeling and separation MVP S-L20/W-L11</small></p>

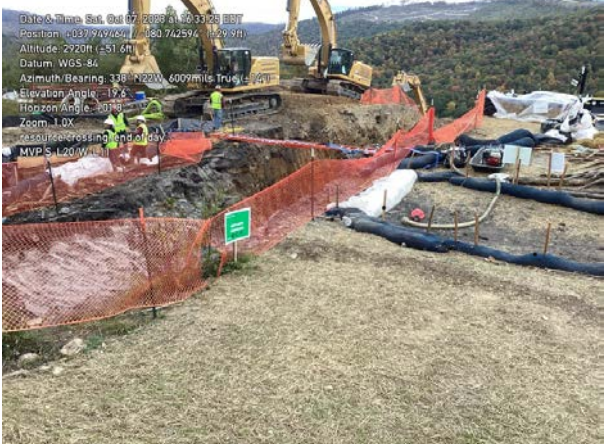
<p style="font-size: small; margin-top: 5px;">Date & Time: Sat, Oct 07, 2023 at 10:33:25 EDT Position: +037.9476517, -080.742594, (+20.9ft) Altitude: 2920ft (+51.6ft) Datum: WGS-84 Azimuth Bearing: 338.1923W, 6009mils True (+12.1) Elevation Angle: -12.8 Horizon Angle: -01.8 Zoom: 1.0X resource: crossing aquatic resource MVP: S-120/W-111</p>

<p style="font-size: small; margin-top: 5px;">Date & Time: Mon, Oct 02, 2023 at 11:56:59 EDT Position: +037.946886 N, -080.742843 W (+20.9ft) Altitude: +3047ft (+36.7ft) Datum: WGS-84 Azimuth Bearing: 018. N16E, 028mils True (+12.1) Elevation Angle: -18.1 Horizon Angle: +02.8 Zoom: 2.0X S-120/W-111 MOVING PIPE Mountain Valley</p>
GPS Location See Photo	GPS Location See Photo
Description Photo 3: Trench crossing aquatic resource.	Description Photo 4: Moving pipe to lower into aquatic resource area.

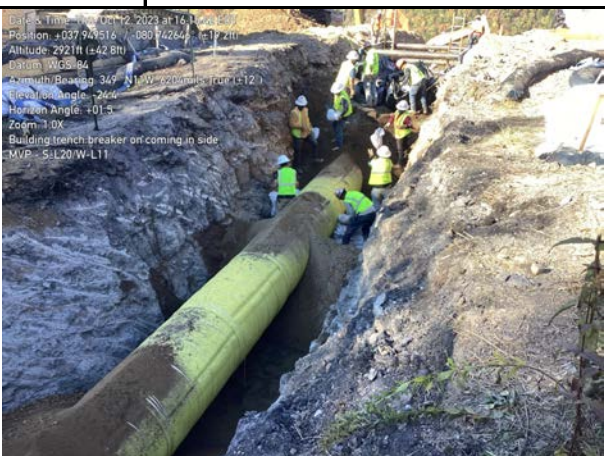
<p style="font-size: small; margin-top: 5px;">Date & Time: Sat, Oct 12, 2023 at 16:11:56 EDT Position: +037.9491617, -080.742644, (+17.2ft) Altitude: 2921ft (+52.8ft) Datum: WGS-84 Azimuth Bearing: 349. N14W, 533mils True (+12.1) Elevation Angle: -26.8 Horizon Angle: +01.5 Zoom: 1.0X Building trench breaker on coming in side MVP: S-120/W-111</p>

GPS Location See Photo	GPS Location See Photo
Description Photo 5: Building trench breaker adjacent to resource area.	Description Photo 6: Aquatic resource area backfilled. Prior to stream restoration.

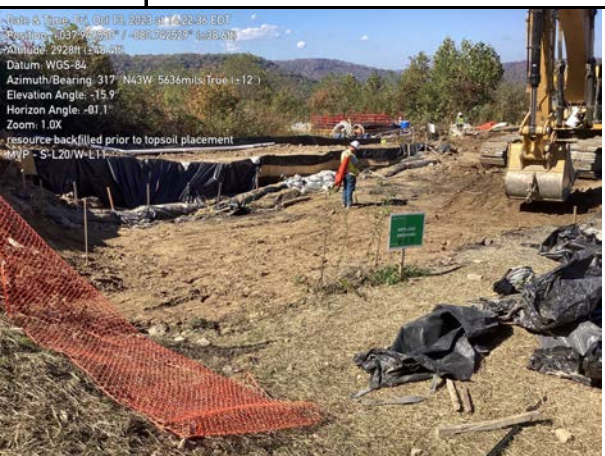
<p style="font-size: small; margin-top: 5px;">Date & Time: Thu, Oct 05, 2023 at 14:33:46 EDT Position: +037.9465017, -080.742978, (+20.8ft) Altitude: 2928ft (+53.0ft) Datum: WGS-84 Azimuth Bearing: 317. N43W, 563mils True (+12.1) Elevation Angle: -15.9 Horizon Angle: -01.1 Zoom: 1.0X resource backfilled prior to topsoil placement MVP: S-120/W-111</p>

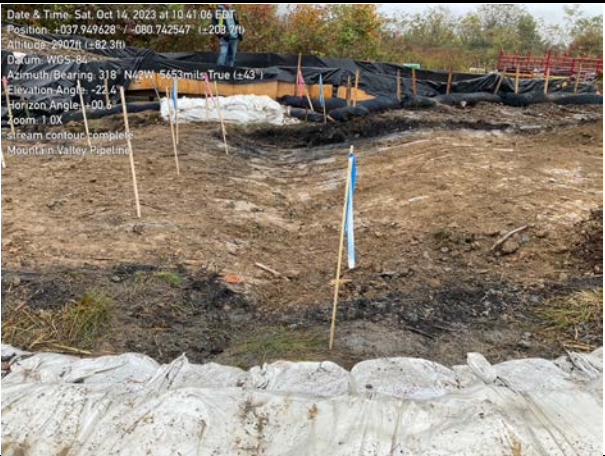
<p style="font-size: small; margin-top: 5px;">Date & Time: Sat, Oct 14, 2023 at 10:41:06 EDT Position: +037.9496287, -080.742547, (+20.8ft) Altitude: 2907ft (+52.3ft) Datum: WGS-84 Azimuth Bearing: 318. N42W, 5653mils True (+43.1) Elevation Angle: -22.4 Horizon Angle: +00.4 Zoom: 1.0X stream contour complete Mountain Valley Pipeline</p>

Description Photo 7: Creating contour of stream.	Description Photo 8: Stream substrate restored.

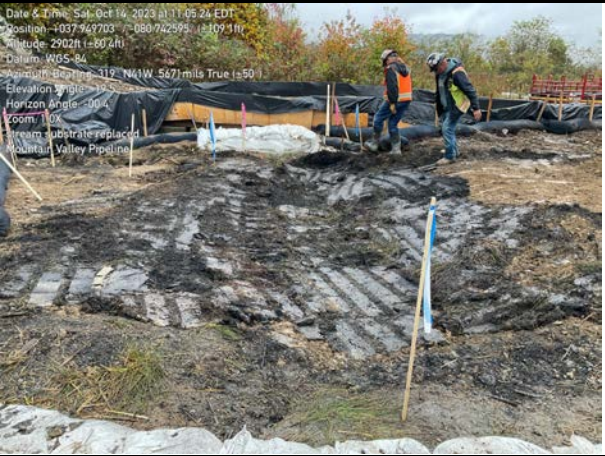
<p style="font-size: small; margin-top: 5px;">Date & Time: Sat, Oct 14, 2023 at 11:05:24 EDT Position: +037.9497037, -080.742593, (+16.9ft) Altitude: 2902ft (+50.6ft) Datum: WGS-84 Azimuth Bearing: 319. N41W, 5671mils True (+50.1) Elevation Angle: -19.4 Horizon Angle: +01.4 Zoom: 1.0X stream substrate replaced Mountain Valley Pipeline</p>
GPS Location See Photo	GPS Location See Photo
