Stream Biological Conditions EA Report

Project Name	H-600 Pipeline Spread E	AFE	124300134	Spread	H-600 Pipeline Spread E
Contractor	Price Gregory	Report #	219		
Environmental Auditor	Kristin Duty	Date/Time	9/6/2023 12:27 PM		
Stream ID	S-L22	Crossing Start Date	9/20/2023	Crossing Completion Date	10/14/2023
Milepost	147.00	Pre-Con Assessment Date	9/6/2023	Post-Con Assessment Date	10/14/2023
Station	7761+60	Bankfull Width (ft.)	25.8	Riffle:Pool Complexes Present?	No
State	WV	Stream Classification	Perennial		
County	Greenbrier	303(d) Impairment Listing	Tier 1 (Fecal/Iron)

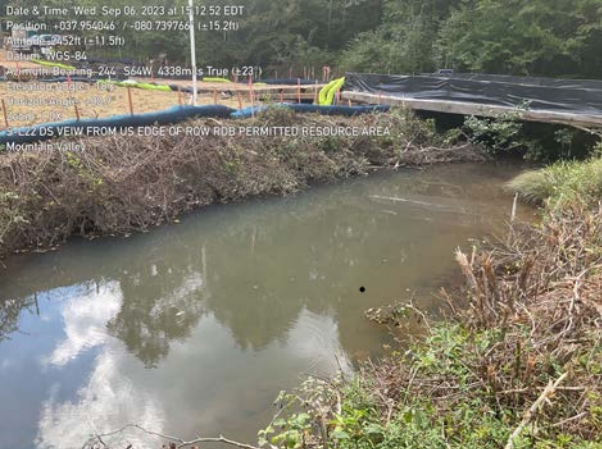
<p>Date & Time: Wed, Sep 06, 2023 at 15:12:52 EDT Position: +037.954066 / -080.739766 (±15.2ft) Altitude: 2452ft (±11.5ft) Datum: WGS-84 Azimuth Bearing: 242° S64W 4338m/s True (±23°) Elevation Angle: 10° Horizontal Angle: 0° Zoom: 1.0X S-122 DS VIEW FROM US EDGE OF ROW RDB PERMITTED RESOURCE AREA Mountain Valley</p>

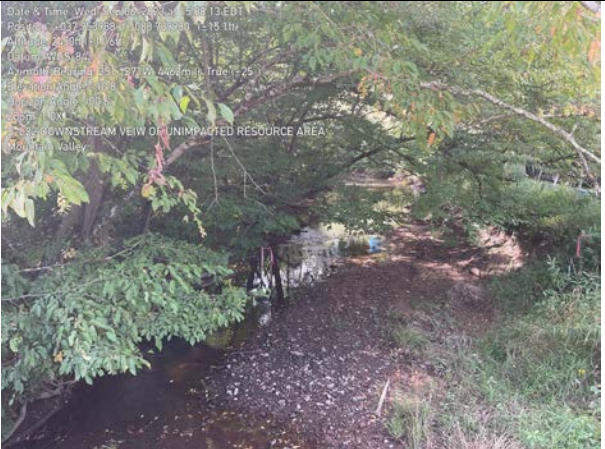
<p>Date & Time: Wed, Sep 06, 2023 at 15:13:01 EDT Position: +037.954089 / -080.739800 (±15.1ft) Altitude: 2451ft (±11.6ft) Datum: WGS-84 Azimuth Bearing: 255° S57W 2424m/s True (±25°) Elevation Angle: 10° Horizontal Angle: 0° Zoom: 1.0X S-122 DOWNSTREAM VIEW OF UNIMPACTED RESOURCE AREA Mountain Valley</p>		GPS Location	See Photo	GPS Location	See Photo
Description	Downstream view of permitted impact area during pre-construction assessment.	Description	Downstream view of unimpacted area during pre-construction assessment.

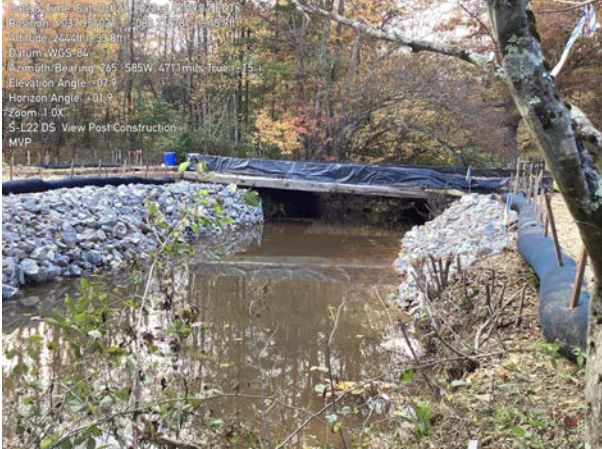
<p>Date & Time: Sat, Oct 07, 2023 at 15:24:43 EDT Position: +037.954062 / -080.739752 (±15.0ft) Altitude: 2444ft (±13.3ft) Datum: WGS-84 Azimuth Bearing: 305° S68W 4711m/s True (±15°) Elevation Angle: 9° Horizontal Angle: 0° Zoom: 1.0X S-122 DS View Post-Construction MVP</p>

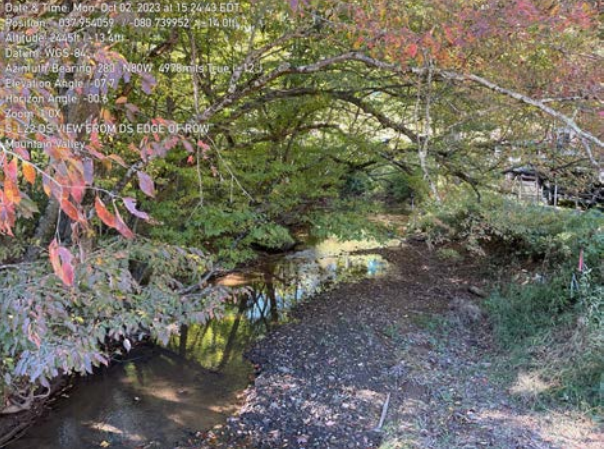
<p>Date & Time: Mon, Oct 02, 2023 at 15:24:43 EDT Position: +037.954059 / -080.739952 (±15.0ft) Altitude: 2431ft (±13.4ft) Datum: WGS-84 Azimuth Bearing: 280° N80W 4998m/s True (±12°) Elevation Angle: 10° Horizontal Angle: 0° Zoom: 1.0X S-122 DS VIEW FROM DS EDGE OF ROW Mountain Valley</p>		GPS Location	See Photo	GPS Location	See Photo
Description	Downstream view of permitted impact area during post-construction assessment.	Description	Downstream view of unimpacted area during post-construction assessment.

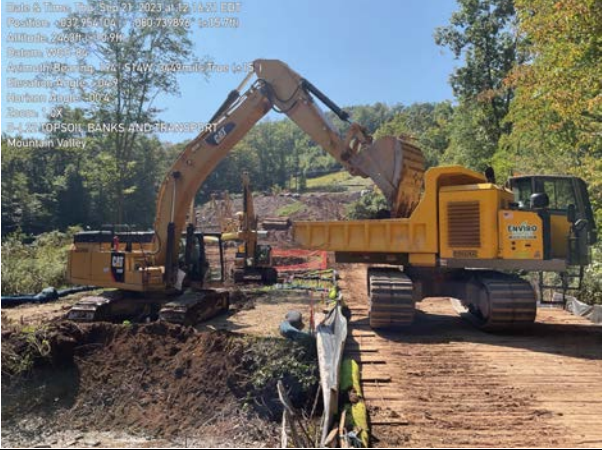
<p>Date & Time: Thu, Sep 21, 2023 at 12:44:00 EDT Position: +037.953350 / -080.739700 (±15.0ft) Altitude: 2463ft (±11.6ft) Datum: WGS-84 Azimuth Bearing: 234° S14W 0480m/s True (±13°) Elevation Angle: 11° Horizontal Angle: 0° Zoom: 1.0X S-122 TOPSOIL BANKS AND BRASSBERRY Mountain Valley</p>

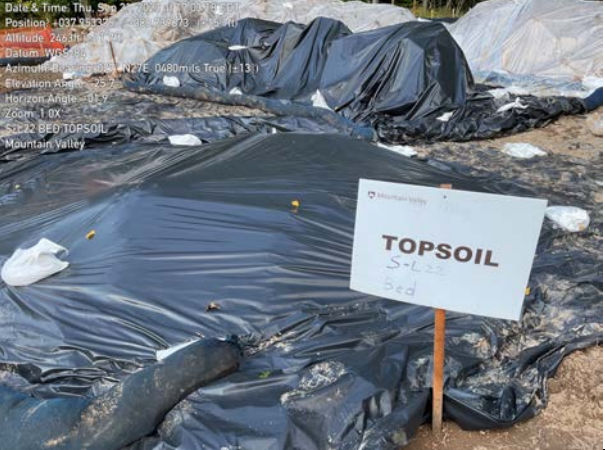
<p>Date & Time: Thu, Sep 21, 2023 at 12:45:00 EDT Position: +037.953350 / -080.739700 (±15.0ft) Altitude: 2463ft (±11.6ft) Datum: WGS-84 Azimuth Bearing: 234° S14W 0480m/s True (±13°) Elevation Angle: 11° Horizontal Angle: 0° Zoom: 1.0X S-122 BEG TOPSOIL Mountain Valley</p>		GPS Location	See Photo	GPS Location	See Photo
