Stream Biological Conditions EA Report

Project Name	H-600 Pipeline Spread E	AFE	124300134	Spread	H-600 Pipeline Spread E
Contractor	Price Gregory	Report #	218		
Environmental Auditor	Kristin Duty	Date/Time	9/6/2023 12:27 PM		
Stream ID	S-L30	Crossing Start Date	9/8/2023	Crossing Completion Date	10/14/2023
Milepost	146.97	Pre-Con Assessment Date	9/6/2023	Post-Con Assessment Date	10/14/2023
Station	7760+02	Bankfull Width (ft.)	8.8	Riffle:Pool Complexes Present?	No
State	WV	Stream Classification	Intermittent		
County	Greenbrier	303(d) Impairment Listing	No

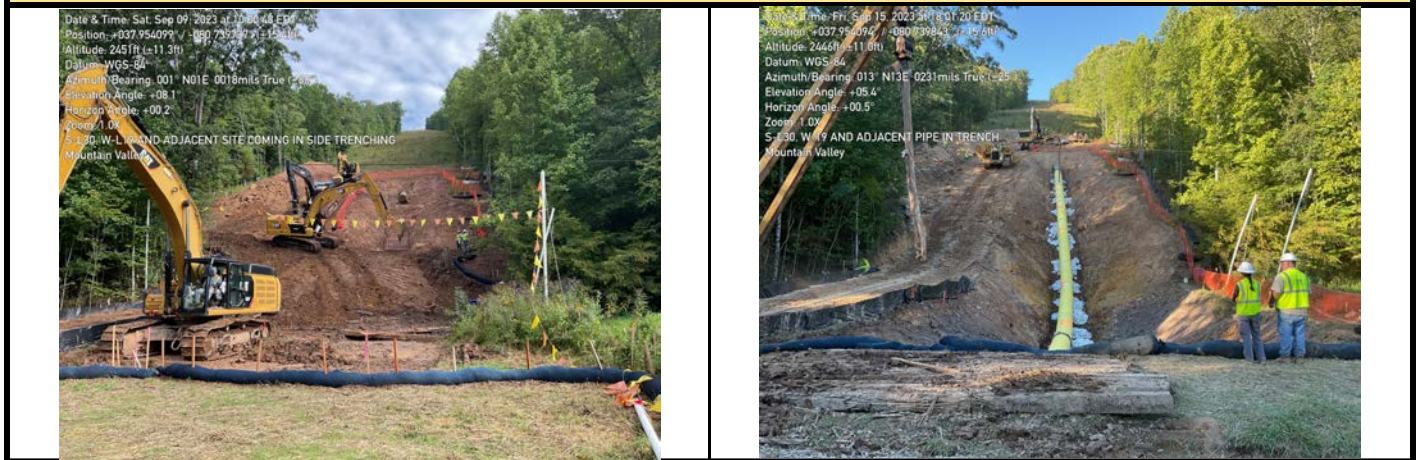
GPS Location See Photo	GPS Location See Photo
Description Photo 3: Excavation of trench in aquatic resource.	Description Photo 4: Pipe placed into trench in aquatic resource lined with bedding.

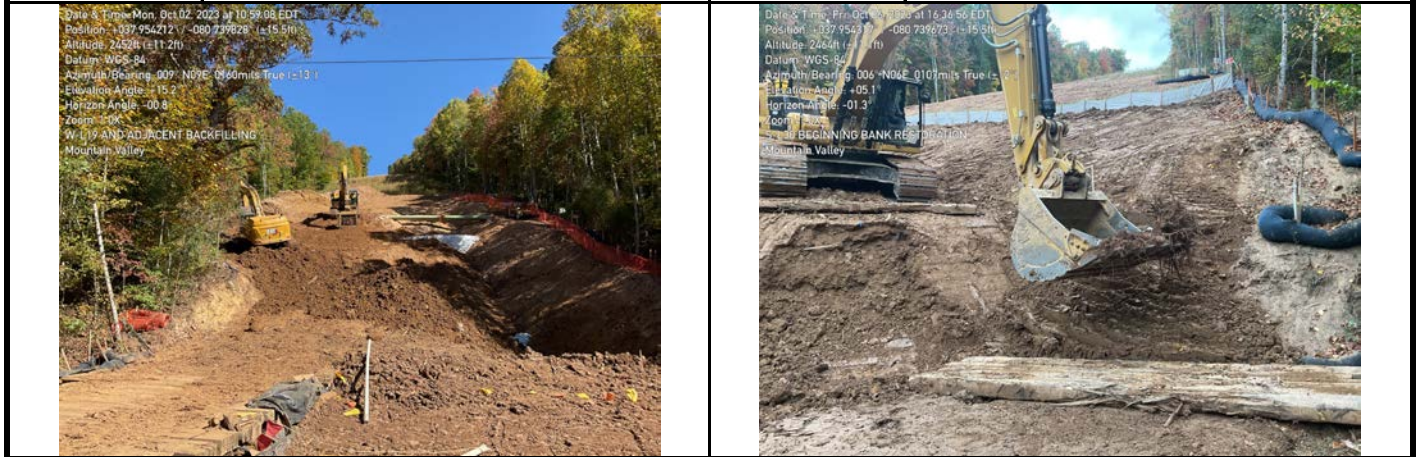
GPS Location See Photo	GPS Location See Photo
Description Photo 5: Trench breaker construction complete, backfilling of aquatic resource.	Description Photo 6: Beginning restoration of aquatic resource.

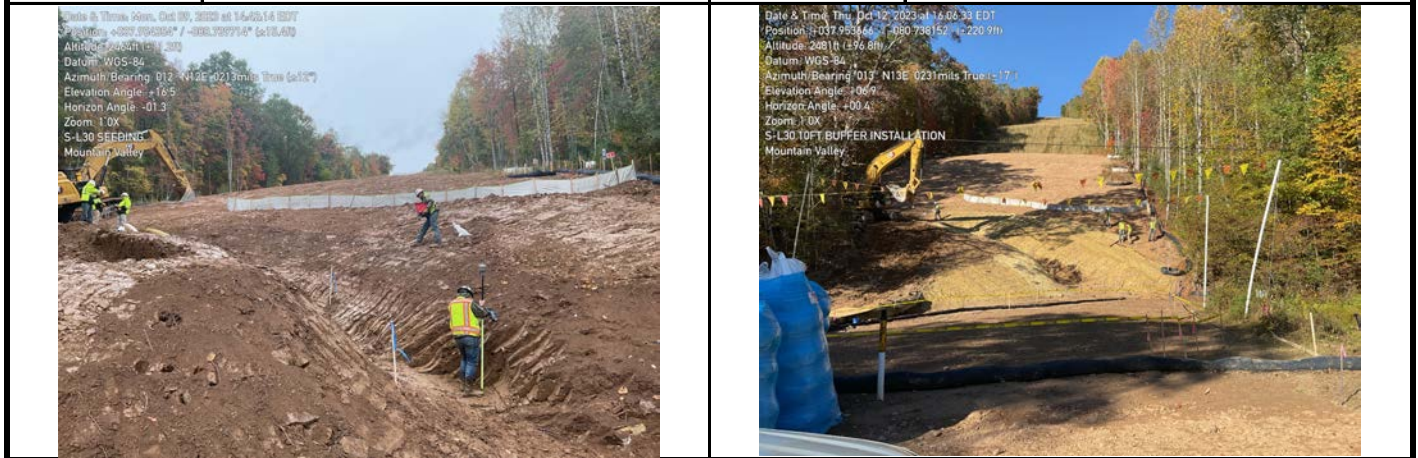
GPS Location See Photo	GPS Location See Photo
Description Photo 7: Seeding stream banks and surveying elevations.	Description Photo 8: Installing curlex on a portion of buffer.
