Stream Biological Conditions EA Report

Project Name	H-600 Pipeline Spread C	AFE	124300131	Spread	H-600 Pipeline Spread C
Contractor	Precision	Report #	259		
Environmental Auditor	Brian Montgomery	Date/Time	9/28/2023 8:28 PM		
Stream ID	S-L44	Crossing Start Date	9/28/2023	Crossing Completion Date	9/30/2023
Milepost	78.25	Pre-Con Assessment Date	9/25/2023	Post-Con Assessment Date	10/2/2023
Station	4131+69	Bankfull Width (ft.)	8.0	Riffle:Pool Complexes Present?	No
State	WV	Stream Classification	Perennial		
County	Braxton	303(d) Impairment Listing	No

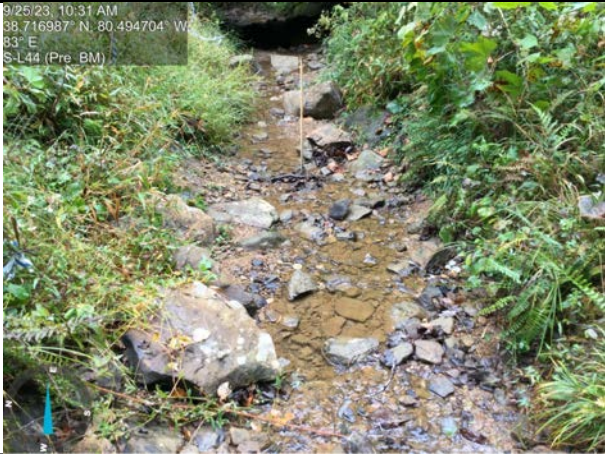
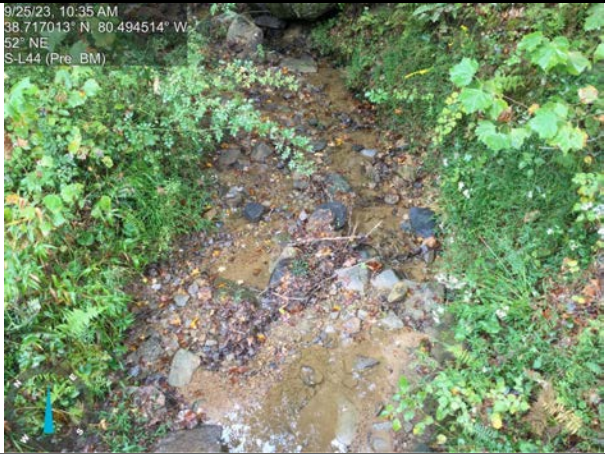
GPS Location	See photo	GPS Location	See photo
Description	Downstream view of permitted impact area during pre-construction assessment.	Description	Downstream view of unimpacted area during pre-construction assessment.

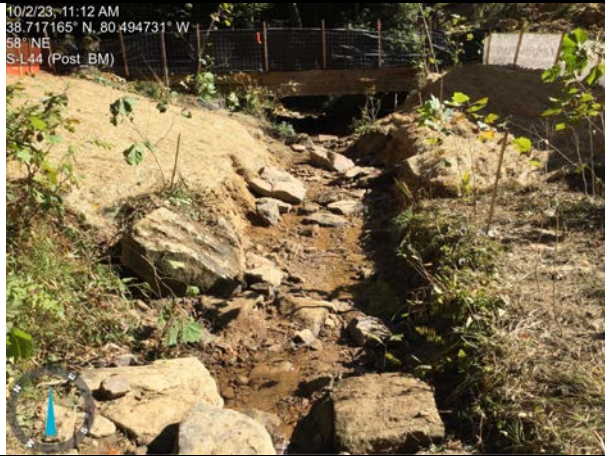
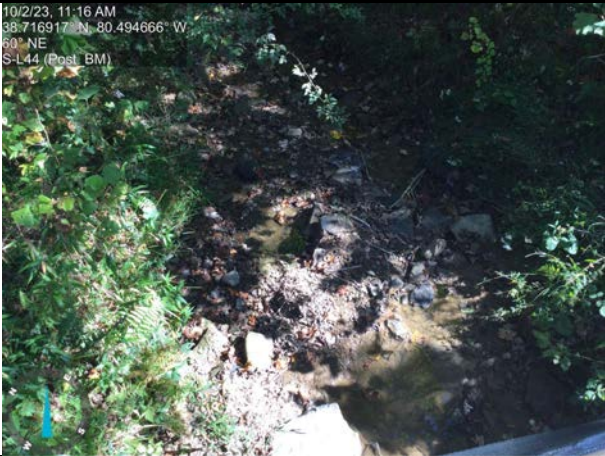
GPS Location	See photo	GPS Location	See photo
Description	Downstream view of permitted impact area during post-construction assessment.	Description	Downstream view of unimpacted area during post-construction assessment.

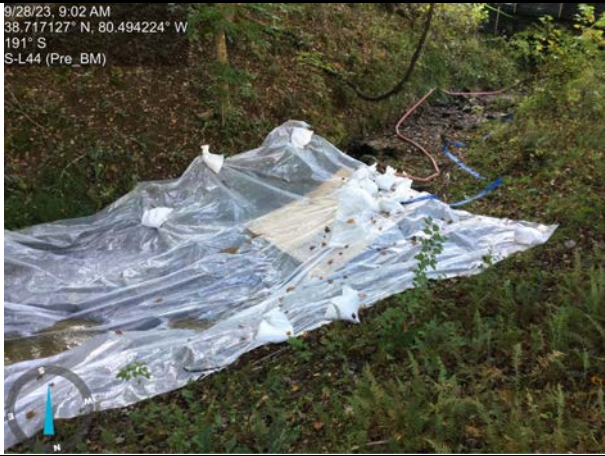
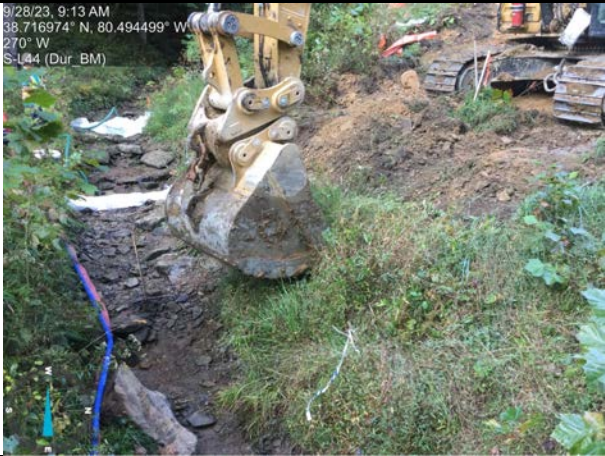
GPS Location	See photo	GPS Location	See photo
Description	Dam and pump spillway downstream of the Right of Way	Description	Stripping topsoil to the high water marks.
