# Stream Biological Conditions EA Report

| <b>Project Name</b> | H-600 Pipeline Spread F | <b>AFE</b> | 124300135 | <b>Spread</b> | H-600 Pipeline Spread F |
| <b>Stream ID</b> | S-N5 | <b>Crossing Start Date</b> | 10/9/2023 | <b>Crossing Completion Date</b> | 10/14/2023 |

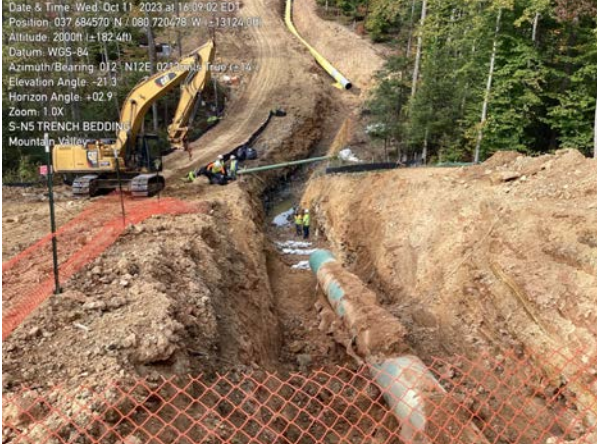
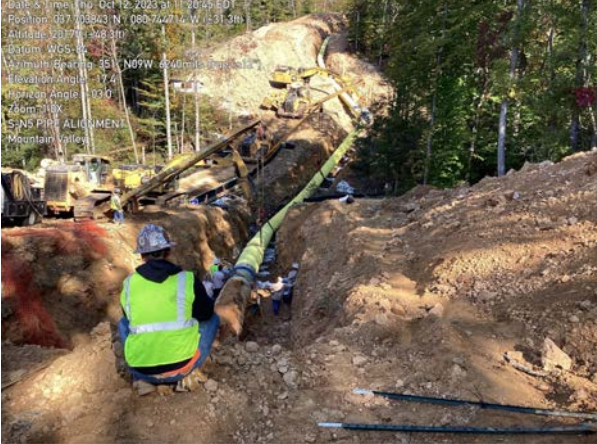
| <p><small>Date &amp; Time: Wed, Oct 11, 2023 at 16:09:02 EDT<br/>Position: 037.684570 N / 080.720478 W (-13124.0ft)<br/>Altitude: 2000ft (-182.4ft)<br/>Datum: WGS-84<br/>Azimuth/Bearing: 012° N12E 0230mils True (-17)<br/>Elevation Angle: -21.3<br/>Horizon Angle: +02.9<br/>Zoom: 1.0X<br/>S-NS TRENCH BEDDING<br/>Mountain Valley</small></p> | <p><small>Date &amp; Time: Thu, Oct 12, 2023 at 11:26:45 EDT<br/>Position: 037.703823 N / 080.742714 W (-1313.3ft)<br/>Altitude: 2079ft (-168.3ft)<br/>Datum: WGS-84<br/>Azimuth/Bearing: 851° N09W 8940mils True (-12)<br/>Elevation Angle: -17.4<br/>Horizon Angle: 10.0<br/>Zoom: 1.0X<br/>S-NS PIPE ALIGNMENT<br/>Mountain Valley</small></p> |
| <b>Description</b> Photo 3: Adding sandbag bedding to trench. | <b>Description</b> Photo 4: Pipe lowered into trench and adjustments made to pipe. |

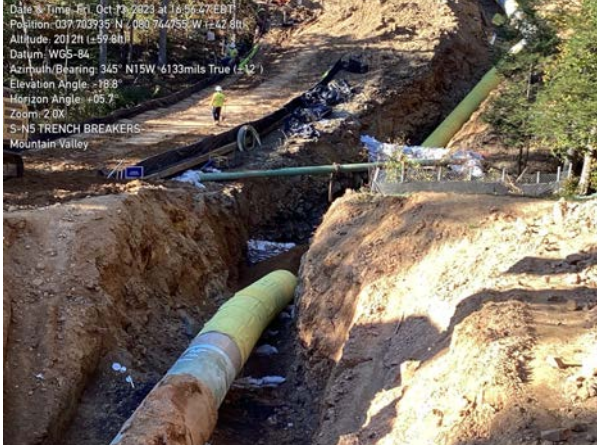
| <p><small>Date &amp; Time: Fri, Oct 13, 2023 at 16:52:27 EDT<br/>Position: 037.703935 N / 080.744755 W (-1312.8ft)<br/>Altitude: 2012ft (-159.8ft)<br/>Datum: WGS-84<br/>Azimuth/Bearing: 345° N15W 6133mils True (-12)<br/>Elevation Angle: -19.8<br/>Horizon Angle: +05.8<br/>Zoom: 2.0X<br/>S-NS TRENCH BREAKERS<br/>Mountain Valley</small></p> | <p><small>Date &amp; Time: Sat, Oct 14, 2023 at 12:34:48 EDT<br/>Position: 037.704009 N / 080.744805 W (-1312.9ft)<br/>Altitude: 1968ft (-146.7ft)<br/>Datum: WGS-84<br/>Azimuth/Bearing: 202° N80E 4977mils True (-12)<br/>Elevation Angle: -16.5<br/>Horizon Angle: +02.4<br/>Zoom: 1.0X<br/>S-NS BACKFILLED PRE-RESTORATION<br/>Mountain Valley</small></p> |
| <b>Description</b> Photo 5: Construction of trench breakers and filling of trench. | <b>Description</b> Photo 6: Site prepared for substrate restoration. |

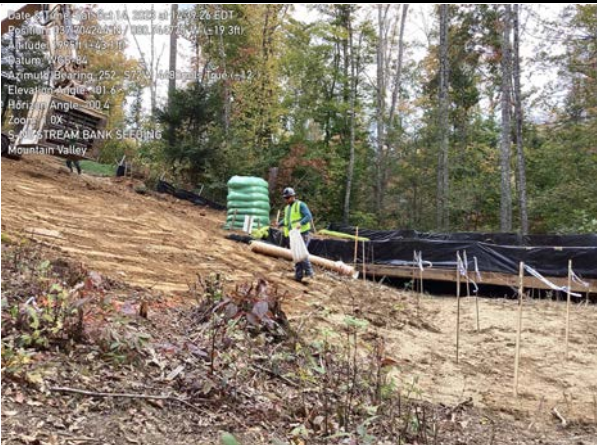
| <p><small>Date &amp; Time: Sat, Oct 14, 2023 at 16:19:26 EDT<br/>Position: 037.704251 N / 080.744911 W (-1313ft)<br/>Altitude: 1983ft (-142.3ft)<br/>Datum: WGS-84<br/>Azimuth/Bearing: 252° N32W 4880mils True (-12)<br/>Elevation Angle: -15.5<br/>Horizon Angle: +00.4<br/>Zoom: 1.0X<br/>S-NS STREAM BANK SEEDING<br/>Mountain Valley</small></p> | <p><small>Date &amp; Time: Sat, Oct 14, 2023 at 15:27:08 EDT<br/>Position: 037.704187 N / 080.744805 W (-1313.9ft)<br/>Altitude: 1968ft (-146.7ft)<br/>Datum: WGS-84<br/>Azimuth/Bearing: 081° N81E 1440mils True (-12)<br/>Elevation Angle: -19.5<br/>Horizon Angle: -01.2<br/>Zoom: 1.0X<br/>S-NS CURLEX WOOD PROXIMITY FLAG PLACEMENT<br/>Mountain Valley</small></p> |
| <b>Description</b> Photo 7: Seeding of banks above OHWM. | <b>Description</b> Photo 8. Curlex installed on banks to edge of OHWM. |
