Stream Biological Conditions EA Report

Project Name	H-600 Pipeline Spread A	AFE	124300129	Spread	H-600 Pipeline Spread A
Contractor	Precision	Report #	247		
Environmental Auditor	Samantha Felix	Date/Time	10/6/2023 7:45 PM		
Stream ID	S-UU3	Crossing Start Date	9/25/2023	Crossing Completion Date	10/4/2023
Milepost	26.06	Pre-Con Assessment Date	9/22/2023	Post-Con Assessment Date	10/9/2023
Station	1375+88	Bankfull Width (ft.)	60.0	Riffle:Pool Complexes Present?	Yes
State	WV	Stream Classification	Perennial		
County	Harrison	303(d) Impairment Listing	Biological, fecal, iron

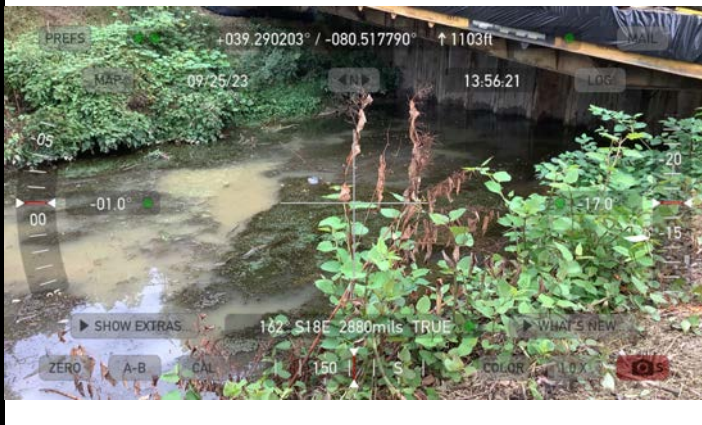
GPS Location	See above.		GPS Location	See above.	
Description	Downstream view of permitted impact area during post-construction assessment.		Description	Downstream view of unimpacted area during post-construction assessment.

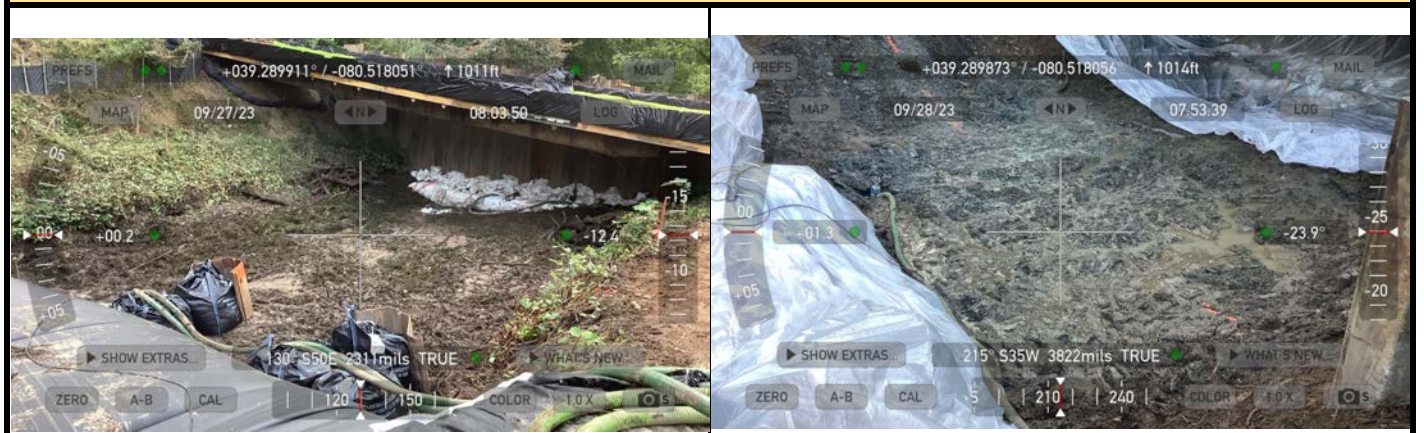
GPS Location	See above.		GPS Location	See above.	
Description	Sheet piling was installed upstream in order to prevent water from flowing into the work area.		Description	The work area was fully drained by Tuesday.

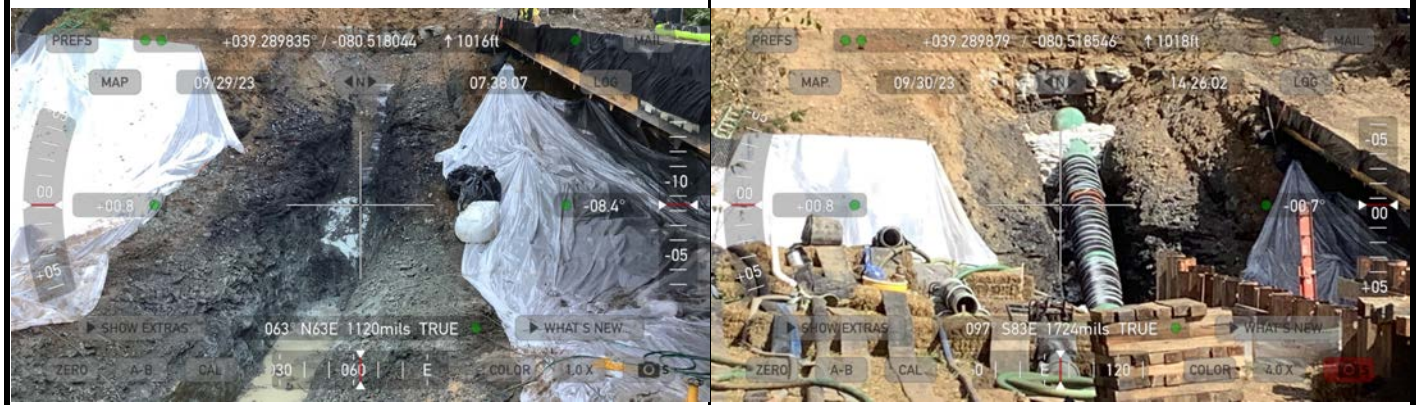
GPS Location	See above.	GPS Location	See above.
Description	Some upland soil was removed so that sheet piling could begin.	Description	First 12 inches of soil removed yesterday. Crew continued sheet piling and installing I-beams.

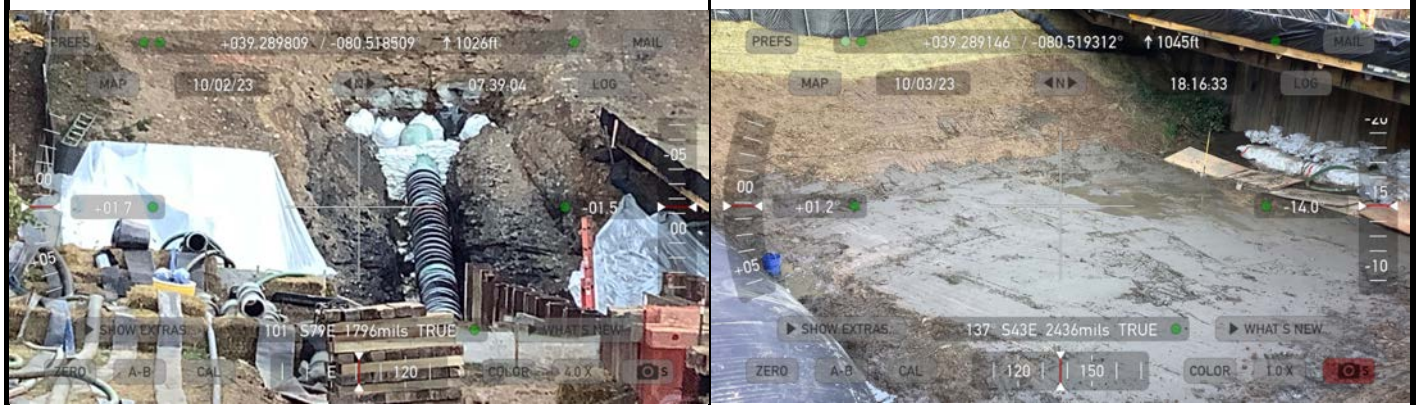
GPS Location	See above	GPS Location	See above
Description	Trench after excavation.	Description	Welding taking place.
