Stream Biological Conditions EA Report

Project Name	H-600 Pipeline Spread A	AFE	124300129	Spread	H-600 Pipeline Spread A
Contractor	Precision	Report #	276		
Environmental Auditor	Jake Pokorny	Date/Time	10/3/2023 9:40 PM		
Stream ID	S-UU5	Crossing Start Date	10/2/2023	Crossing Completion Date	10/7/2023
Milepost	30.25	Pre-Con Assessment Date	9/27/2023	Post-Con Assessment Date	10/9/2023
Station	1597+15	Bankfull Width (ft.)	4.0	Riffle:Pool Complexes Present?	Yes
State	WV	Stream Classification	Perennial		
County	Harrison	303(d) Impairment Listing	No

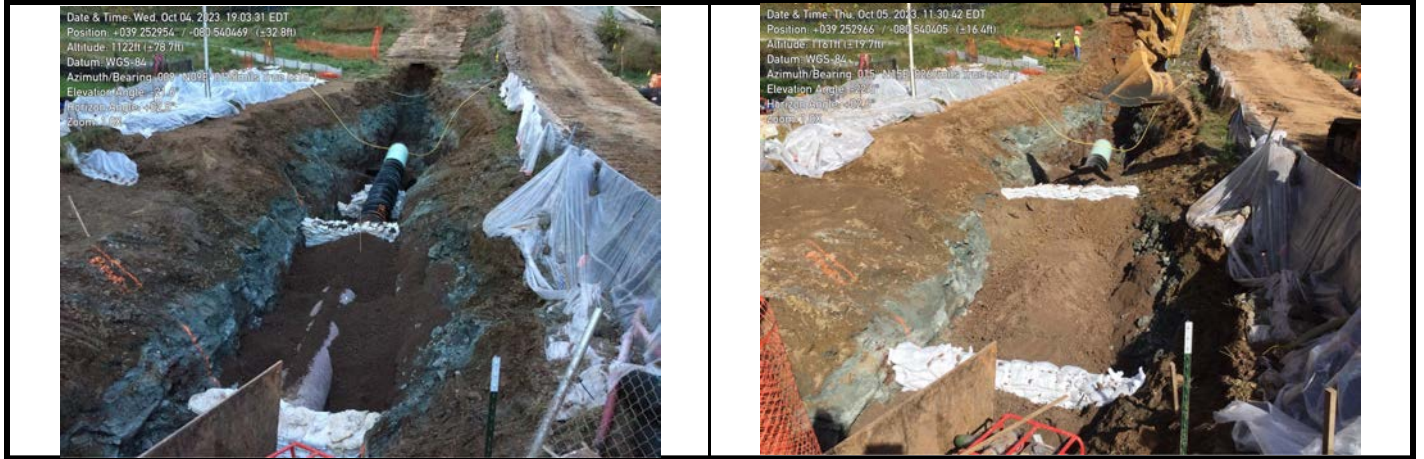
GPS Location	See Above.	GPS Location	See Above.
Description	10/04/23 - Pipeline installed, trench breakers built and backfilling begun.	Description	10/05/23 - backfilling completed in stream area and trench breakers completed.
