# Stream Biological Conditions EA Report

<b>Project Name</b>	H-600 Pipeline Spread B	<b>AFE</b>	124300130	<b>Spread</b>	H-600 Pipeline Spread B
<b>Contractor</b>	Precision	<b>Report #</b>	217		
<b>Environmental Auditor</b>	Elyse Johnston	<b>Date/Time</b>	9/5/2023 10:09 AM		
<b>Stream ID</b>	S-VV12	<b>Crossing Start Date</b>	9/27/2023	<b>Crossing Completion Date</b>	9/30/2023
<b>Milepost</b>	61.43	<b>Pre-Con Assessment Date</b>	9/5/2023	<b>Post-Con Assessment Date</b>	9/30/2023
<b>Station</b>	3243+29	<b>Bankfull Width (ft.)</b>	12.0	<b>Riffle:Pool Complexes Present?</b>	No
<b>State</b>	WV	<b>Stream Classification</b>	Perennial		
<b>County</b>	Lewis	<b>303(d) Impairment Listing</b>	N/A

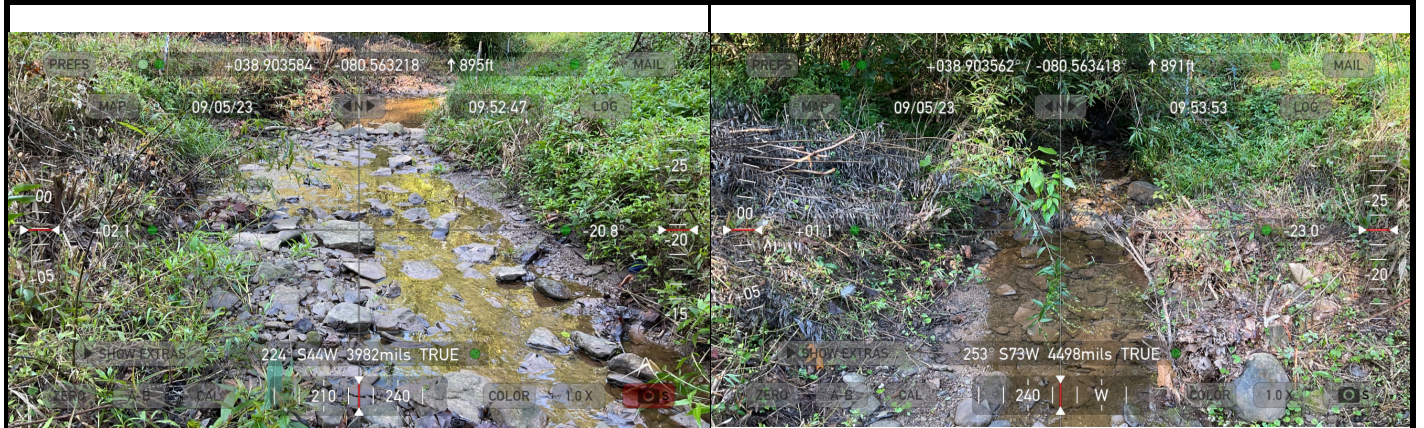
<b>GPS Location</b>	See Above.	<b>GPS Location</b>	See Above.
<b>Description</b>	Downstream view of permitted impact area during pre-construction assessment.	<b>Description</b>	Downstream view of unimpacted area during pre-construction assessment.

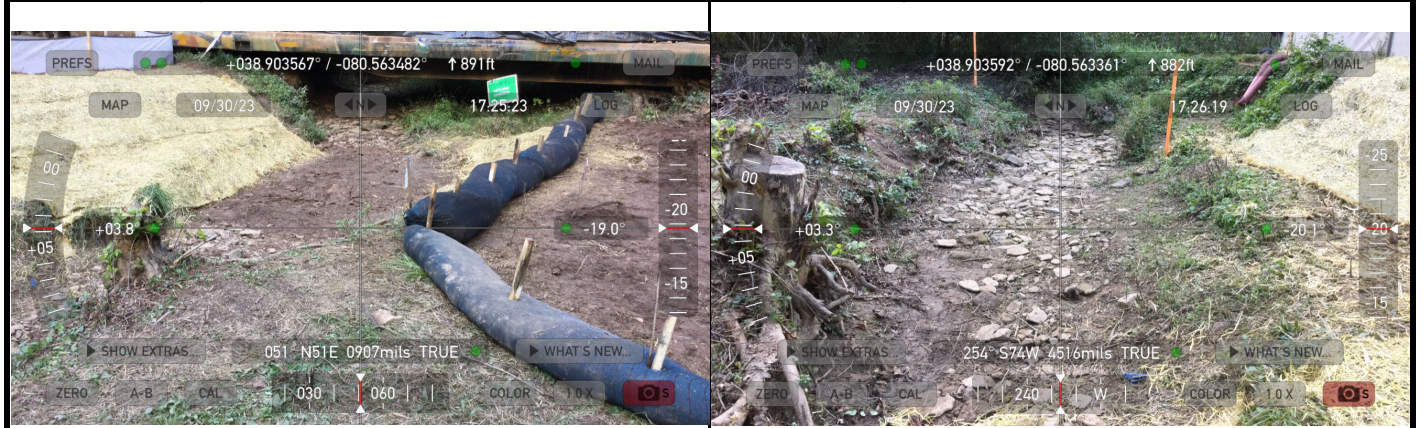
<b>GPS Location</b>	See Above.	<b>GPS Location</b>	See Above.
<b>Description</b>	Downstream view of permitted impact area during post-construction assessment.	<b>Description</b>	Downstream view of unimpacted area during post-construction assessment.

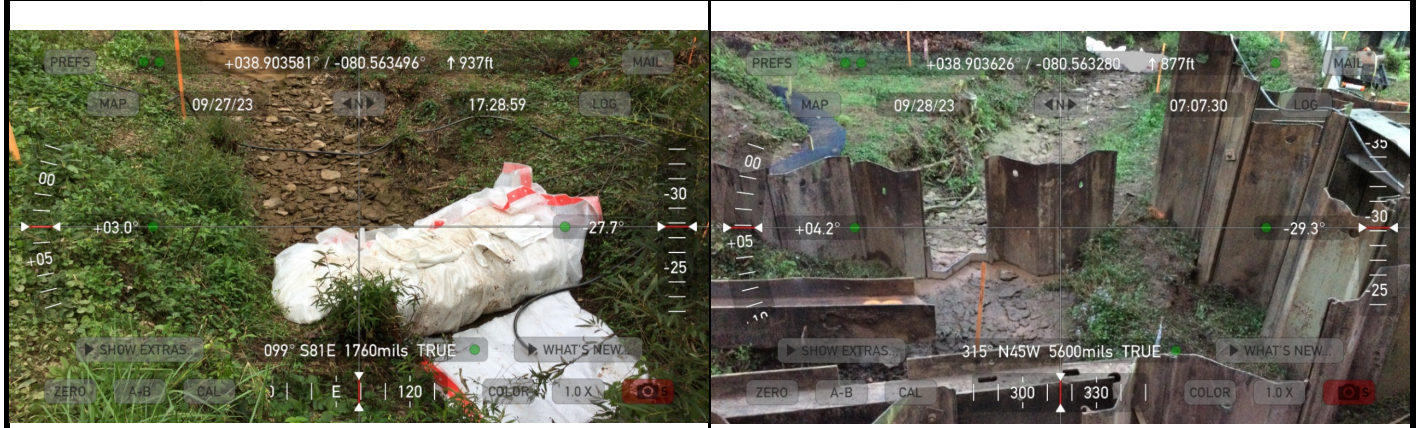
<b>GPS Location</b>	See Above.	<b>GPS Location</b>	See Above.
<b>Description</b>	This photo shows the dam and pump installed in the stream prior to construction	<b>Description</b>	This photo shows the excavated trench in the stream
