Wetland Biological Conditions EA Report

Project Name	H-600 Pipeline Spread B	AFE	124300130	Spread	H-600 Pipeline Spread B
Contractor	Precision	Report #	64		
Environmental Auditor	Joe Ventura			Date/Time	9/21/2023 12:33 PM
Wetland ID	W-B46	Crossing Start Date	9/22/2023	Crossing Completion Date	10/12/2023
Milepost	45.98	Pre-Con Assessment Date	9/21/2023	Post-Con Assessment Date	10/12/2023
Station	2427+86	Cowardin Classification	PEM	Wetland Impact Area(acres)	0.1255
State	WV				
County	Lewis

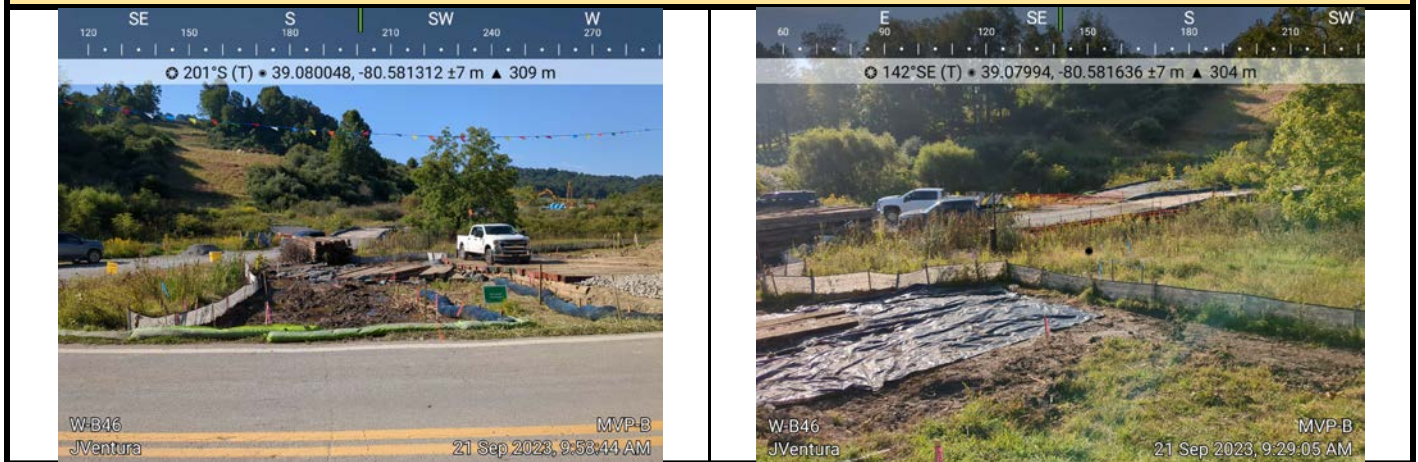
GPS Location	See photograph	GPS Location	See photograph
Description	View of permitted resource impact area during pre-construction assessment.	Description	At edge of LOD, view of unimpacted resource area conditions during pre-construction assessment.

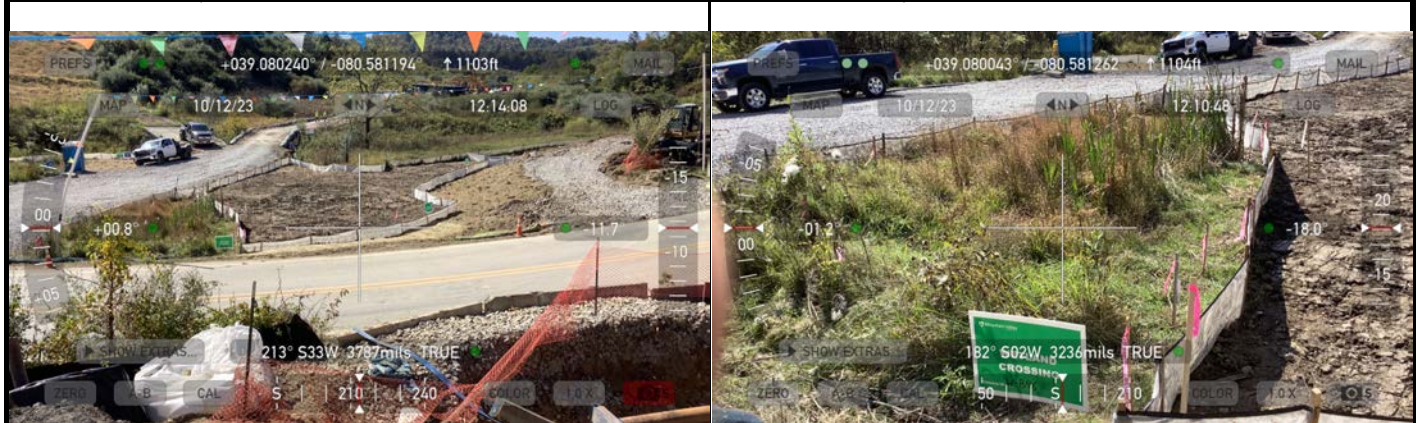
10/11 The contractor replaced the original 12" of segregated wetland topsoil to the wetland area and graded it to the correct contour. Erosion and sediment controls were then installed around the wetland. Conditions 18 and 19 were given a rating of 4 during post-construction assessment due to lack of vegetation in the disturbed permitted impact area following the completion of the crossing and restoration efforts. The disturbed wetland area has been seeded with the appropriate permanent seed mix in accordance with Appendix B: Restoration Work Plan of the Mountain Valley Pipeline Comprehensive Stream and Wetland Monitoring, Restoration and Mitigation Framework. -C Biden

GPS Location	See photograph	GPS Location	See photograph
Description	View of permitted resource impact area during post-construction assessment.	Description	At edge of LOD, view of unimpacted resource area conditions during post-construction assessment.

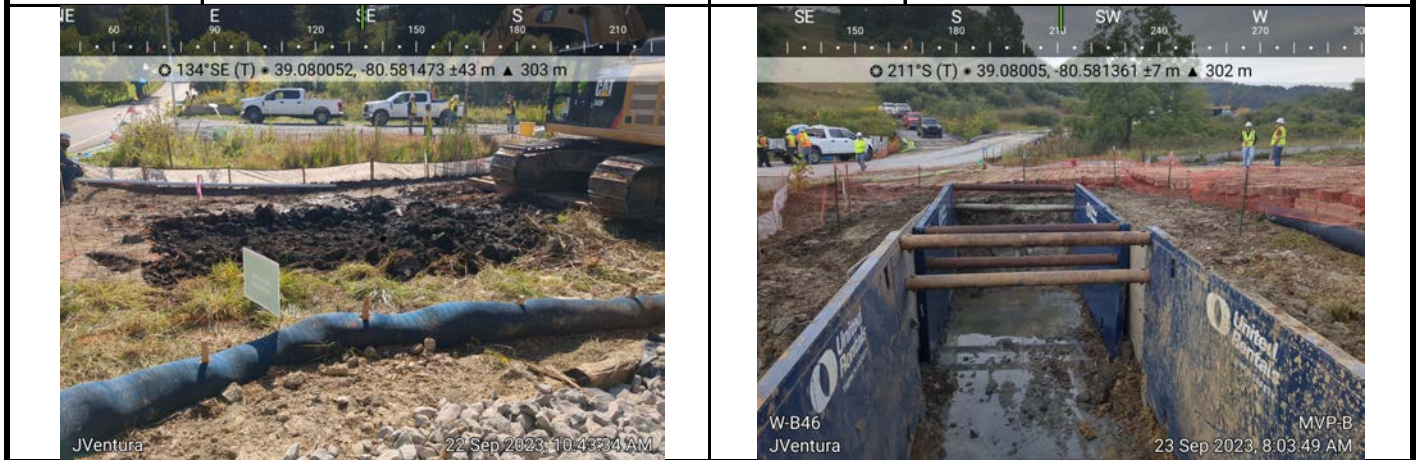
GPS Location	See photograph	GPS Location	See photograph
Description	This photo shows the contractor working on removing the wetland from the topsoil prior to excavating the trench.	Description	This photo shows the excavated trench in the wetland with trench boxes installed.
