# Wetland Biological Conditions EA Report

<b>Project Name</b>	H-600 Pipeline Spread B	<b>AFE</b>	124300130	<b>Spread</b>	H-600 Pipeline Spread B
<b>Contractor</b>	Precision	<b>Report #</b>	38		
<b>Environmental Auditor</b>	Elyse Johnston			<b>Date/Time</b>	9/5/2023 9:48 AM
<b>Wetland ID</b>	W-CD16	<b>Crossing Start Date</b>	9/19/2023	<b>Crossing Completion Date</b>	10/5/2023
<b>Milepost</b>	61.20	<b>Pre-Con Assessment Date</b>	9/5/2023	<b>Post-Con Assessment Date</b>	10/6/2023
<b>Station</b>	3231+36	<b>Cowardin Classification</b>	PEM	<b>Wetland Impact Area(acres)</b>	0.024881
<b>State</b>	WV				
<b>County</b>	Lewis

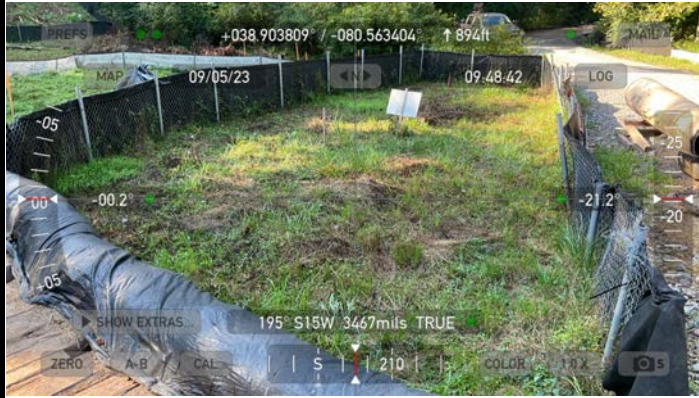
<b>GPS Location</b>	See photo
<b>Description</b>	View of permitted resource impact area during pre-construction assessment.

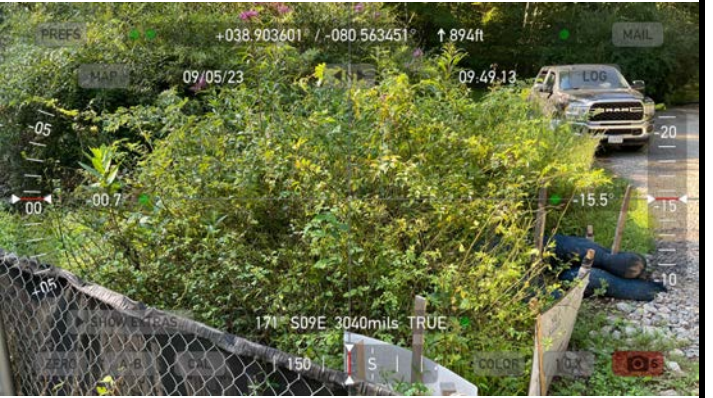
<b>GPS Location</b>	See photo
<b>Description</b>	At edge of LOD, view of unimpacted resource area conditions during pre-construction assessment.

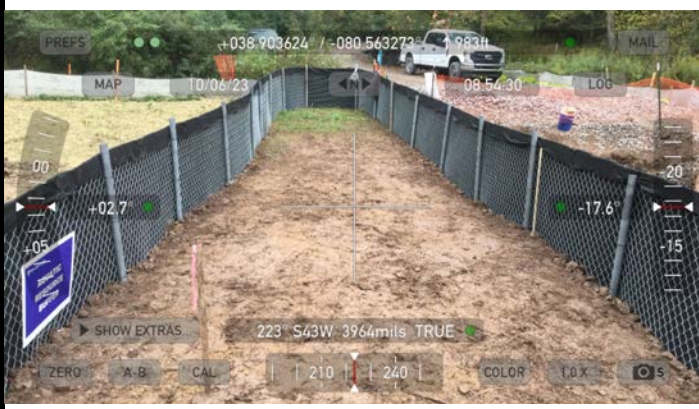
Post construction assessment:  
 Conditions 18 and 19 were given a rating of 4 during the post-construction assessment due to the lack of vegetation in the disturbed area following completion of the crossing. For condition 13, due to resource work on the associated stream and wetland crossings, restoration of the wetland topsoil was delayed. A. Dunn

<b>GPS Location</b>	See photo
<b>Description</b>	View of permitted resource impact area during post-construction assessment.

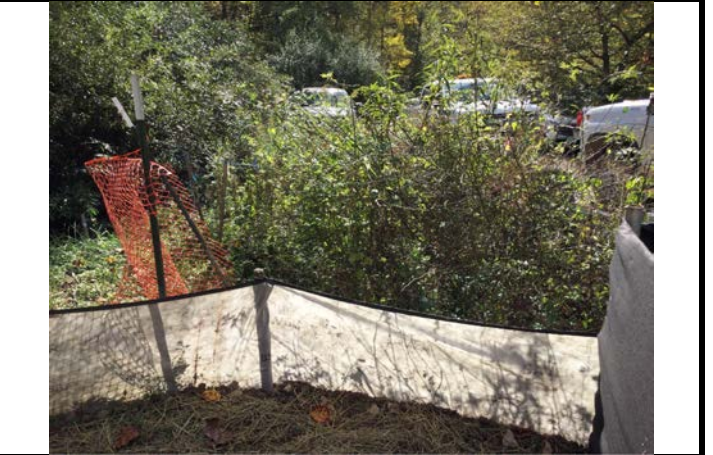
<b>GPS Location</b>	See photo
<b>Description</b>	At edge of LOD, view of unimpacted resource area conditions during post-construction assessment.

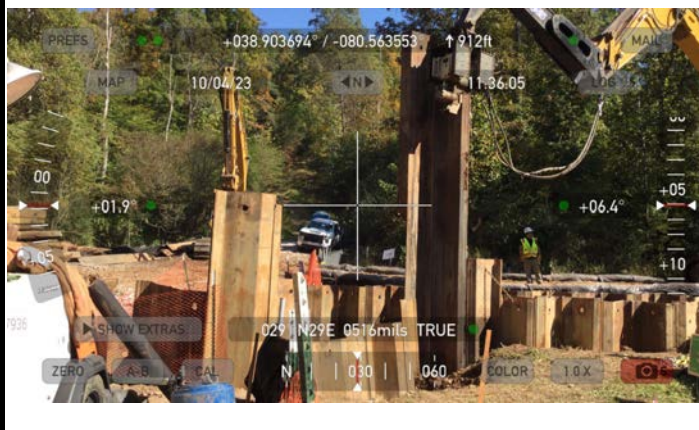
<b>GPS Location</b>	See photo
<b>Description</b>	This photo shows the contractor removing the sheet piling from the wetland

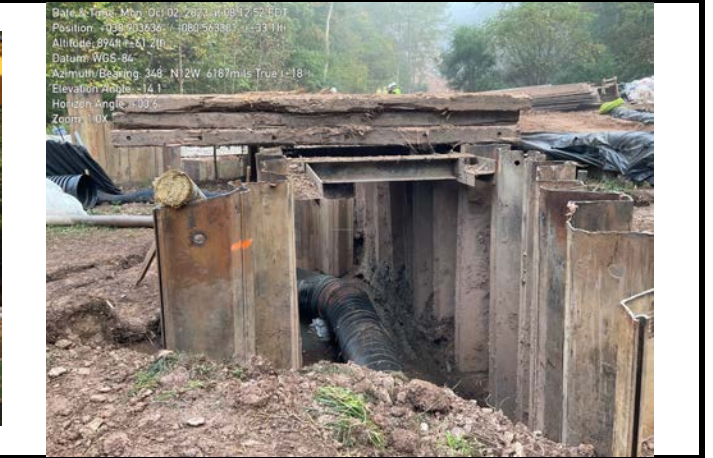
<b>GPS Location</b>	See photo
<b>Description</b>	This photo shows the pipe installed in the wetland

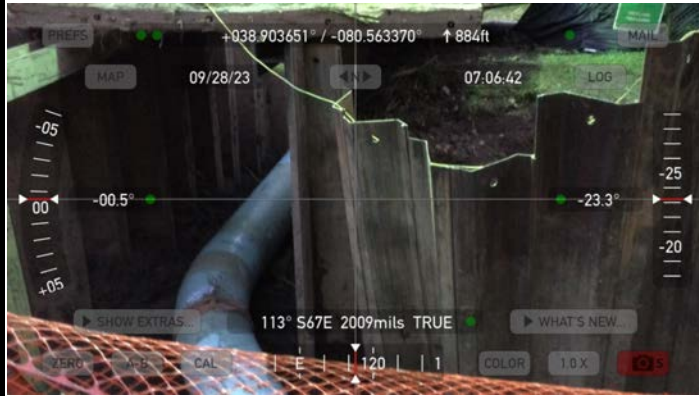
**Description** This photo shows the pipe installed in the wetland

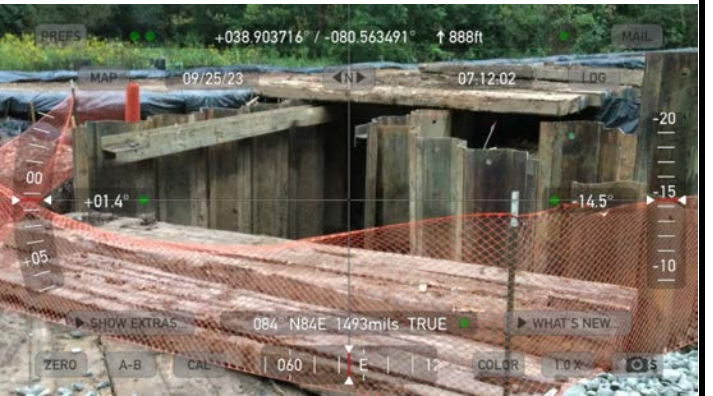
**Description** This photo shows the trench excavated in the wetland

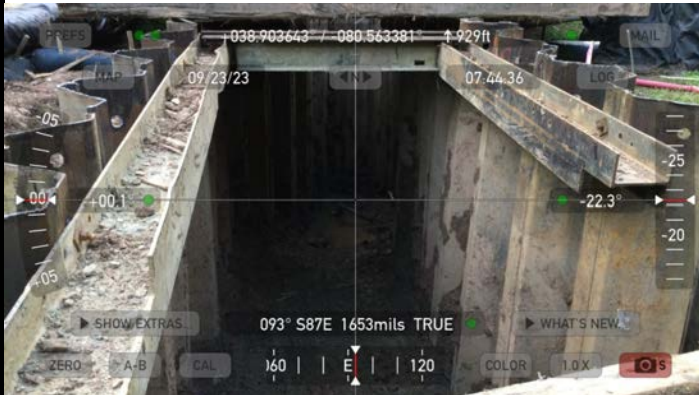
**Description** This photo shows the trench excavated in the wetland

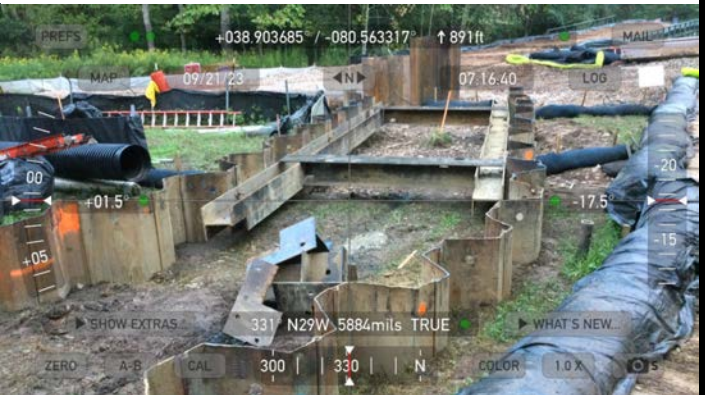
**Description** This photo shows the sheet piling installed in the wetland

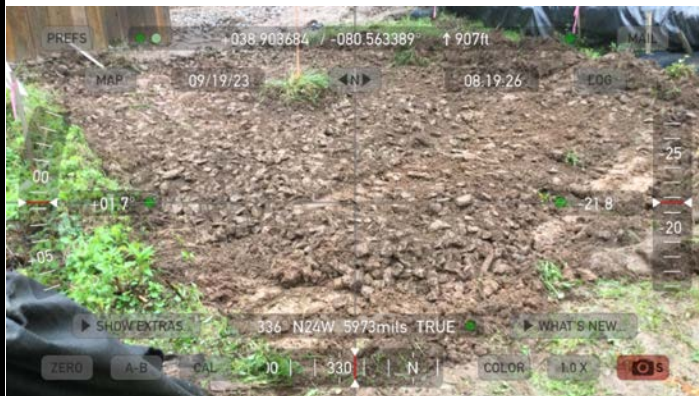
**Description** This photo shows the subgrade of the wetland following removal and segregation of the wetland topsoil
