Wetland Biological Conditions EA Report

Project Name	H-600 Pipeline Spread E	AFE	124300134	Spread	H-600 Pipeline Spread E
Contractor	Price Gregory	Report #	12		
Environmental Auditor	Charles Haden			Date/Time	8/8/2023 9:28 AM
Wetland ID	W-EF31	Crossing Start Date	8/8/2023	Crossing Completion Date	9/20/2023
Milepost	133.20	Pre-Con Assessment Date	8/8/2023	Post-Con Assessment Date	9/20/2023
Station	7032+96	Cowardin Classification	PEM	Wetland Impact Area(acres)	0.0208
State	WV				
County	Nicholas

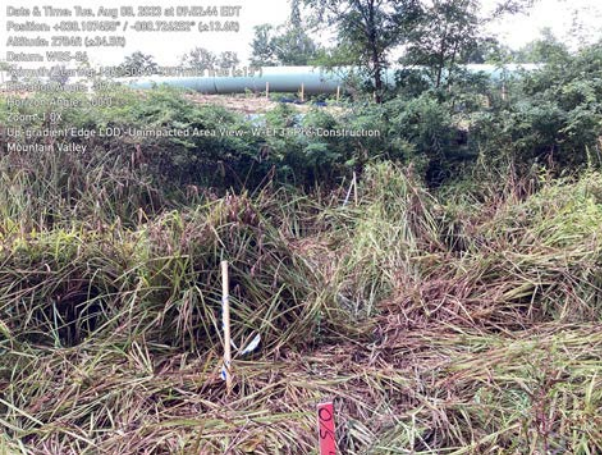
GPS Location	See Photo		GPS Location	See Photo	
Description	View of permitted resource impact area during pre-construction assessment.		Description	At edge of LOD, view of unimpacted resource area conditions during pre-construction assessment.

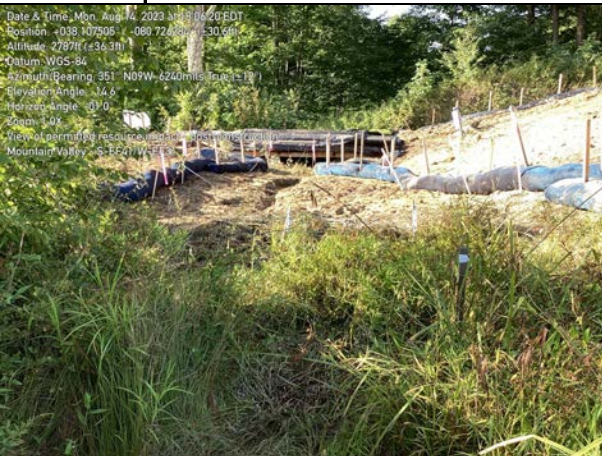
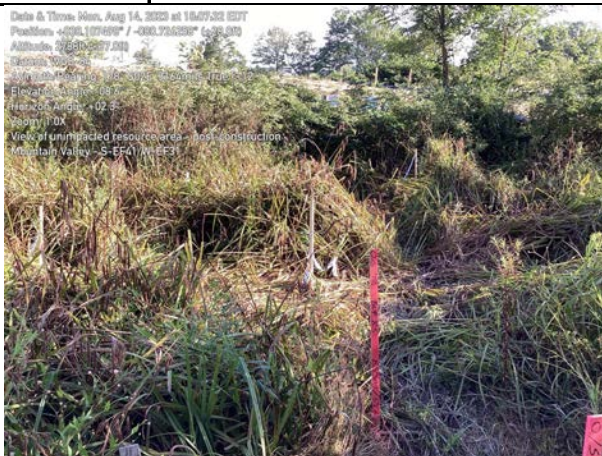
GPS Location	See Photo		GPS Location	See Photo	
Description	View of permitted resource impact area during post-construction assessment. Original post construction photo.		Description	At edge of LOD, view of unimpacted resource area conditions during post-construction assessment. Original post construction photo.

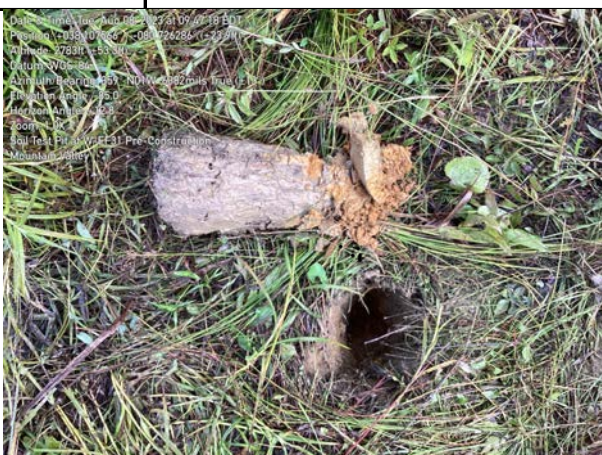
Pre-Construction Notes
 17. Pre-Con - Water recharged into the test pit and soils were saturated (A2 and A3) (Photo 1).
 18. Pre-Con - Timber mat present (travel lane).

GPS Location	See Photo		GPS Location	See Photo	
Description	Photo 1. Soil Test Pit - Saturated Soils		Description	Photo 2. Removal of wetland topsoil and stream substrate.

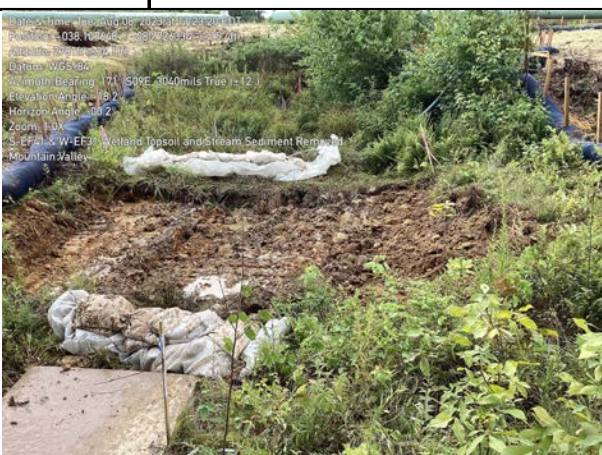
Day 1 (8/8/2023)
 Pre-Construction meeting at 0900.
 EI for crossing is Johnny Graham.
 0.69" of precipitation recorded in previous 24-hours.
 Both wetland topsoil and stream substrate were removed to upland area (Photo 2) and segregated separately.

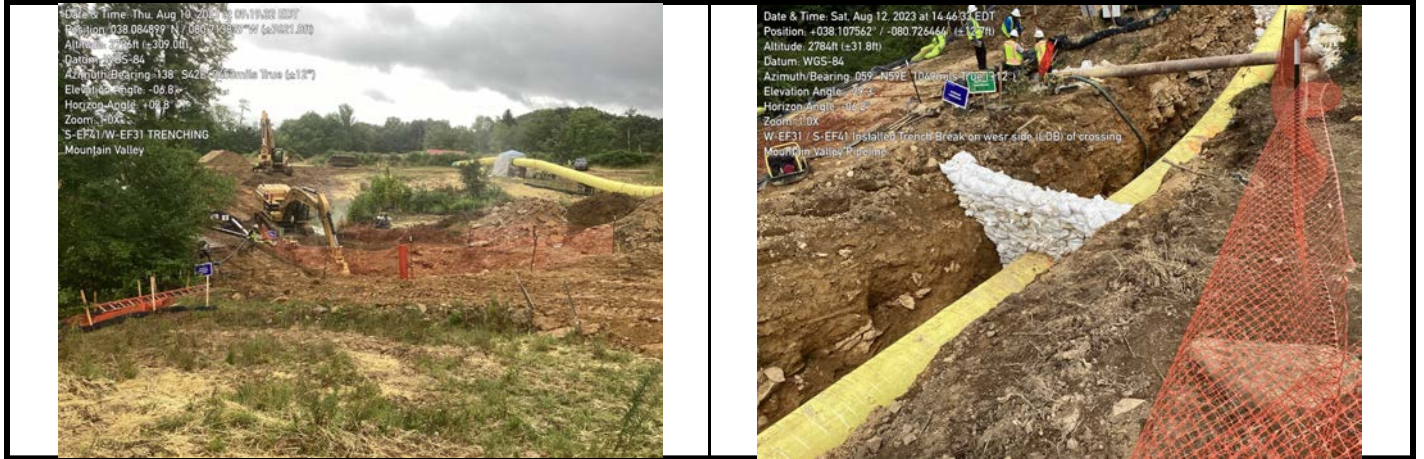
Day 3 (8/10/2023)
 Continuation of trench hammering and soil/rock removal (Photo 3).
 Trench completed, additional soil removal around pipe ends, and end plate cut and pipe end grinded/cleaned.
 Intermittent heavy rain all day.

Day 5 (8/14/2023)
 Pipe is installed with appropriate trench breakers (Photo 4).
 Upland areas have been backfilled and brought to grade.
 Top 12" of wetland topsoil was replaced and graded to original wetland topography (Photo 5).
 Permanent wetland seed was applied (Photo 8).

GPS Location See Photo	GPS Location See Photo
Description Photo 3. Excavating trench at crossing.	Description Photo 4: Trench Breakers

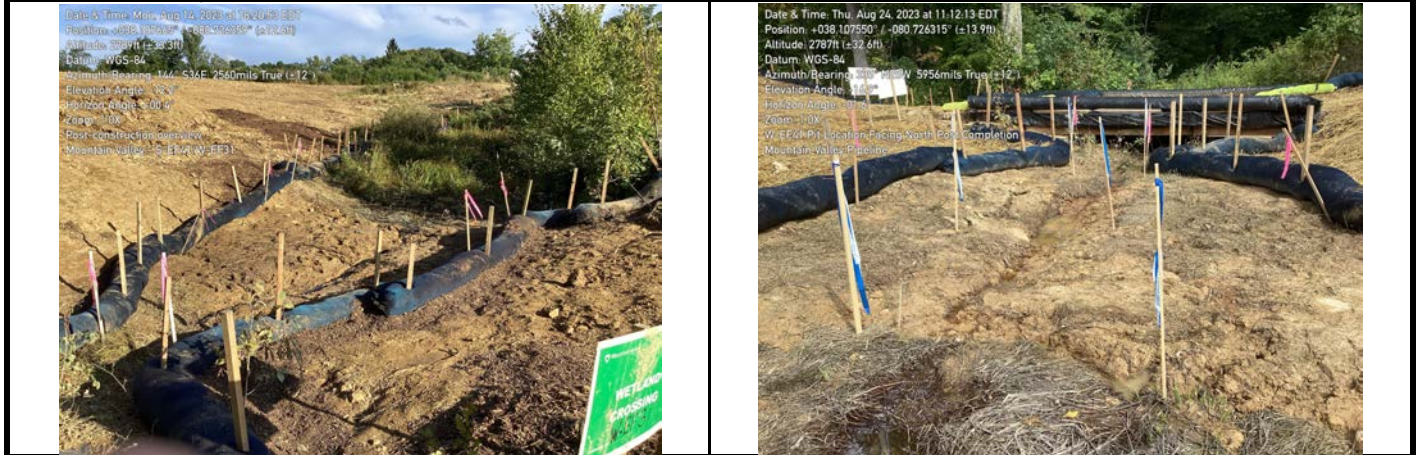
Discovered stream and wetland have sunken, yet flow was still present (8/24/2023).

GPS Location See Photo	GPS Location See Photo
Description Photo 5: Regraded wetland.	Description Photo 6: Sinking wetland (8/24/2023).

9/19/2023
 Wetland has recharge and saturated soils (Photo 7). Some vegetative growth noted. Wetland topsoil was removed wetland above trench area and placed in an upland area. Additional fill placed in wetland. Wetland surveyed and restored with original wetland soils.

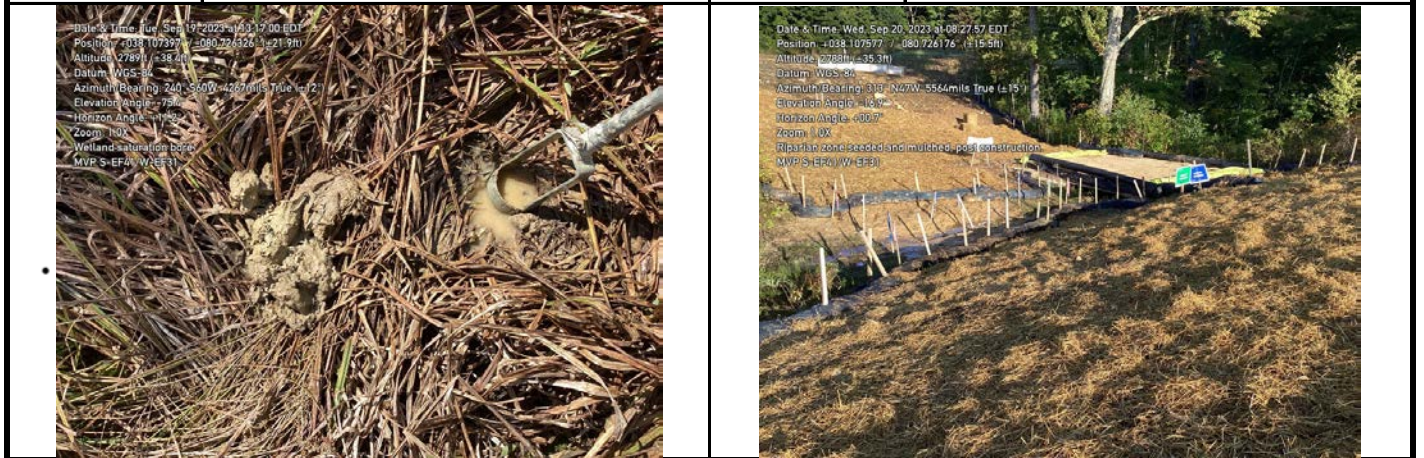
9/20/2023
 Area seeded and riparian zone completed (Photo 8). Post Construction Assessment completed. Wetland test pit was saturated.

GPS Location See Photo	GPS Location See Photo
Description Photo 7: Wetland test pit recharged and soils are saturated (9/19/2023).	Description Photo 8: Restored wetland and associated riparian area (9/20/2023).
