Wetland Biological Conditions EA Report

Project Name	H-600 Pipeline Spread C	AFE	124300131	Spread	H-600 Pipeline Spread C
Contractor	Precision	Report #	51		
Environmental Auditor	Jeffrey Arbogast			Date/Time	9/11/2023 3:54 PM
Wetland ID	W-H64-PEM2	Crossing Start Date	9/11/2023	Crossing Completion Date	9/22/2023
Milepost	93.31	Pre-Con Assessment Date	9/11/2023	Post-Con Assessment Date	9/22/2023
Station	4926+72	Cowardin Classification	PEM	Wetland Impact Area(acres)	0.0289
State	WV				
County	Webster

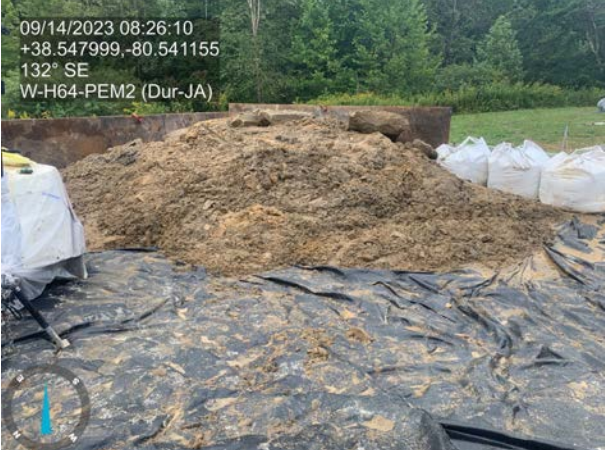
<p>09/14/2023 08:26:10 +38.547999,-80.541155 132° SE W-H64-PEM2 (Dur-JA)</p>

<p>09/14/2023 11:41:45 +38.548158,-80.540387 272° W W-H64-PEM2 (Dur-JA)</p>	
GPS Location	See caption in photo	GPS Location	See caption in photo
Description	Wetland subsoil has been segregated using geotech fabric and road plates.	Description	Welding up sections of pipe that will be stubbed into loose end on the GAS of wetland.

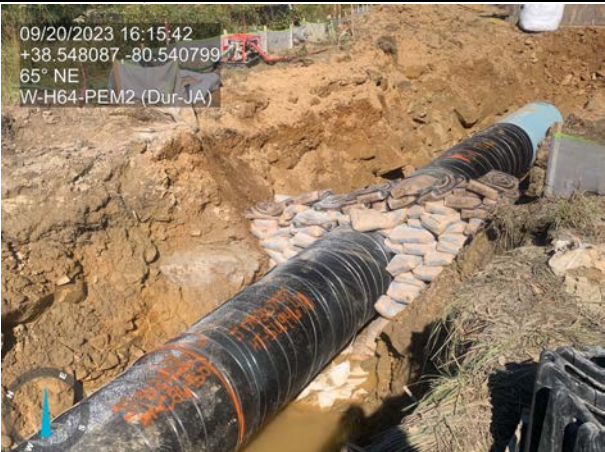
<p>09/20/2023 16:15:42 +38.548087,-80.540799 65° NE W-H64-PEM2 (Dur-JA)</p>

<p>09/21/2023 14:20:12 +38.548116,-80.540820 297° NW W-H64-PEM2 (Dur-JA)</p>	
GPS Location	See caption in photo	GPS Location	See caption in photo
Description	Bentonite trench breaker being built 4' outside of wetland boundary.	Description	Using a padding bucket to backfill ditch. River weight was placed on pipe for stability.
  <p>09/21/2023 15:19:48 +38.548105,-80.540631 301° NW W-H64-PEM2 (Dur-JA)</p>

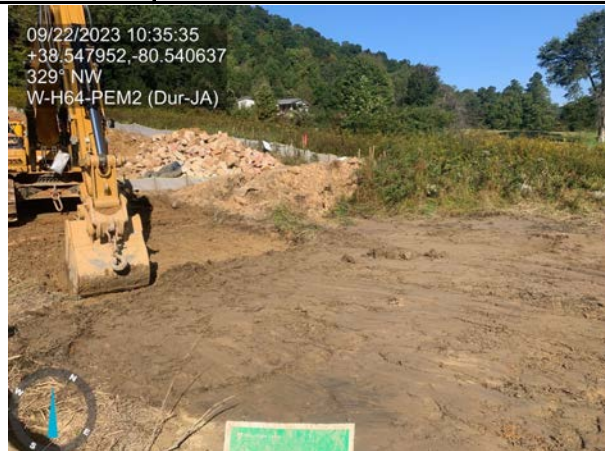
<p>09/22/2023 10:35:35 +38.547952,-80.540637 329° NW W-H64-PEM2 (Dur-JA)</p>

GPS Location	See caption in photo	GPS Location	See caption in photo
Description	Subsoil brought up to within 12" of final grade prior to topsoil replacement.	Description	Operator carefully replacing wetland topsoil.
