Wetland Biological Conditions EA Report

Project Name	H-600 Pipeline Spread C	AFE	124300131	Spread	H-600 Pipeline Spread C
Contractor	Precision	Report #	48		
Environmental Auditor	Jeffrey Arbogast			Date/Time	9/11/2023 3:35 PM
Wetland ID	W-H64-PSS	Crossing Start Date	9/11/2023	Crossing Completion Date	9/22/2023
Milepost	93.31	Pre-Con Assessment Date	9/11/2023	Post-Con Assessment Date	9/22/2023
Station	4926+65	Cowardin Classification	PSS	Wetland Impact Area(acres)	0.0422
State	WV				
County	Webster

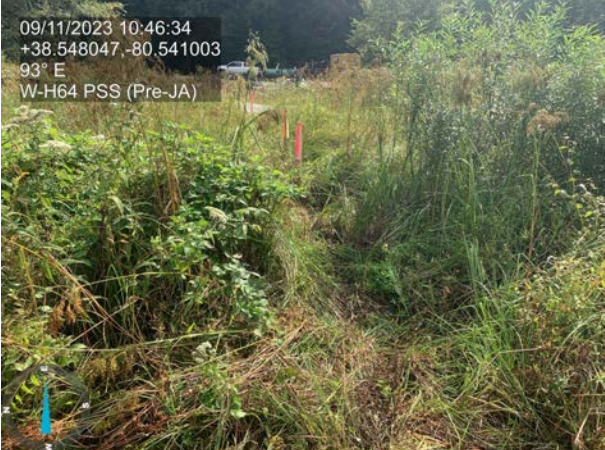
<p>09/11/2023 10:46:34 +38.548047,-80.541023 93° E W-H64 PSS (Pre-JA)</p>

<p>09/11/2023 10:44:02 +38.548068,-80.541047 177° S W-H64 PSS (Pre-JA)</p>	
GPS Location	See caption in photo	GPS Location	See caption in photo
Description	View of permitted resource impact area during pre-construction assessment. View from GAS of center line looking up LOD pre-construction.	Description	At edge of LOD, view of unimpacted resource area conditions during pre-construction assessment. View of left LOD edge at unimpacted resource pre-construction.

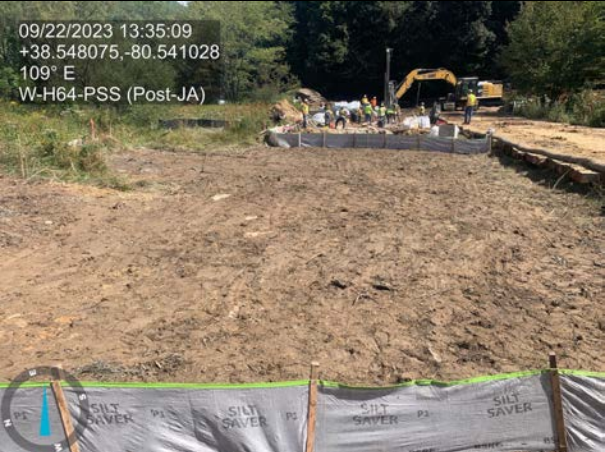
<p>09/22/2023 13:35:09 +38.548075,-80.541028 109° E W-H64-PSS (Post-JA)</p>

Conditions 18 and 19 were given a rating of 4 due to the lack of vegetation in the disturbed permitted impact area following completion of the crossing and restoration efforts. Wetland W-H64-PSS topsoil has been properly stabilized and the disturbed area has been seeded with the appropriate permanent seed mix in accordance with Appendix B: Restoration Work Plan of the Mountain Valley Pipeline Comprehensive Stream and Wetland Monitoring, Restoration and Mitigation Framework.

<p>09/22/2023 12:16:58 +38.548061,-80.541016 159° S W-H64-PSS (Post-JA)f</p>	
GPS Location	See caption in photo	GPS Location	See caption in photo
Description	View of permitted resource impact area during post-construction assessment. View from GAS of center line looking up LOD post-construction.	Description	At edge of LOD, view of unimpacted resource area conditions during post-construction assessment. View of left LOD edge at unimpacted resource post-construction.

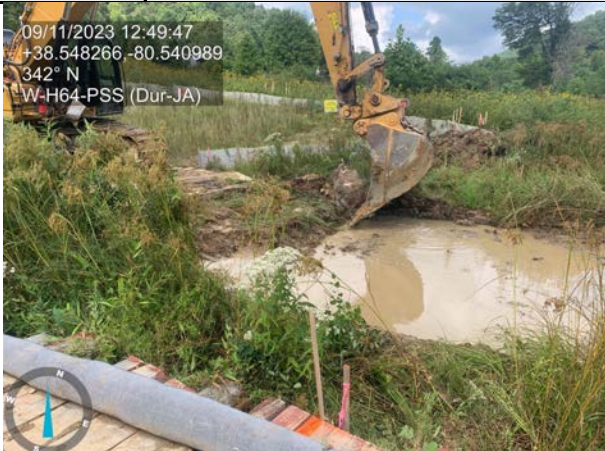
<p>09/11/2023 12:49:47 +38.548266,-80.540989 342° N W-H64-PSS (Dur-JA)</p>

9/11/2023: Pre-Construction meeting was conducted at 9 a.m. The crew immediately started removing wetland topsoil and segregating it from all other soils (Ref. MVP Restoration and Rehabilitation Plan Sec. 3.1) before the blasting crew began drilling in preparation for the ditch line to be shot tomorrow. Welding up of pipe sections continued all day. The John Henry rock drill broke down so blasting prep halted outside of the wetland on the going away side (GAS).

<p>09/13/2023 09:24:10 +38.548398,-80.540546 274° W W-H64-PSS (Dur-JA)</p>	
GPS Location	See caption in photo	GPS Location	See caption in photo
Description	Top 12" of wetland topsoil being removed and segregated	Description	Blasting crew drilling rock in wetland so explosives can be set.

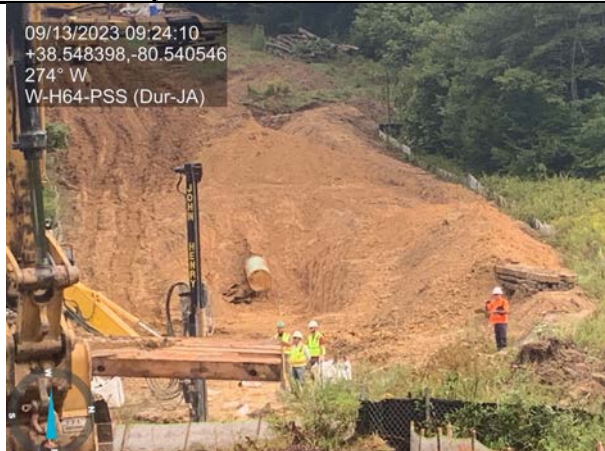
9/13/2023: The blasting crew started drilling but another equipment failure forced them to stop shortly after entering into the W-H64-PSS wetland boundary. A decision was made to shoot the area blasting had finished thus far then try to dig the remaining ditch line without blasting. Subsoil was removed from the adjoining wetland (W-H64-PEM2) and segregated on geo fabric in an upland area. Ditch excavation continued but was slow due to rock. Welders continued making up pipe sections.
