# Wetland Biological Conditions EA Report

<b>Project Name</b>	H-600 Pipeline Spread C	<b>AFE</b>	124300131	<b>Spread</b>	H-600 Pipeline Spread C
<b>Contractor</b>	Precision	<b>Report #</b>	69		
<b>Environmental Auditor</b>	Jeffrey Arbogast			<b>Date/Time</b>	9/28/2023 2:43 PM
<b>Wetland ID</b>	W-H66	<b>Crossing Start Date</b>	9/28/2023	<b>Crossing Completion Date</b>	10/21/2023
<b>Milepost</b>	93.20	<b>Pre-Con Assessment Date</b>	9/11/2023	<b>Post-Con Assessment Date</b>	10/21/2023
<b>Station</b>	4920+78	<b>Cowardin Classification</b>	PFO	<b>Wetland Impact Area(acres)</b>	0.2496
<b>State</b>	WV				
<b>County</b>	Webster

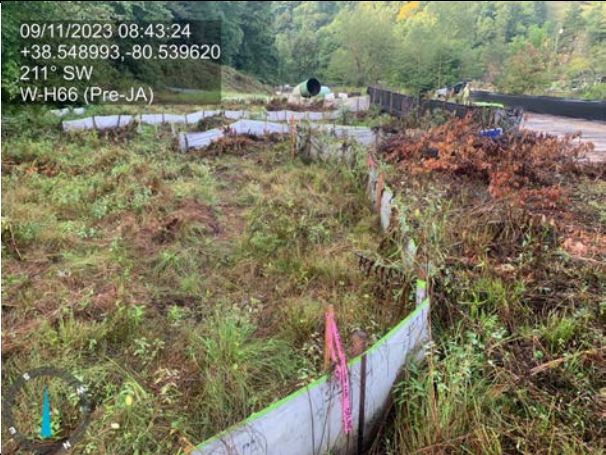
<p data-bbox="175 191 383 275">09/11/2023 08:43:24 +38.548993,-80.539620 211° SW W-H66 (Pre-JA)</p>

<p data-bbox="870 191 1078 275">09/28/2023 09:39:52 +38.548600,-80.539649 120° SE W-H66 (Pre-JA)</p>		<b>GPS Location</b>	See Caption in Photo	<b>GPS Location</b>	See Caption in Photo				
<b>Description</b>	View of permitted resource impact area during pre-construction assessment. Photo taken standing near the centerline, CIS, facing SW.	<b>Description</b>	At edge of LOD, view of unimpacted resource area conditions during pre-construction assessment. Photo taken on left side of LOD facing SE.

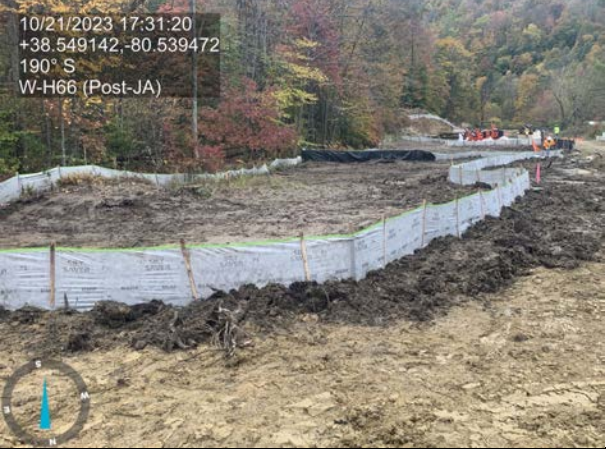
<p data-bbox="175 800 383 884">10/21/2023 17:31:20 +38.549142,-80.539472 190° S W-H66 (Post-JA)</p>

Conditions 18 and 19 were given a post-construction rating of 4 due to the lack of vegetation in the disturbed permitted impact area following completion of the crossing and restoration efforts. The W-H66 PFO topsoil has been properly stabilized and the disturbed area was seeded with the appropriate permanent seed mix in accordance with Appendix B: Restoration Work Plan of the Mountain Valley Pipeline Comprehensive Stream and Wetland Monitoring, Restoration and Mitigation Framework.

<b>Description</b>	View of permitted resource impact area during post-construction assessment. Photo taken standing near the centerline, CIS, facing SSW.	<b>Description</b>	At edge of LOD, view of unimpacted resource area conditions during post-construction assessment. Photo taken on left side of LOD facing SE.

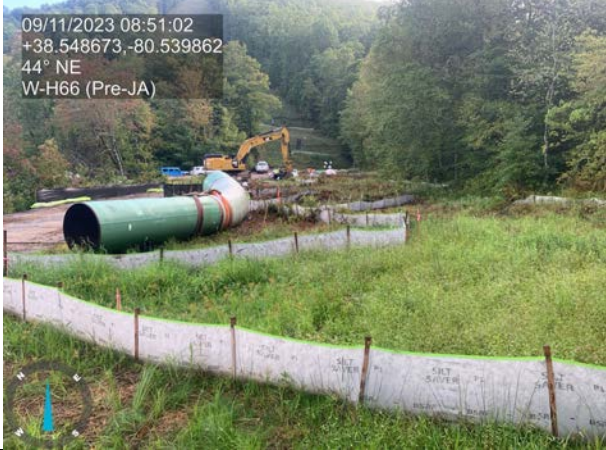
<p data-bbox="175 1402 383 1486">09/11/2023 08:51:02 +38.548673,-80.539862 44° NE W-H66 (Pre-JA)</p>

<p data-bbox="870 1402 1078 1486">10/21/2023 17:33:44 +38.548548,-80.539779 42° NE W-H66 (Post-JA)</p>		<b>GPS Location</b>	See Caption in Photo	<b>GPS Location</b>	See Caption in Photo
<b>Description</b>	Photo taken from the GAS end of the wetland. Pre-Construction.	<b>Description</b>	Photo taken from the GAS end of the wetland. Post-Construction.
