# Wetland Biological Conditions EA Report

<b>Project Name</b>	H-600 Pipeline Spread C	<b>AFE</b>	124300131	<b>Spread</b>	H-600 Pipeline Spread C
<b>Contractor</b>	Precision	<b>Report #</b>	85		
<b>Environmental Auditor</b>	Jeffrey Arbogast			<b>Date/Time</b>	10/13/2023 12:34 PM
<b>Wetland ID</b>	W-H67	<b>Crossing Start Date</b>	10/12/2023	<b>Crossing Completion Date</b>	10/19/2023
<b>Milepost</b>	93.17	<b>Pre-Con Assessment Date</b>	9/11/2023	<b>Post-Con Assessment Date</b>	10/20/2023
<b>Station</b>	4919+60	<b>Cowardin Classification</b>	PFO	<b>Wetland Impact Area(acres)</b>	0.0908
<b>State</b>	WV				
<b>County</b>	Webster

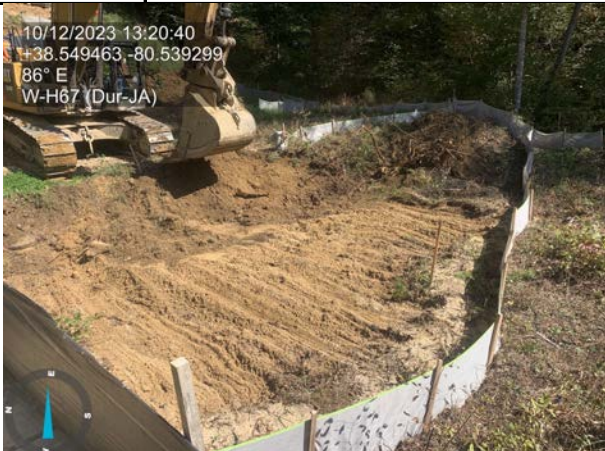
<p>10/12/2023 13:20:40 +38.549463,-80.539299 86° E W-H67 (Dur-JA)</p>

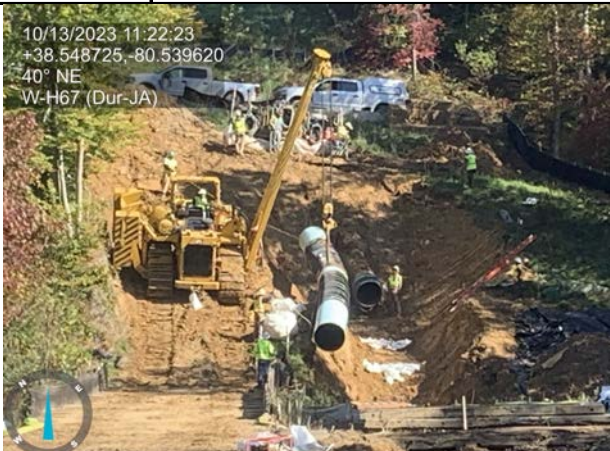
<p>10/13/2023 11:22:23 +38.548725,-80.539620 40° NE W-H67 (Dur-JA)</p>	
<b>GPS Location</b>	See Caption in Photo	<b>GPS Location</b>	See Caption in Photo
<b>Description</b>	Topsoiling the wetland down to the 10-foot stream buffer on the CIS.	<b>Description</b>	Lowering in the first pipe section on the CIS of the wetland.
