Wetland Biological Conditions EA Report

Project Name	H-600 Pipeline Spread E	AFE	124300134	Spread	H-600 Pipeline Spread E
Contractor	Price Gregory	Report #	65		
Environmental Auditor	Tim Ferguson			Date/Time	9/22/2023 8:45 AM
Wetland ID	W-QR2	Crossing Start Date	9/22/2023	Crossing Completion Date	10/9/2023
Milepost	144.17	Pre-Con Assessment Date	9/22/2023	Post-Con Assessment Date	10/9/2023
Station	7612+18	Cowardin Classification	PEM	Wetland Impact Area(acs)	0.2435
State	WV				
County	Greenbrier

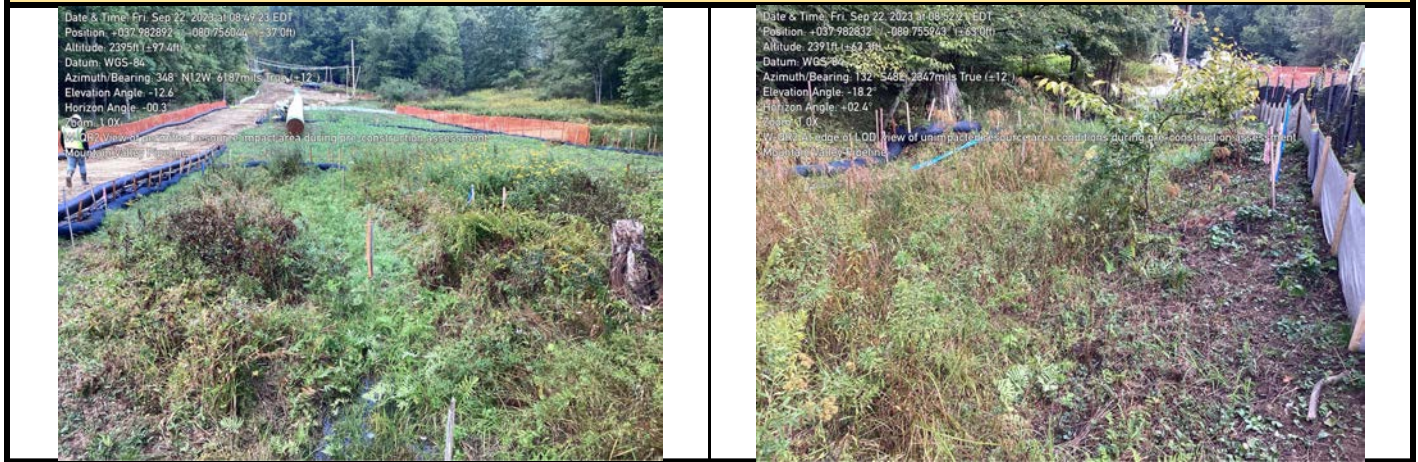
GPS Location	See Photo	GPS Location	See Photo
Description	View of permitted resource impact area during pre-construction assessment.	Description	At edge of LOD, view of unimpacted resource area conditions during pre-construction assessment.

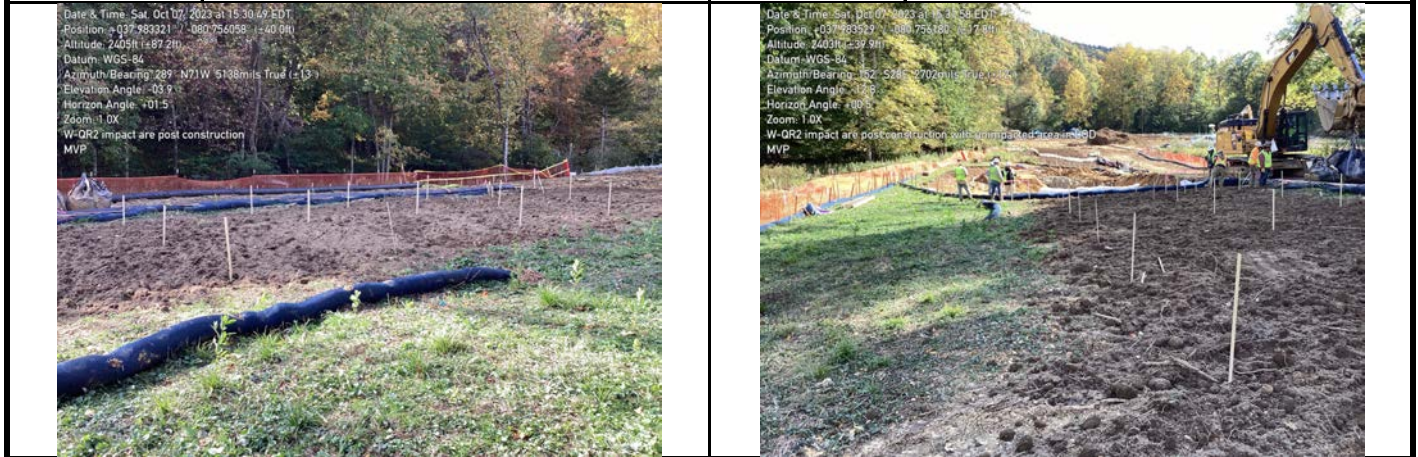
Post Construction Notes
 17. Post Construction test pit contained saturated soils.
 18. Does not include timber mats that remain in place for travel lane.
 19. Crossing and riparian areas have been recently restored. These areas will be monitored until 80% vegetative cover has been achieved and areas that do not have 80% vegetative cover within 30 days will be reseeded.

GPS Location	See Photo	GPS Location	See Photo
Description	View of permitted resource impact area during post-construction assessment.	Description	At edge of LOD, view of unimpacted resource area conditions during post-construction assessment.

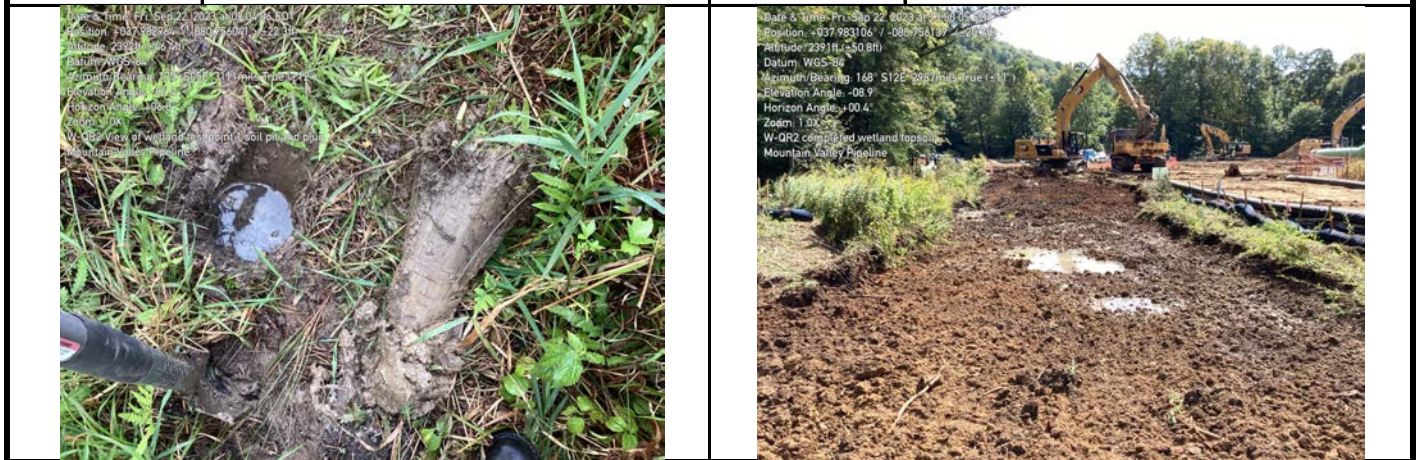
Pre-Construction Notes
 Pre-Construction Meeting 9/19/2023
 Resource crosses ROW in two locations.
 17. Pre-Construction - Test pit recharged and contained saturated soils (Photo 1).
 18. Pre-Construction - Timber mat present (travel lane)

Day 1 (9/22/2023)
 Began wetland topsoil removed (Photo 2) at first resource crossing and segregated in an upland area. Trenching began in resource (Photo 3). Pipe brought onsite to prepare for lowering into resource.

GPS Location	See Photo	GPS Location	See Photo
Description	Photo 1: Soil test pit with recharge and saturated soils.	Description	Photo 2: Wetland topsoil removed at first resource crossing.

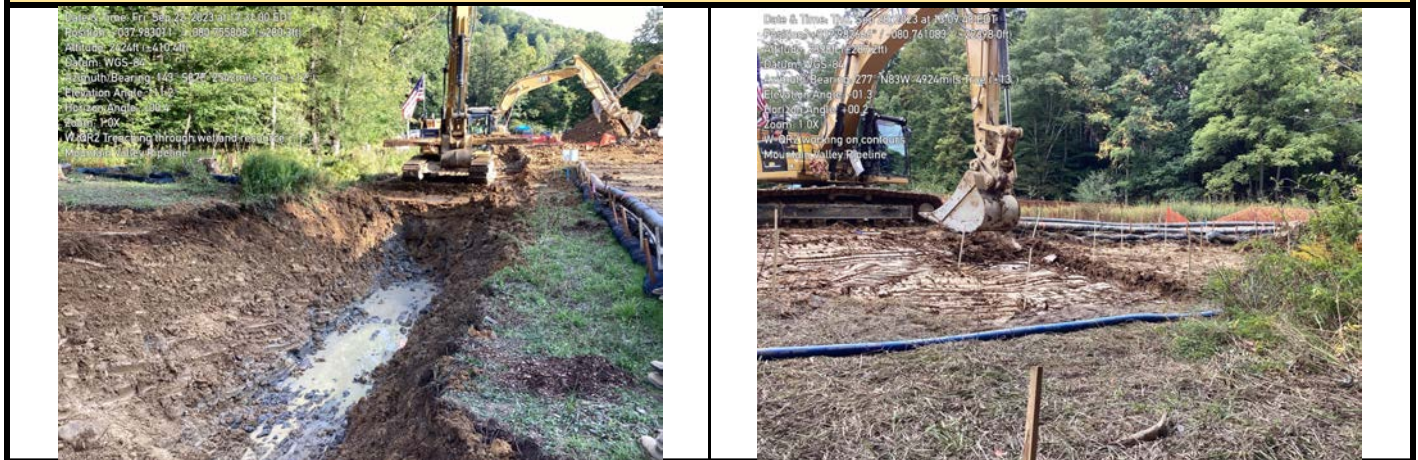
Day 6 (9/28/2023)
 Backfilling in resource area. Elevations checked by survey and topsoil was returned to resource (first crossing only) (Photo 4).

Description Photo 3: Excavating trench through first aquatic resource crossing.	Description Photo 4: Establishing restoration contours at first aquatic resource crossing using segregated topsoil.
--	--

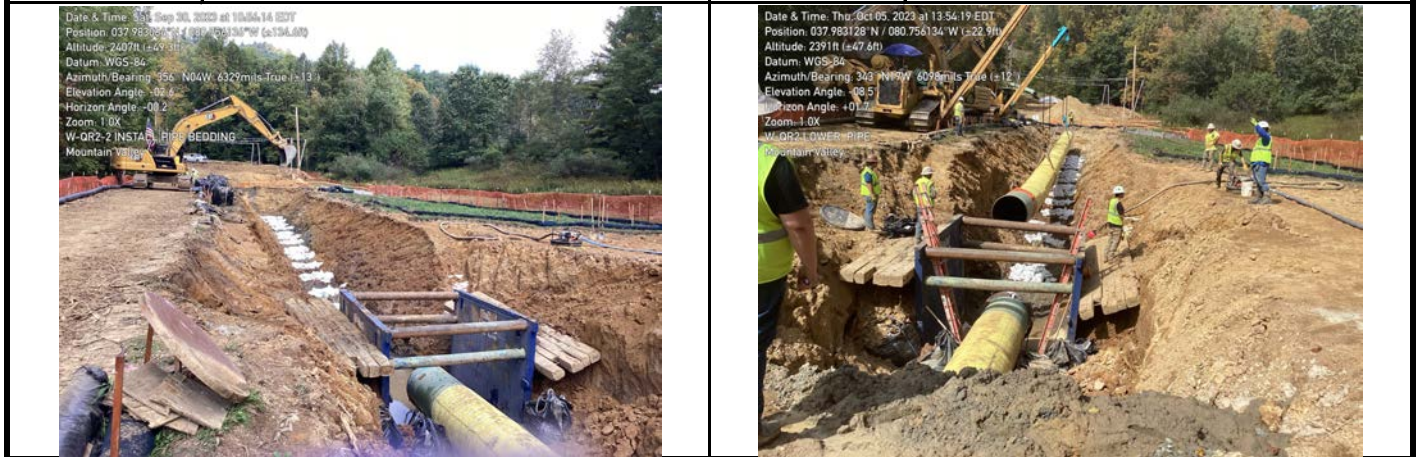
Day 8 - Day 12 (9/30/2023-10/05/2023)
 Activity during this timeframe included welding, coating, sandblasting, placement of rock shielding, and welding all outside of the resource. Pipe bedding was placed in the trench in the aquatic resource (Photo 5). On 10/5/2023 a section of pipe was lowered into resource (Photo 6). Delay was due to an extra section of pipe that was needed to complete the connection at this location.

Description Photo 5: Installing bedding in aquatic resource area.	Description Photo 6: Lowering pipe into second resource crossing.
--	--

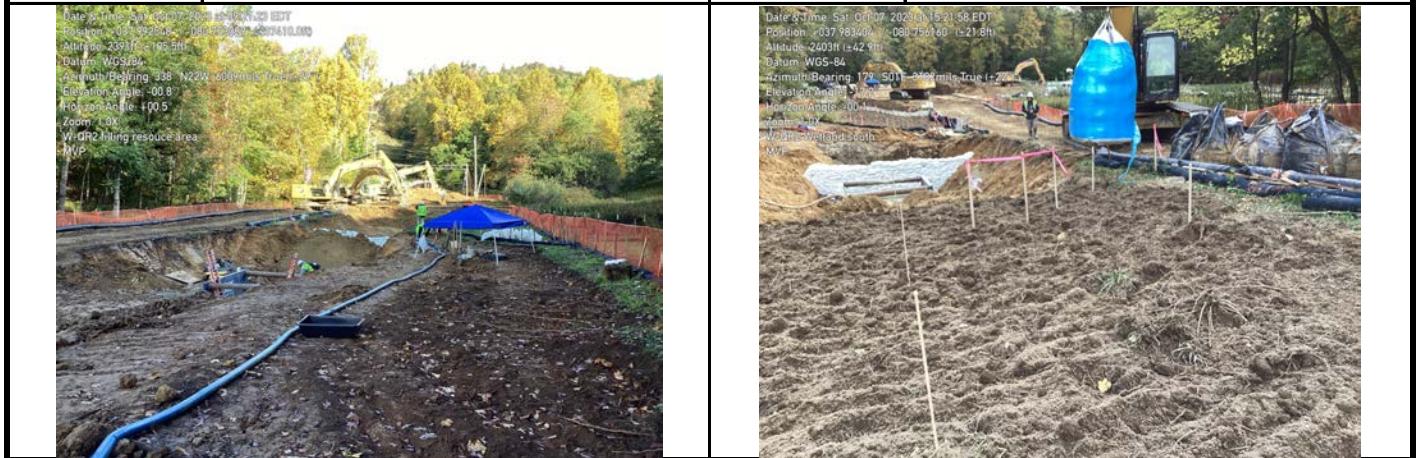
Day 13 (10/6/2023)
 Welding, x-ray, sandblasting, and coating completed on section of pipe that was lowered into trench. Additional trench breakers being installed and backfilling began (Photo 7).

Day 14 (10/7/2023)
 Backfilling completed in resource area. Survey staked out resource and site brought to appropriate grade. Wetland topsoil was placed in aquatic resource area (Photo 8). Survey revisited wetland to determine final grade and to stake resource boundaries. Wetland seeded. EI felt additional seed necessary.

Description Photo 7: Backfilling of second aquatic resource crossing.	Description Photo 8: Wetland topsoil restored in second crossing. Trench breakers being constructed.
--	---
