Wetland Biological Conditions EA Report

Project Name	H-600 Pipeline Spread A	AFE	124300129	Spread	H-600 Pipeline Spread A
Contractor	Precision	Report #	75		
Environmental Auditor	Jake Pokorny	Date/Time	10/2/2023 7:33 AM		
Wetland ID	W-UU4a	Crossing Start Date	10/2/2023	Crossing Completion Date	10/11/2023
Milepost	30.09	Pre-Con Assessment Date	9/27/2023	Post-Con Assessment Date	10/17/2023
Station	1588+75	Cowardin Classification	PEM	Wetland Impact Area(acres)	0.1268
State	WV				
County	Harrison

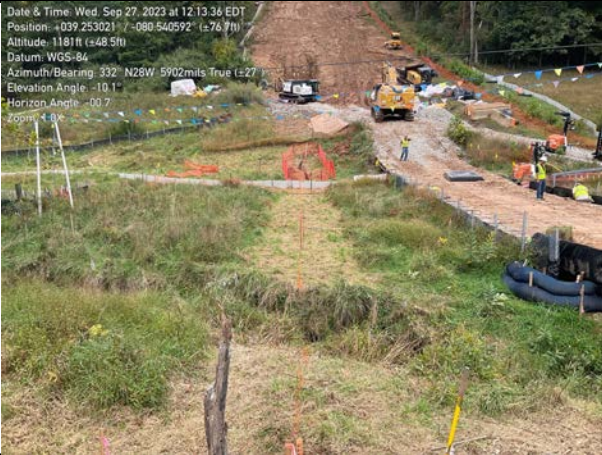
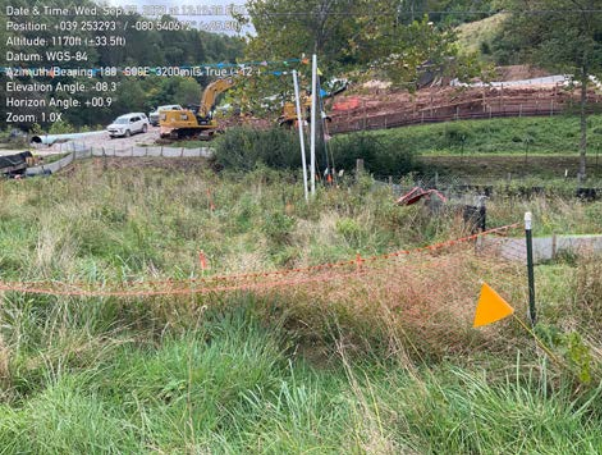
<p>Date & Time: Wed, Sep 27, 2023 at 11:11:58 EDT Position: +039.253293 / -080.540612 (+76.8ft) Altitude: 1170ft (+33.5ft) Datum: WGS-84 Azimuth/Bearing: 108° 608E 3200mils True (+12.1°) Elevation Angle: -08.3° Horizon Angle: +00.9° Zoom: 1.0x</p>			
GPS Location	See Above.	GPS Location	See Above.		
Description	View of permitted resource impact area during pre-construction assessment.	Description	At edge of LOD, view of unimpacted resource area conditions during pre-construction assessment.

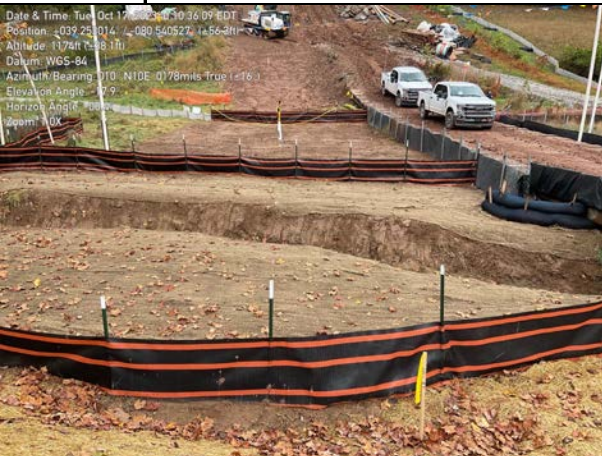
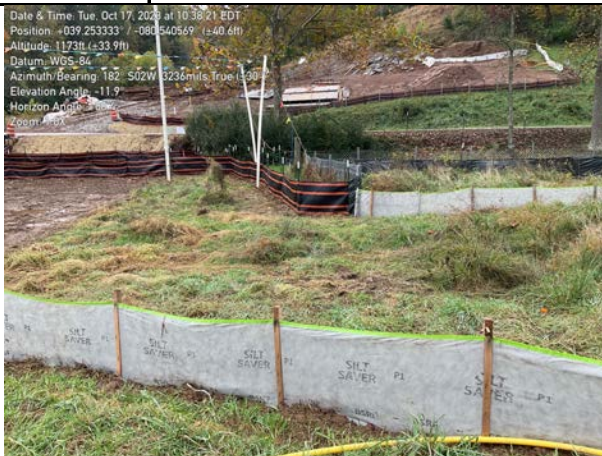
Conditions 18 and 19 were given a rating of 4 during post-construction assessment due to lack of vegetation in the disturbed permitted impact area following the completion of the crossing and restoration efforts. The W-UU4a substrate has been properly stabilized and the disturbed area has been seeded with the appropriate permanent seed mix in accordance with Appendix B: Restoration Work Plan of the Mountain Valley Pipeline Comprehensive Stream and Wetland Monitoring, Restoration and Mitigation Framework.

GPS Location	See Above.	GPS Location	See Above.		
Description	View of permitted resource impact area during post-construction assessment.	Description	At edge of LOD, view of unimpacted resource area conditions during post-construction assessment.

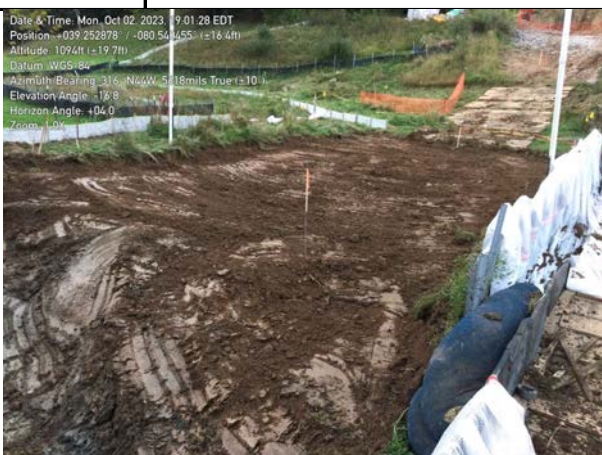
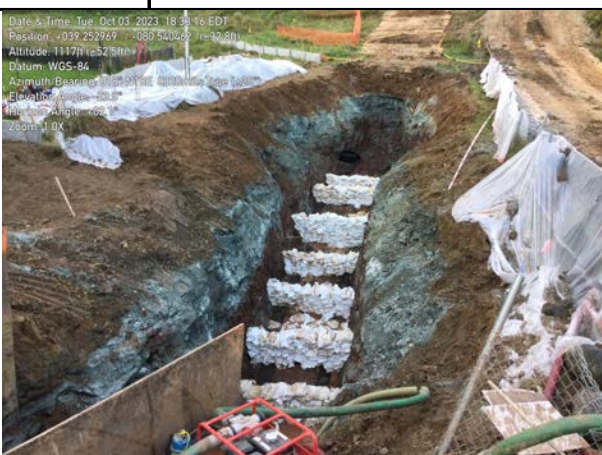
<p>Date & Time: Tue, Oct 03, 2023, 18:38:46 EDT Position: +039.252969 / -080.540468 (+30.8ft) Altitude: 1187ft (+32.8ft) Datum: WGS-84 Azimuth/Bearing: 108° 608E 3200mils True (+12.1°) Elevation Angle: -08.3° Horizon Angle: +00.9° Zoom: 1.0x</p>			
GPS Location	See Above.	GPS Location	See Above		
Description	10/02/23 - Top 12 inches of topsoil and substrate removed and piled separately.	Description	10/03/23 - Excavated down to correct depth.

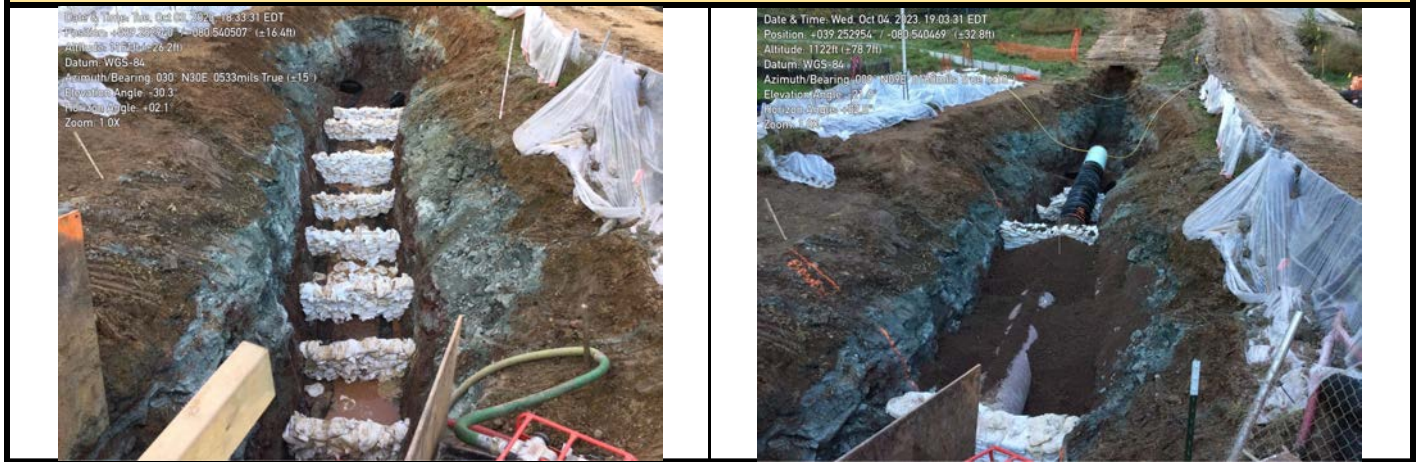
GPS Location See Above,	GPS Location See Above.
Description 10/04/23 - trench breakers installed.	Description 10/04/23 - pipe installed, backfilling begun.

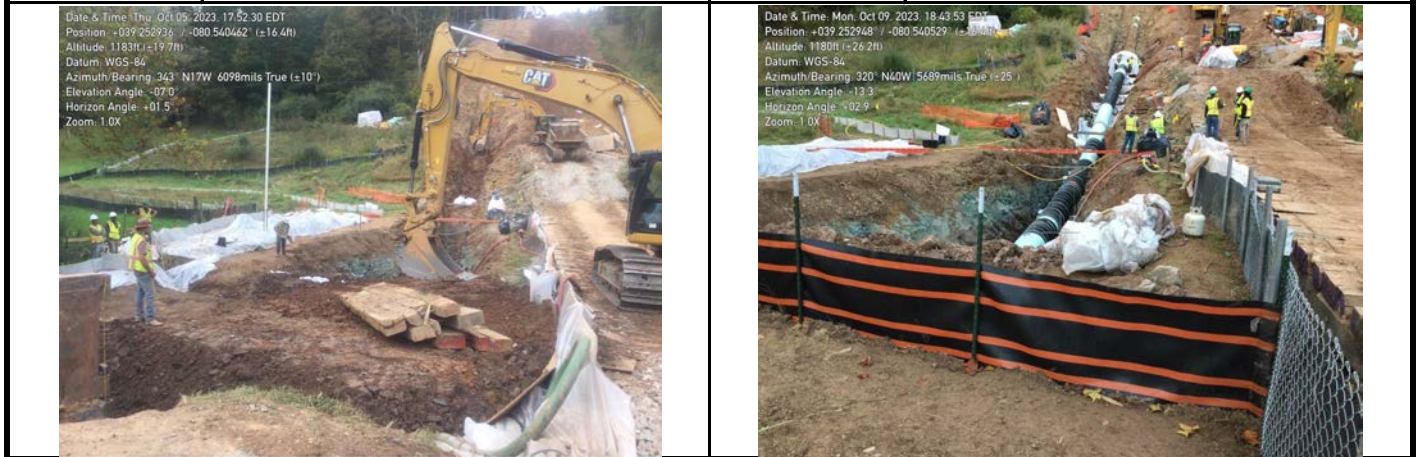
GPS Location See Above.	GPS Location See Above.
Description 10/05/23 - The area continued to be backfilled.	Description 10/09/23 - Welding efforts continued

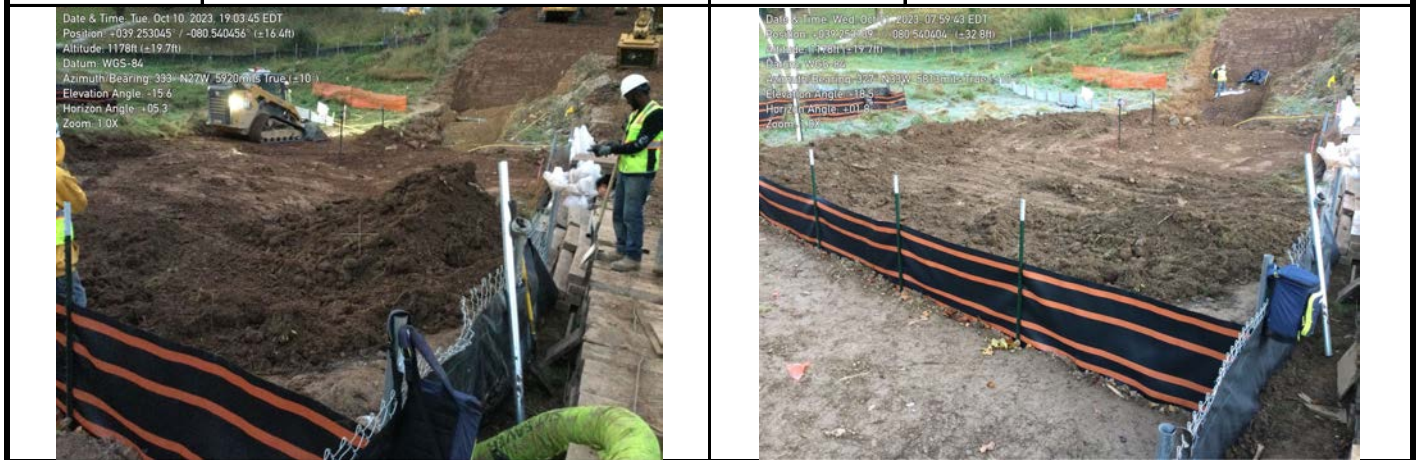
GPS Location See Above.	GPS Location See Above.
Description 10/10/23 - The northern part of the wetland was backfilled and begun backfilling the top 12 inches of topsoil.	Description 10/11/23 - Erosion controls were reinstalled and topsoil graded to pre-construction contour
