Stream Biological Conditions EA Report

Project Name	H-600 Pipeline Spread B	AFE	124300130	Spread	H-600 Pipeline Spread B
Contractor	Precision	Report #	268		
Environmental Auditor	Elyse Johnston	Date/Time	10/4/2023 12:04 PM		
Stream ID	S-A111	Crossing Start Date	10/4/2023	Crossing Completion Date	10/26/2023
Milepost	34.80	Pre-Con Assessment Date	10/4/2023	Post-Con Assessment Date	10/27/2023
Station	1837+44	Bankfull Width (ft.)	14.0	Riffle:Pool Complexes Present?	Yes
State	WV	Stream Classification	Perennial		
County	Doddridge	303(d) Impairment Listing	Iron

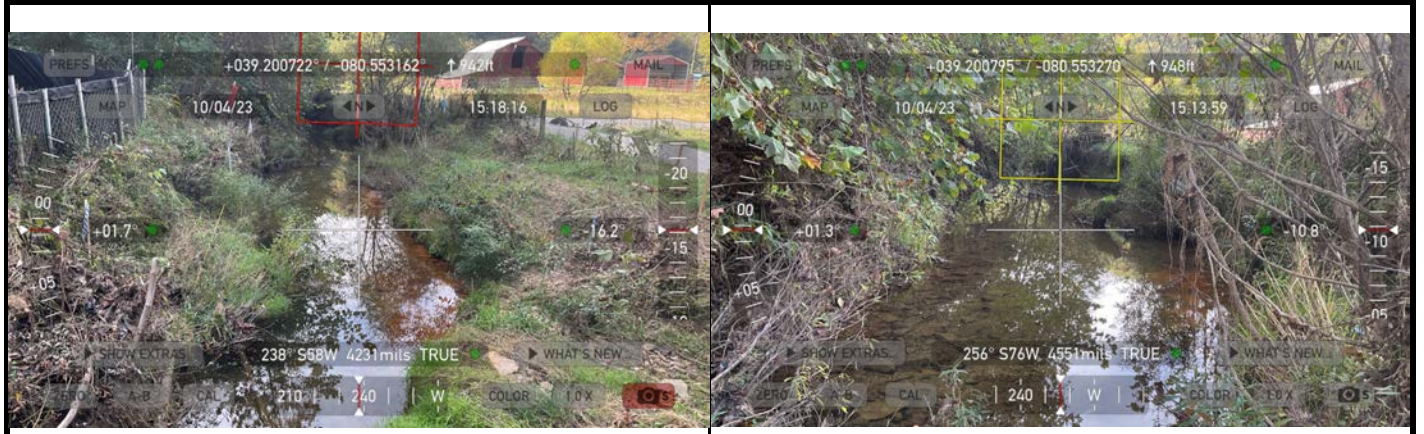
GPS Location See photo	GPS Location See photo
Description Downstream view of permitted impact area during pre-construction assessment.	Description Downstream view of unimpacted area during pre-construction assessment.

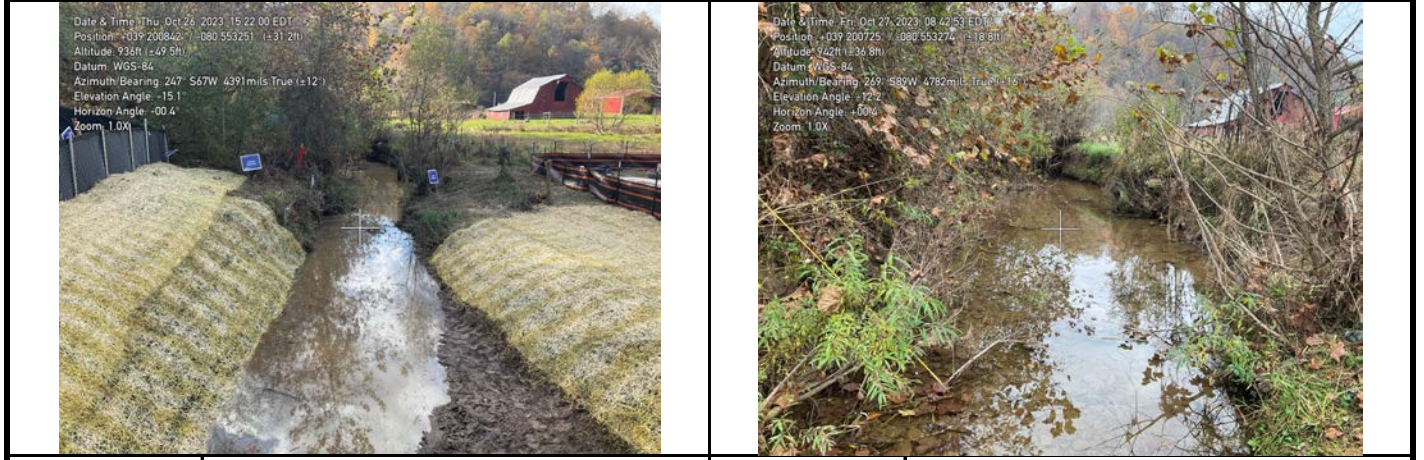
GPS Location See photo	GPS Location See photo
Description Downstream view of permitted impact area during post-construction assessment.	Description Downstream view of unimpacted area during post-construction assessment.

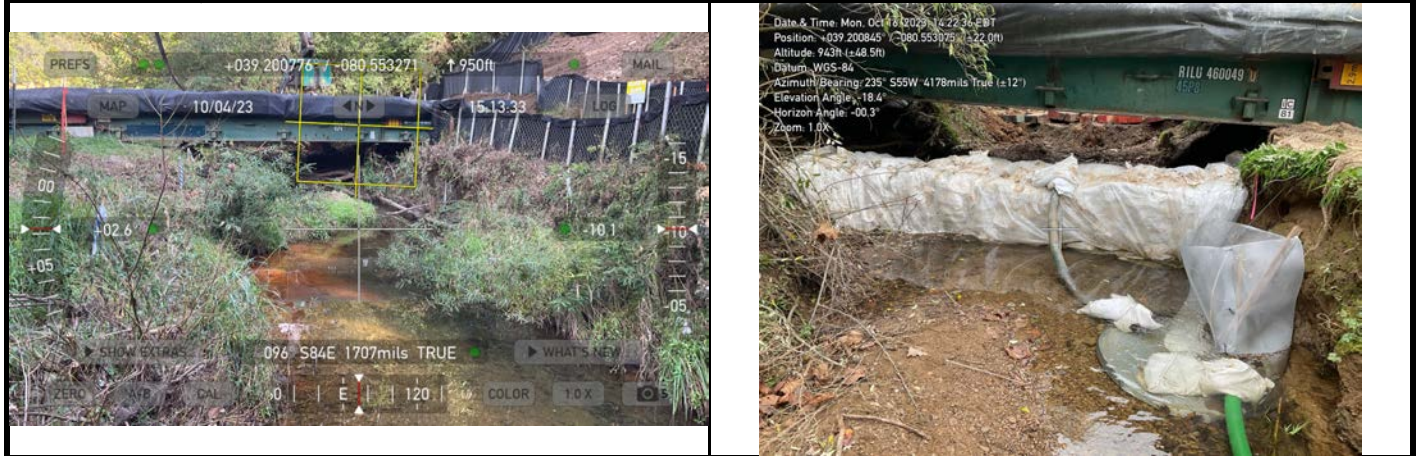
GPS Location See photo	GPS Location See photo
Description Alternate view of pre construction conditions of stream, facing upstream.	Description This photo shows the dam and pump installed in the stream to maintain flow during the crossing.
