STREAM BIOLOGICAL CONDITIONS ENVIRONMENTAL AUDITOR REPORT

Stream ID: S-A18	Crossing Start Date: 10/26/2023	Crossing Completion Date: 10/28/2023
Milepost: 278.7	Pre-Con Assessment Date: 10/13/2023	Post-Con Assessment Date: 10/28/2023
Station: 14722+60	Stream Classification: Intermittent (Perennial, Intermittent, Ephemeral)	Bankfull Width (ft.): 2.6
County: Franklin	303(d) Impairment Listing: Not Impaired	Riffle:Pool Complexes Present? No

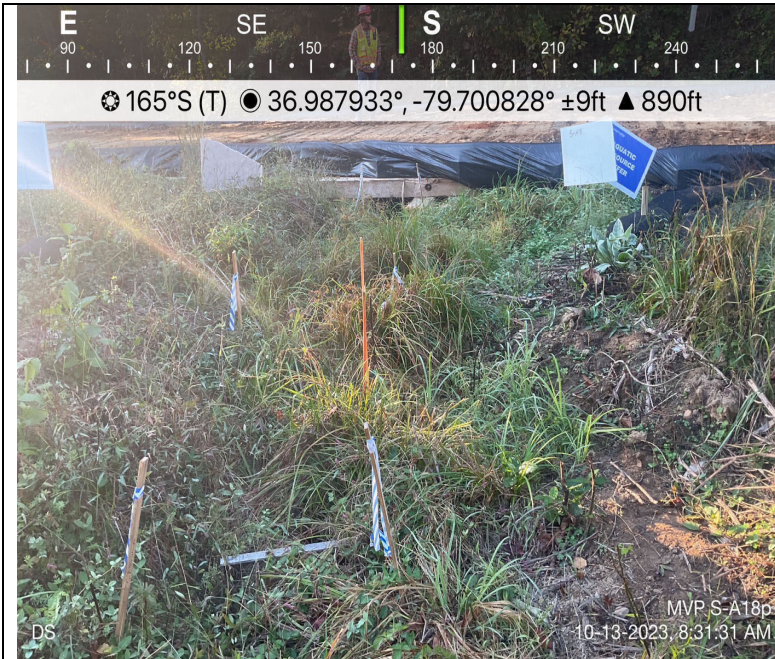
Photo Description: Downstream view of permitted impact area during pre-construction assessment.

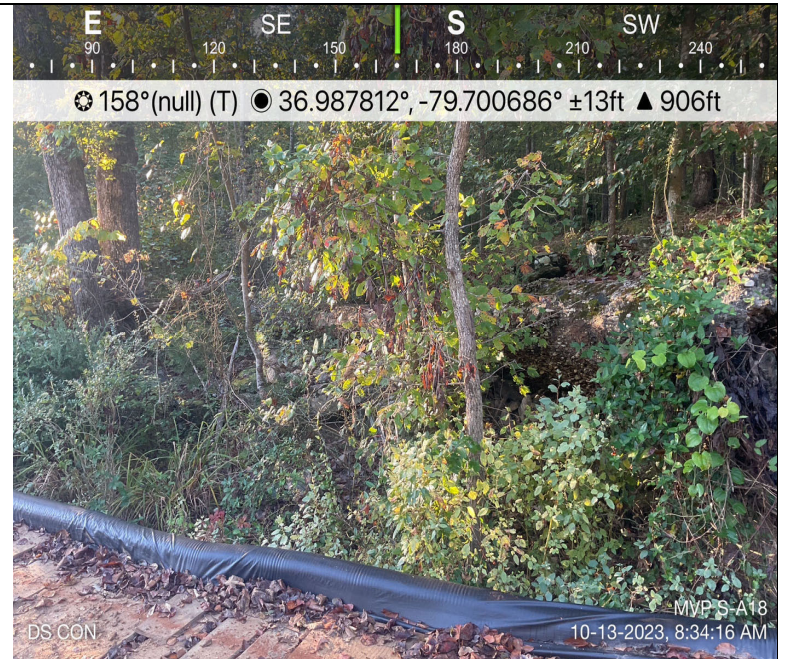
Photo Description: Conditions of the downstream area outside the ROW during pre-construction assessment.

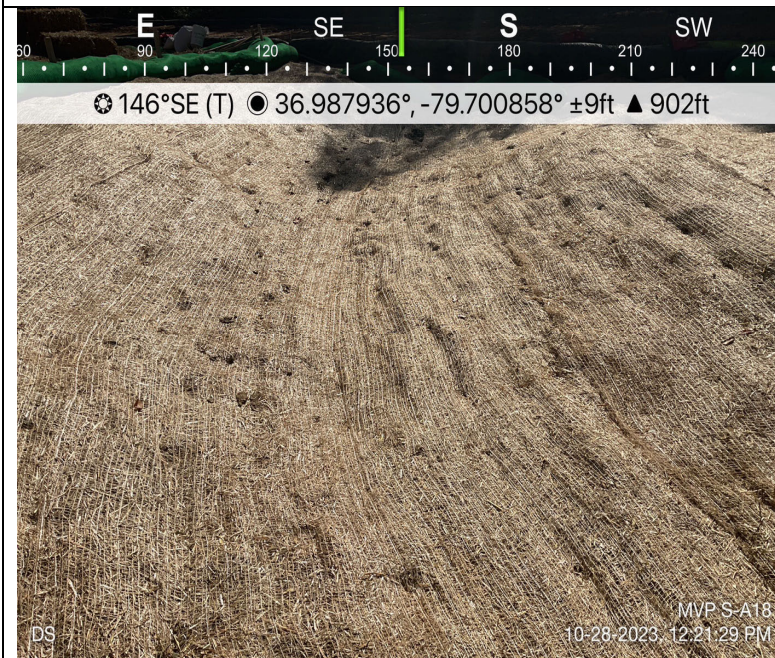
Photo Description: Downstream view of permitted impact area during post-construction assessment.

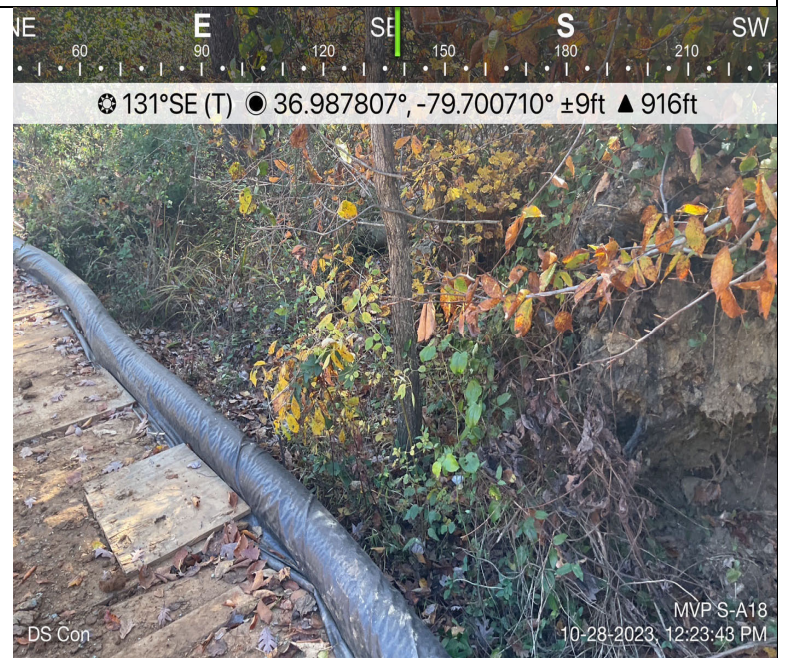
Photo Description: Conditions of the downstream area outside the ROW during post-construction assessment.

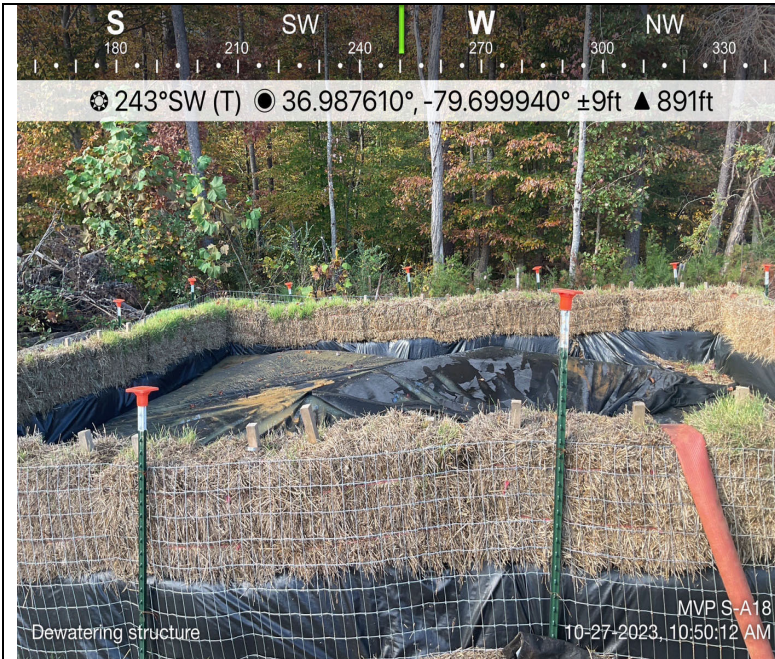
Photo Description: An overview of the dewatering structure.

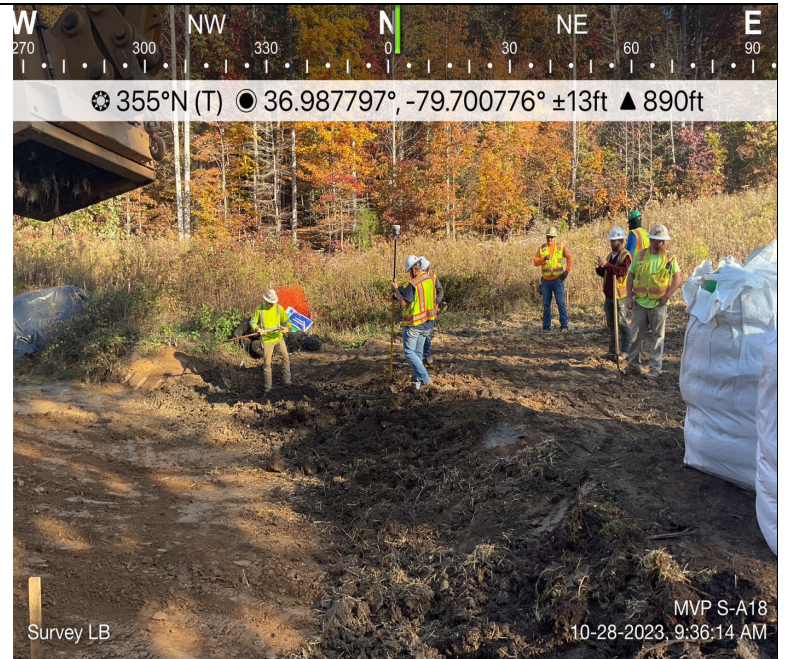
Photo Description: Survey aiding in the reconstruction of the left stream bank.

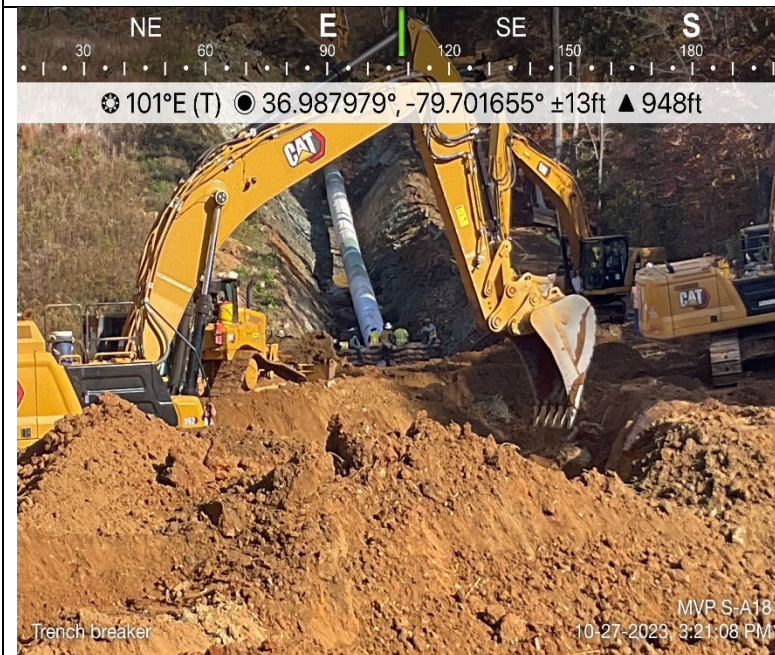
Photo Description: A trench breaker being installed along the pipe.

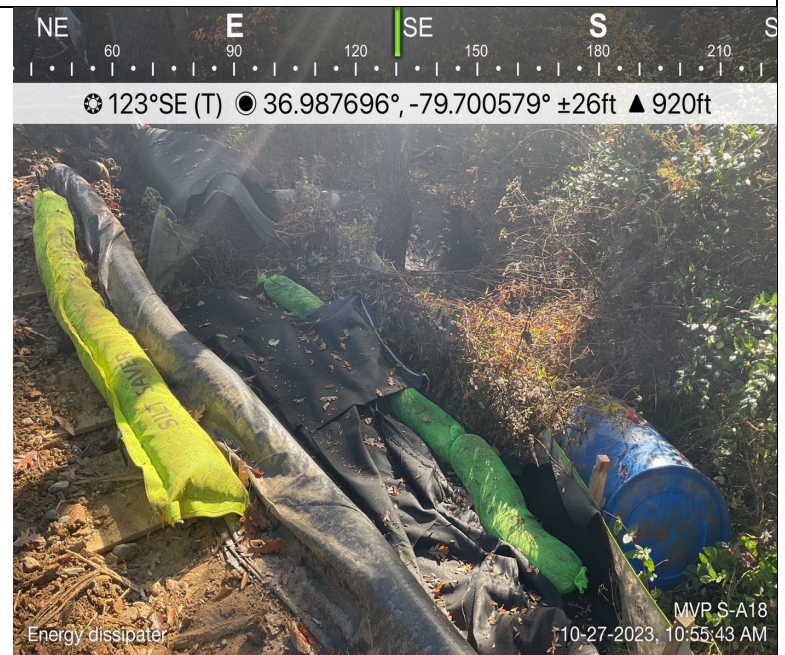
Photo Description: An energy dissipater utilized during construction.
