# STREAM BIOLOGICAL CONDITIONS ENVIRONMENTAL AUDITOR REPORT

Version 2.3

<b>Stream ID:</b> S-A36	<b>Crossing Start Date:</b> 10/03/2023	<b>Crossing Completion Date:</b> 10/05/2023
<b>Milepost:</b> 271.4	<b>Pre-Con Assessment Date:</b> 09/29/2023	<b>Post-Con Assessment Date:</b> 10/05/2023
<b>Station:</b> 14338+58	<b>Stream Classification:</b> Ephemeral (Perennial, Intermittent, Ephemeral)	<b>Bankfull Width (ft.):</b> 4
<b>County:</b> Franklin	<b>303(d) Impairment Listing:</b> Not Impaired	<b>Riffle:Pool Complexes Present?</b> No

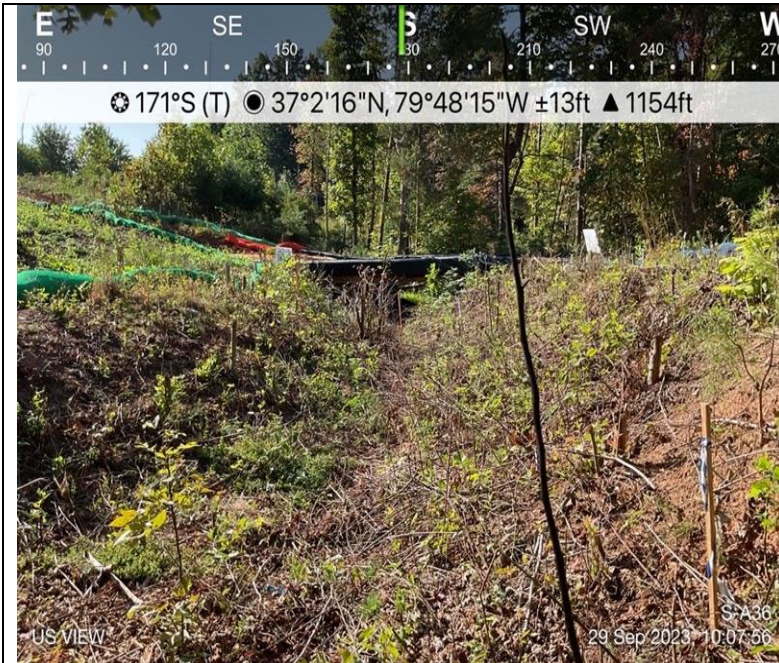
**Photo Description:** Downstream view of permitted impact area during pre-construction assessment. Typo in photo caption. Should read "DS VIEW", not "US VIEW".

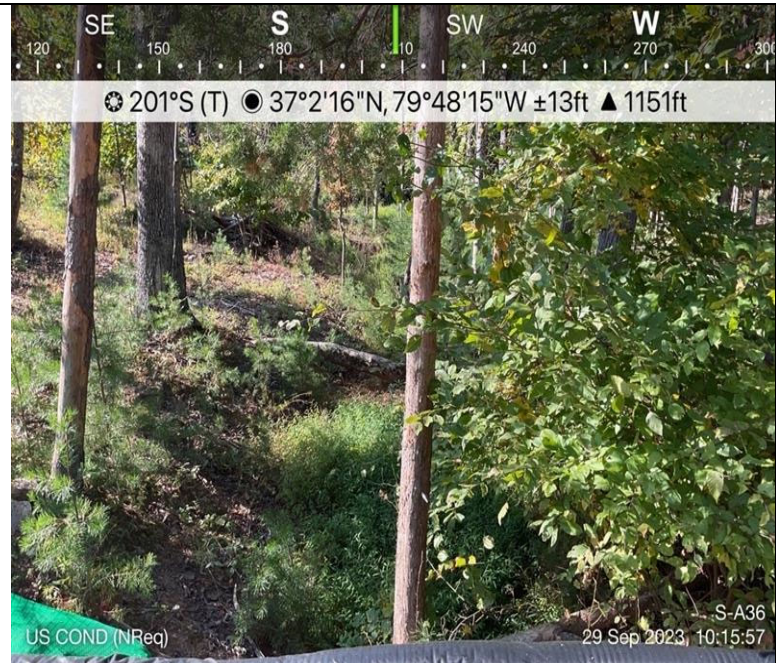
**Photo Description:** Conditions of the downstream area outside the ROW during pre-construction assessment. Typo in photo caption. Should read "DS COND", not "US COND".

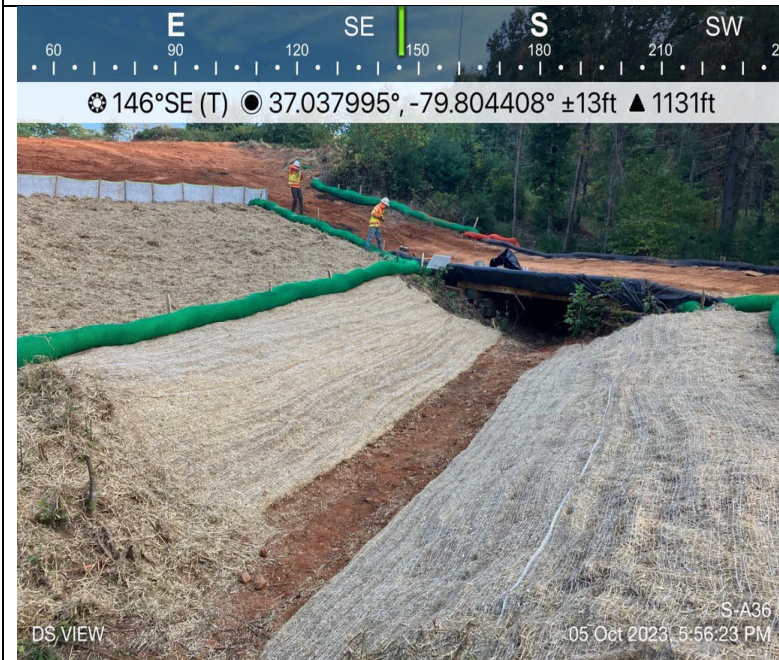
**Photo Description:** Downstream view of permitted impact area during post-construction assessment.

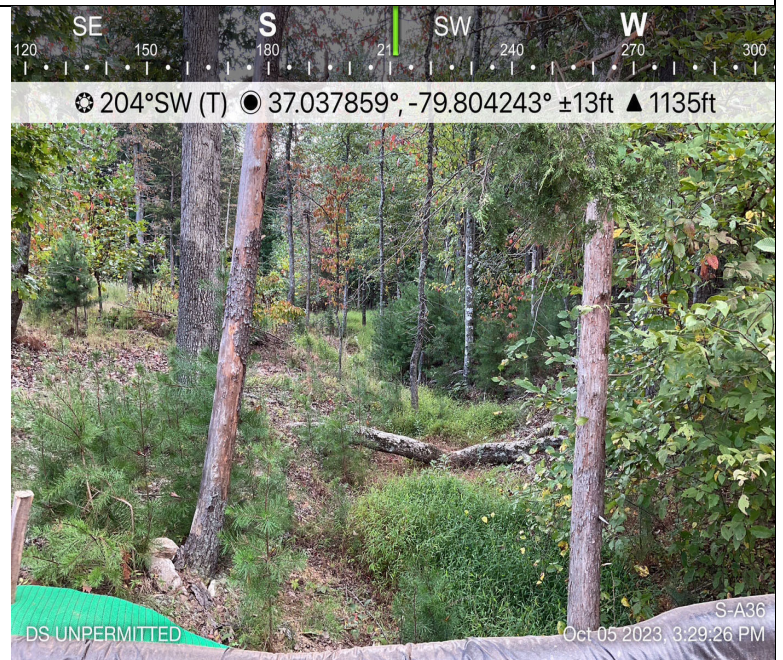
**Photo Description:** Conditions of the downstream area outside the ROW during post-construction assessment.

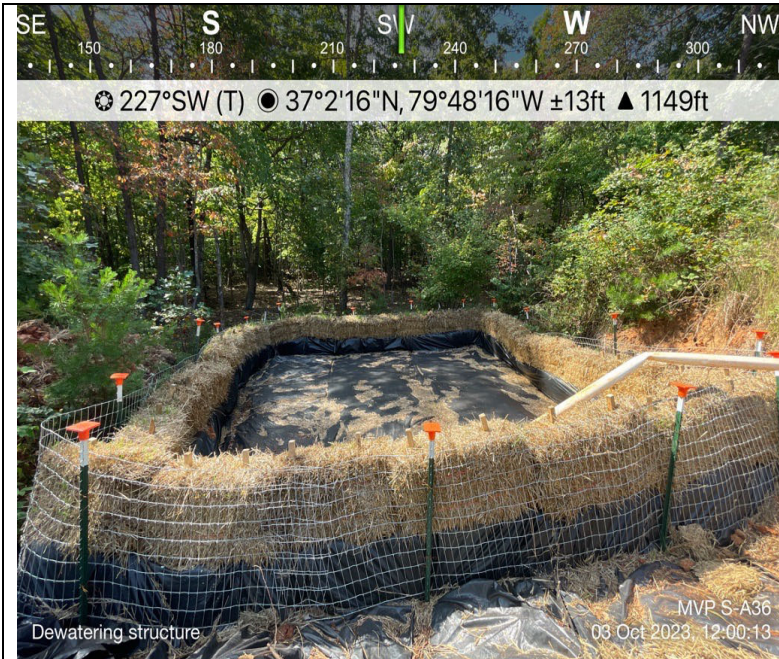
**Photo Description:** Dewatering structure

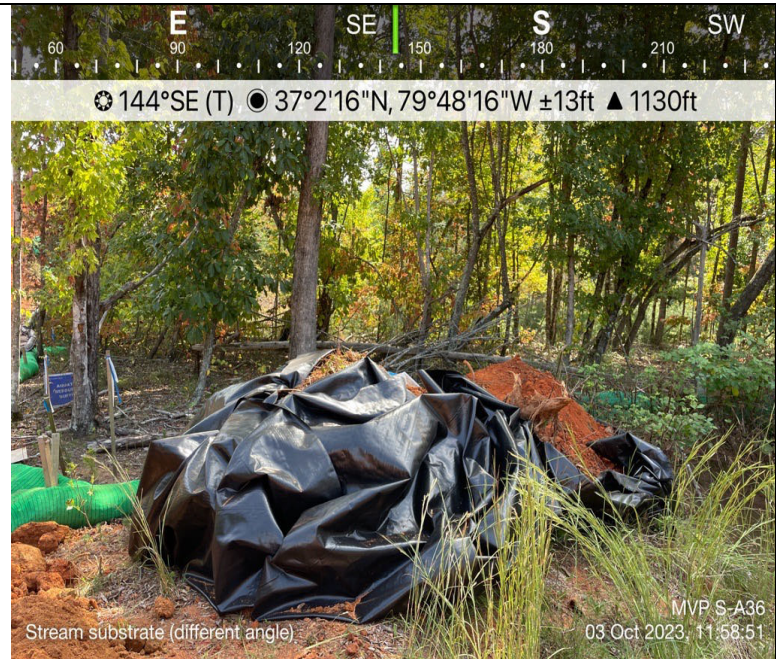
**Photo Description:** First and last 6 inches of stream substrate separated on Geotech

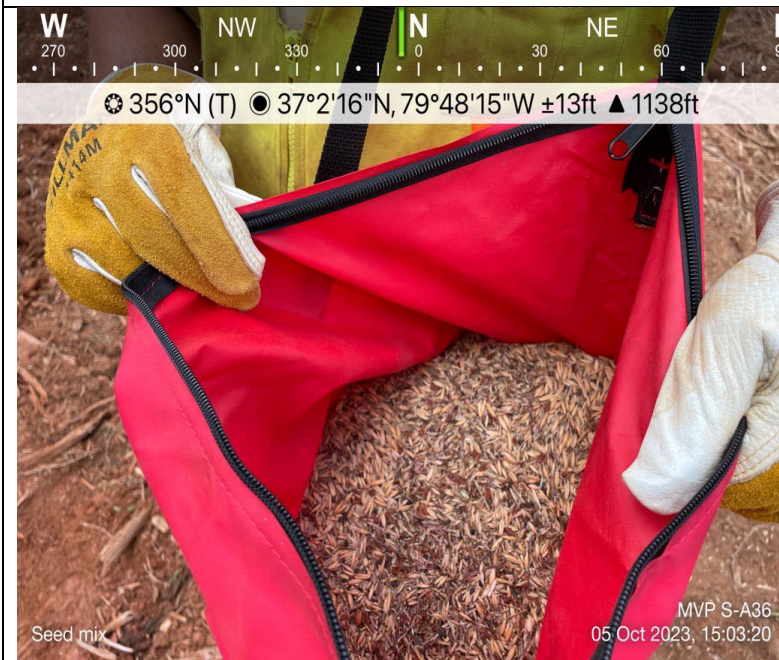
**Photo Description:** 50/50 Riparian and rye seed mix used

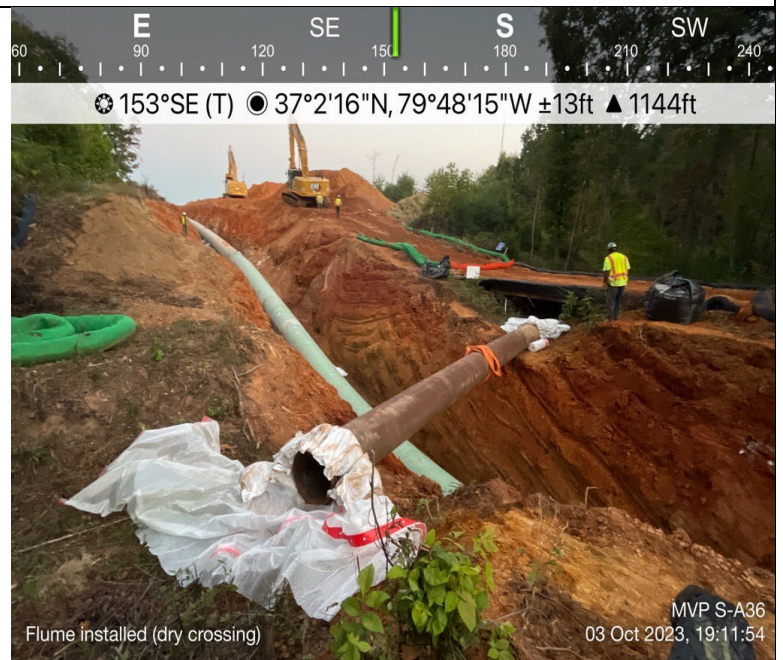
**Photo Description:** Flume installed
