STREAM BIOLOGICAL CONDITIONS ENVIRONMENTAL AUDITOR REPORT

Stream ID: S-A41	Crossing Start Date: 10/17/2023	Crossing Completion Date: 10/20/2023
Milepost: 272.4	Pre-Con Assessment Date: 10/09/2023	Post-Con Assessment Date: 10/20/2023
Station: 14391+65	Stream Classification: Perennial (Perennial, Intermittent, Ephemeral)	Bankfull Width (ft.): 12
County: Franklin	303(d) Impairment Listing: Impaired	Riffle:Pool Complexes Present? No

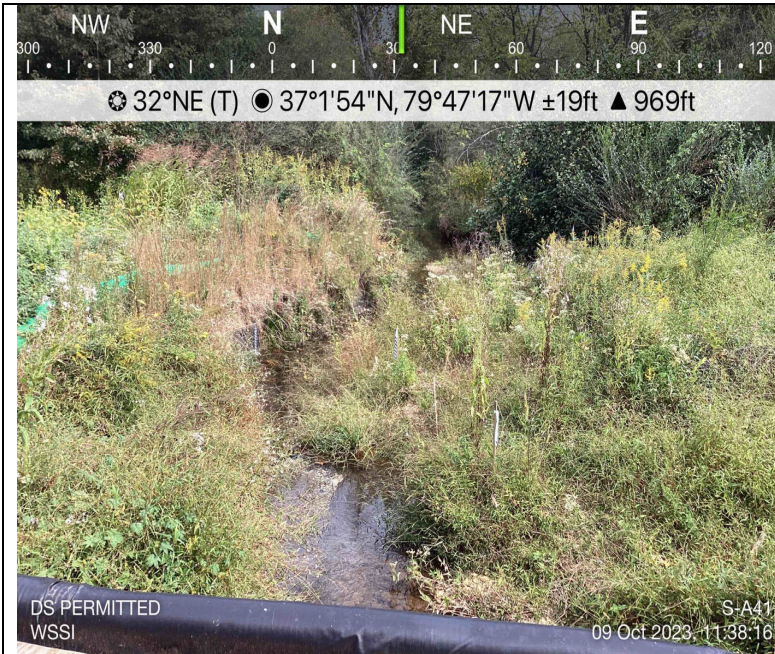
Photo Description: Downstream view of permitted impact area during pre-construction assessment.

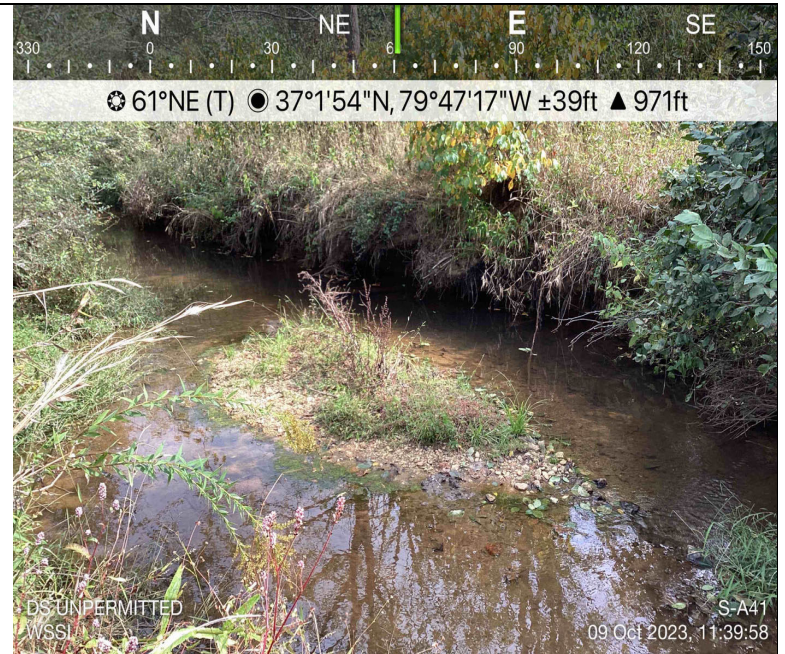
Photo Description: Conditions of the downstream area outside the ROW during pre-construction assessment.

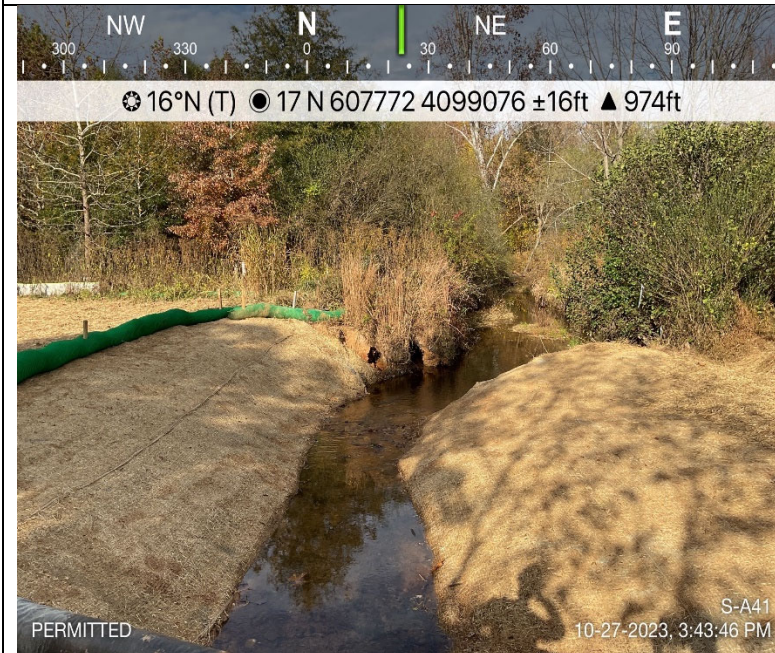
Photo Description: Downstream view of permitted impact area during post-construction assessment.

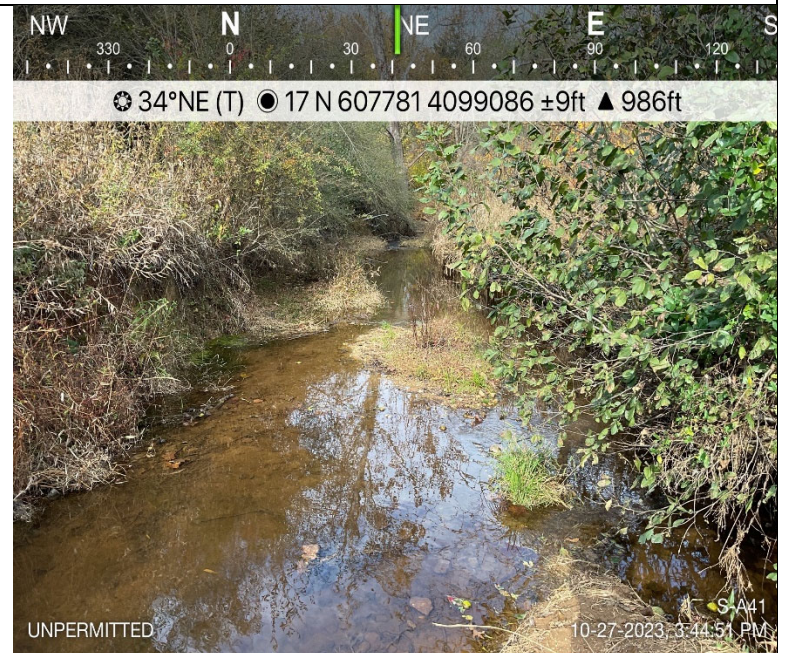
Photo Description: Conditions of the downstream area outside the ROW during post-construction assessment.

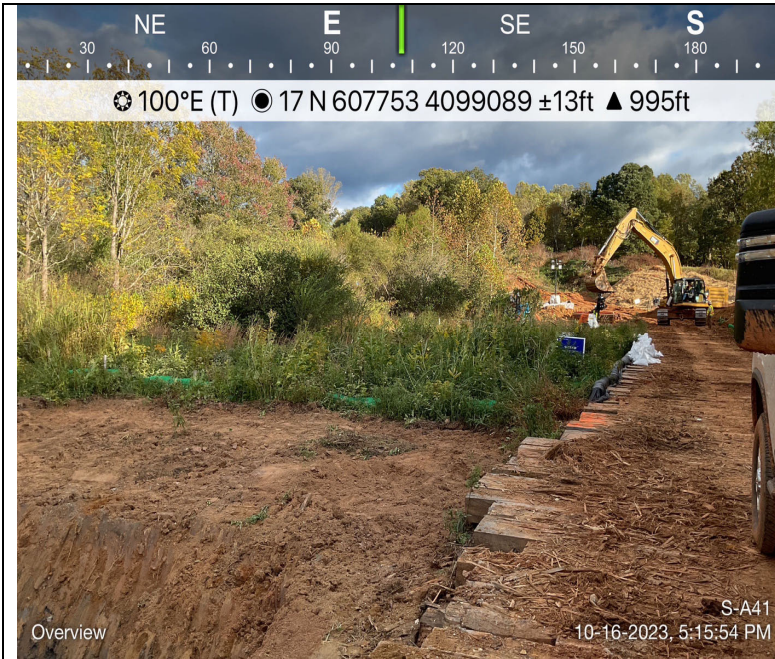
Photo Description: An overview of the pre-construction stream conditions. Bell hole excavation outside resource area.

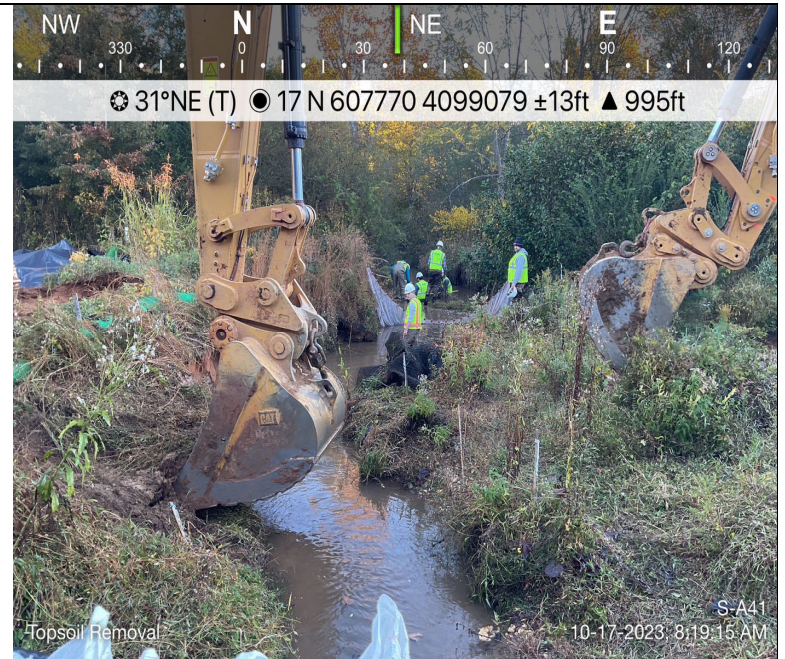
Photo Description: Removal of the topsoil from the stream bank.

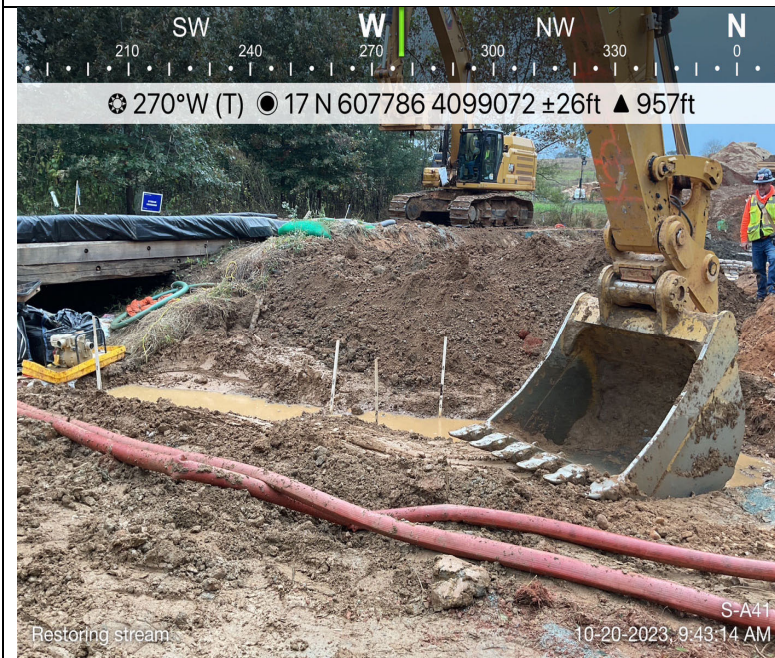
Photo Description: Restoration of the stream banks.

Item #8: Vertical banks were sloped 3:1 for bank stabilization.

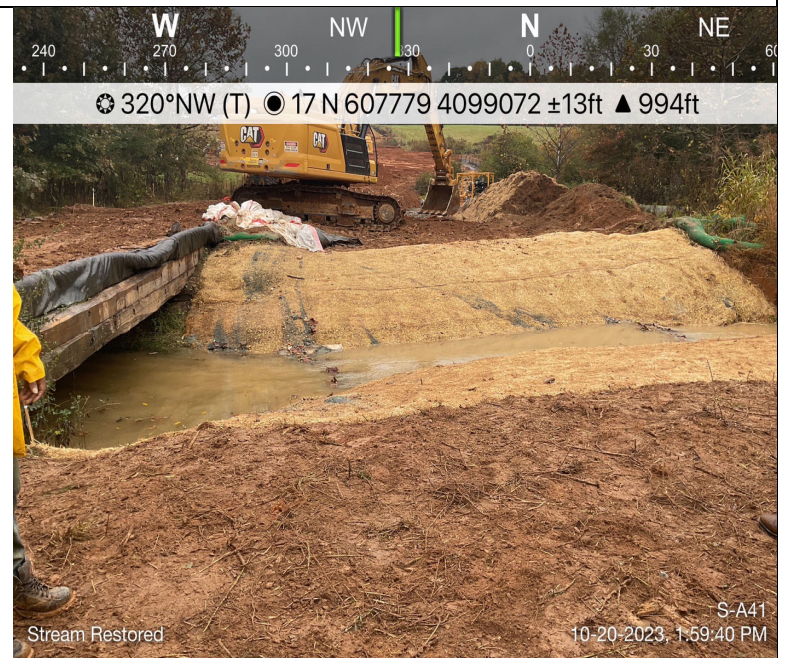
Photo Description: Flow restored to stream after the conclusion of restoration activities. Rock check dams remain installed across channel in attempt to control turbidity.

10-27-2023: New post-con pictures taken to confirm removal of the in-stream rock check dams.
