# Stream Biological Conditions EA Report

<b>Project Name</b>	H-600 Pipeline Spread F	<b>AFE</b>	124300135	<b>Spread</b>	H-600 Pipeline Spread F
<b>Contractor</b>	Price Gregory	<b>Report #</b>	330		
<b>Environmental Auditor</b>	Charles Haden	<b>Date/Time</b>	10/30/2023 2:56 PM		
<b>Stream ID</b>	S-A61	<b>Crossing Start Date</b>	11/10/2023	<b>Crossing Completion Date</b>	11/16/2023
<b>Milepost</b>	182.40	<b>Pre-Con Assessment Date</b>	10/30/2023	<b>Post-Con Assessment Date</b>	11/16/2023
<b>Station</b>	9630+72	<b>Bankfull Width (ft.)</b>	4.1	<b>Riffle:Pool Complexes Present?</b>	No
<b>State</b>	WV	<b>Stream Classification</b>	Ephemeral		
<b>County</b>	Monroe	<b>303(d) Impairment Listing</b>	No

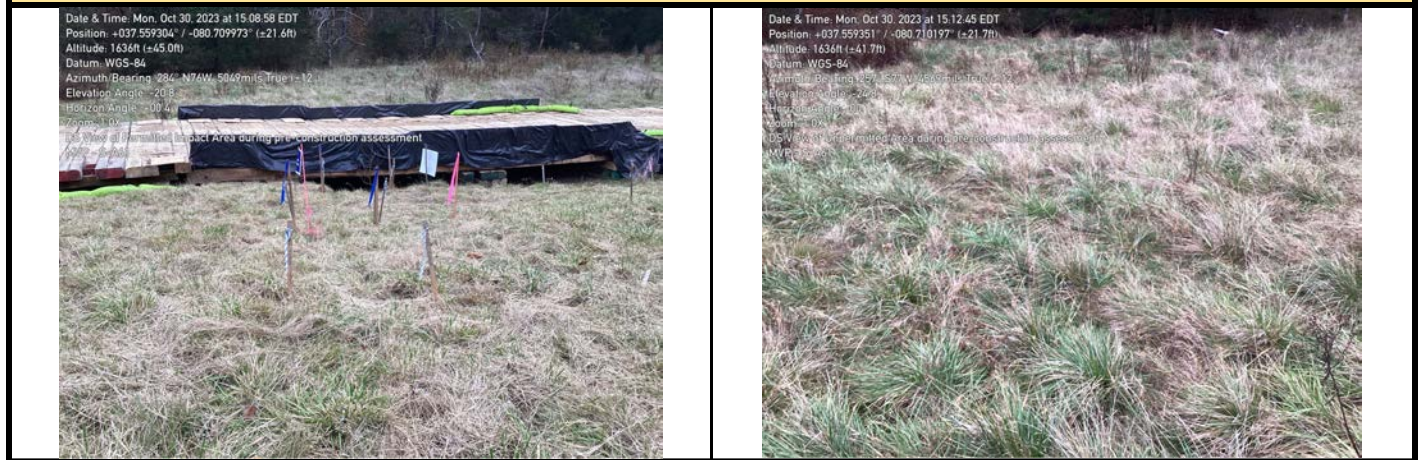
<b>GPS Location</b> See Photo	<b>GPS Location</b> See Photo
<b>Description</b> Downstream view of permitted impact area during pre-construction assessment.	<b>Description</b> Downstream view of unimpacted area during pre-construction assessment.

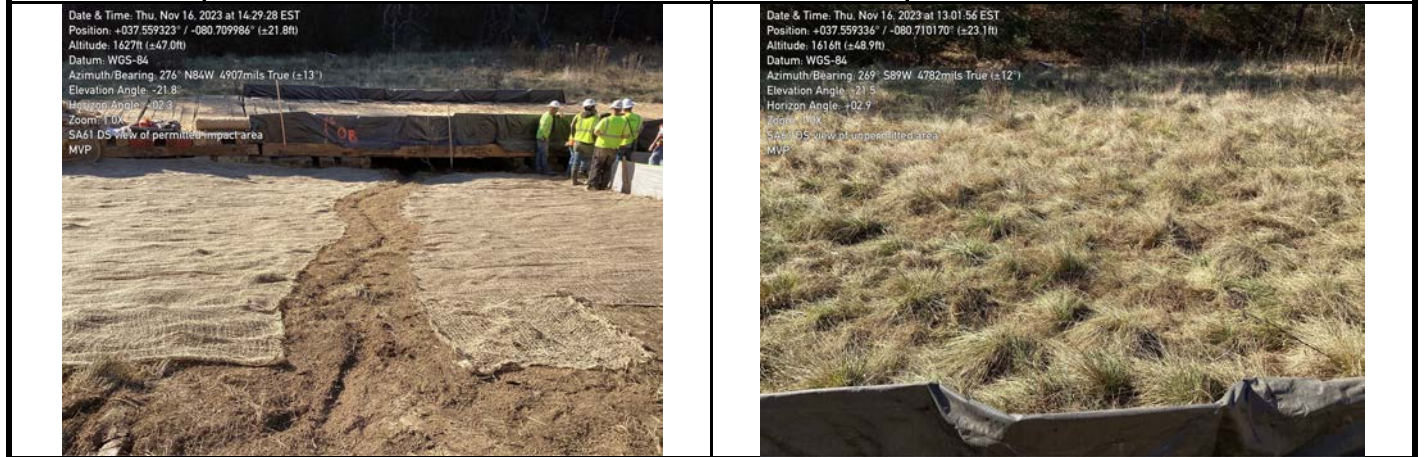
<b>GPS Location</b> See Photo	<b>GPS Location</b> See Photo
<b>Description</b> Downstream view of permitted impact area during post-construction assessment.	<b>Description</b> Downstream view of unimpacted area during post-construction assessment.

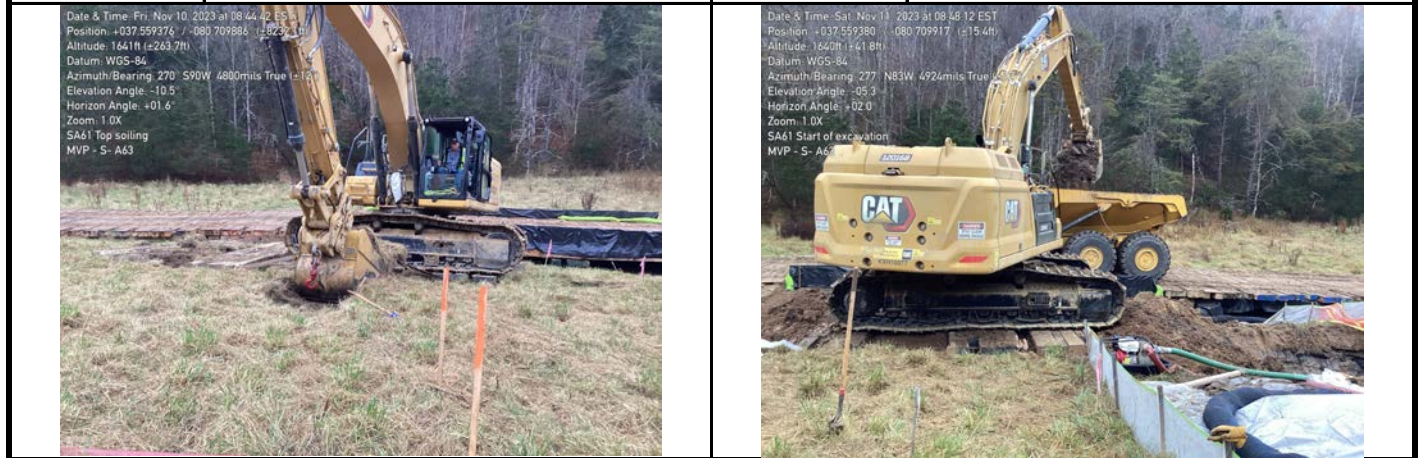
<b>GPS Location</b> See Photo	<b>GPS Location</b> See Photo
<b>Description</b> Photo 1: Excavation of top 12 inches of stream substrate.	<b>Description</b> Photo 2: Beginning to excavate trench in aquatic resource area.

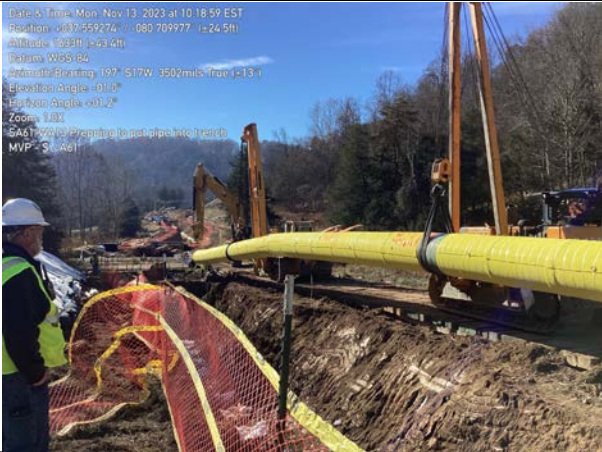
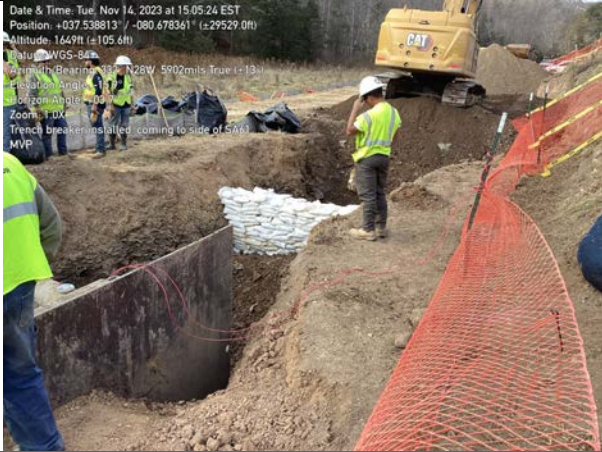
<p><small>Date &amp; Time: Tue, Nov 14, 2023 at 15:05:24 EST Position: +037.538813° / -080.678361° (-29529.0ft) Altitude: 1642ft (+49.6ft) Datum: WGS-84 Azimuth Bearing: 209.926W 5902mils True (+13.1) Elevation Angle: +15.6° Horizon Angle: +15.6° Zoom: 1.0x SAG: 20.00° (relative to the trench breaker) yards MVP: 3.0.401</small></p>		
<b>GPS Location</b>	See Photo	<b>GPS Location</b>	See Photo
<b>Description</b>	Photo 3: Placing pipe in trench in aquatic resource area.	<b>Description</b>	Photo 4: Construction of trench breaker.

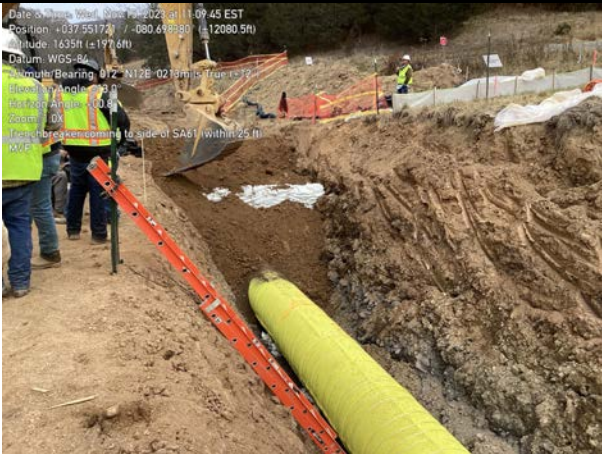
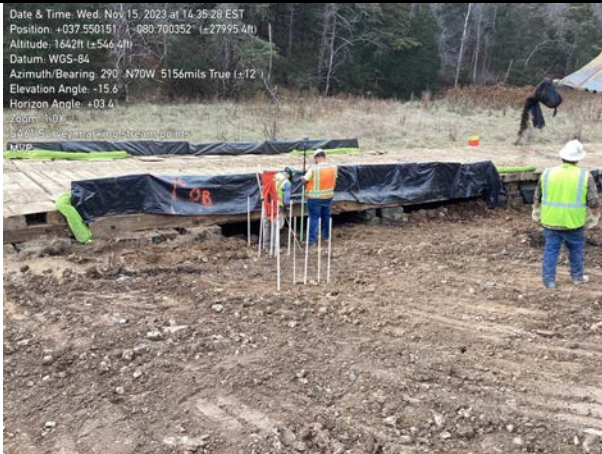
<b>GPS Location</b>	See Photo	<b>GPS Location</b>	See Photo
<b>Description</b>	Photo 5: Backfilling of trench.	<b>Description</b>	Photo 6: Survey staking out aquatic resource prior to restoration.

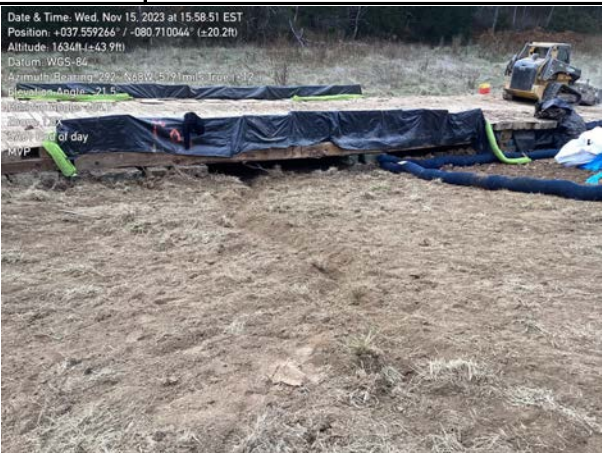
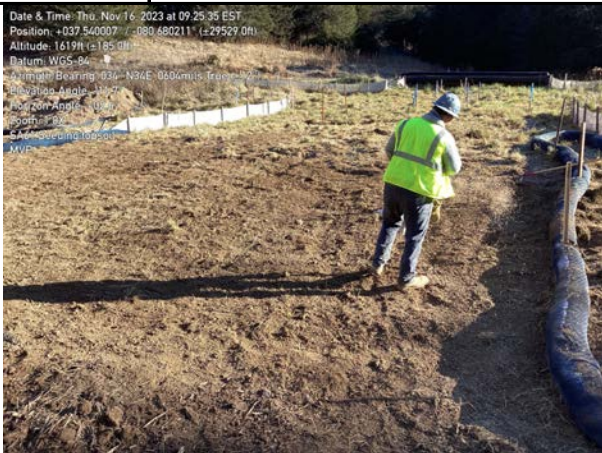
<p><small>Date &amp; Time: Thu, Nov 16, 2023 at 09:25:35 EST Position: +037.540007° / -080.680211° (-29529.0ft) Altitude: 1619ft (+49.0ft) Datum: WGS-84 Azimuth Bearing: 634.194E 0866mils True (+16.1) Elevation Angle: +15.6° Horizon Angle: +15.6° Zoom: 1.0x SAG: 20.00° (relative to the buffer) MVP: 3.0.401</small></p>		
<b>GPS Location</b>	See Photo	<b>GPS Location</b>	See Photo
<b>Description</b>	Photo 7: Aquatic resource after hand work to develop channel.	<b>Description</b>	Photo 8: Seeding of buffer adjacent to aquatic resource.
