Stream Biological Conditions EA Report

Project Name	H-600 Pipeline Spread F	AFE	124300135	Spread	H-600 Pipeline Spread F
Contractor	Price Gregory	Report #	327		
Environmental Auditor	Charles Haden	Date/Time	10/30/2023 8:28 AM		
Stream ID	S-A63	Crossing Start Date	10/30/2023	Crossing Completion Date	11/4/2023
Milepost	182.51	Pre-Con Assessment Date	10/30/2023	Post-Con Assessment Date	11/4/2023
Station	9636+50	Bankfull Width (ft.)	8.7	Riffle:Pool Complexes Present?	No
State	WV	Stream Classification	Perennial		
County	Monroe	303(d) Impairment Listing	No

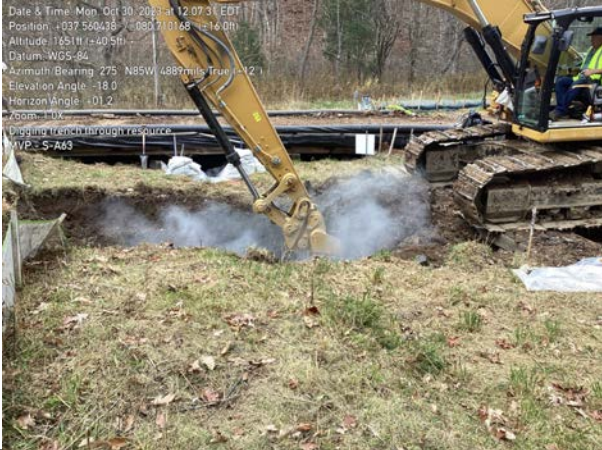
<p><small>Date & Time: Mon, Oct 30, 2023 at 12:07:31 EDT Position: +037.560436° / -080.710165° (-16.0ft) Altitude: 1657ft (-40.5ft) Datum: WGS-84 Azimuth/Bearing: 275 N85W 4889mils True (-12) Elevation Angle: -18.0 Horizon Angle: +01.2 Zoom: 1.0X S463 End of day, topsoil added to banks, survey points approved MVP - S - A63</small></p>

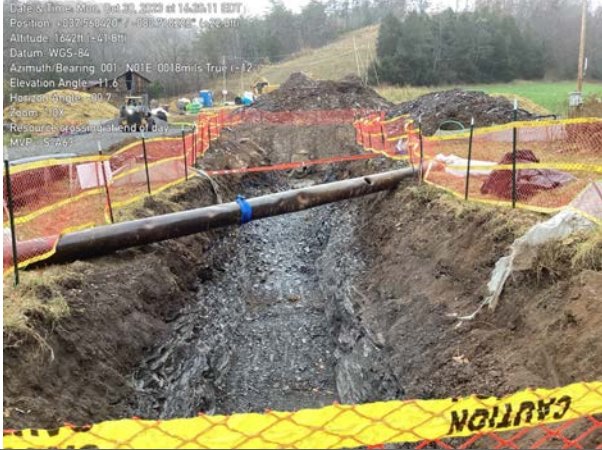
<p><small>Date & Time: Mon, Oct 30, 2023 at 14:05:11 EDT Position: +037.560427° / -080.70998° (-16.0ft) Altitude: 1627ft (-41.6ft) Datum: WGS-84 Azimuth/Bearing: 001 N01E 0018mils True (-12) Elevation Angle: -11.6 Horizon Angle: +00.7 Zoom: 1.0X S463 End of day, topsoil added to banks, survey points approved MVP - S - A63</small></p>	
GPS Location	See Photo	GPS Location	See Photo
Description	Photo 3: Beginning trench excavation through resource.	Description	Photo 4: Trench through resource.

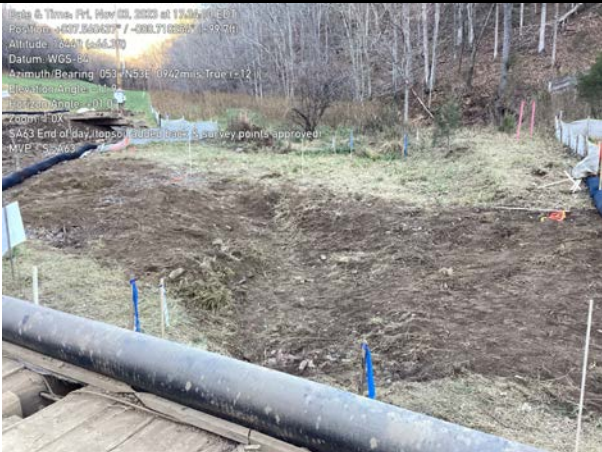
<p><small>Date & Time: Sat, Nov 03, 2023 at 17:04:01 EDT Position: +037.560437° / -080.710267° (-16.0ft) Altitude: 1644ft (-46.6ft) Datum: WGS-84 Azimuth/Bearing: 053 N53E 0762mils True (-12) Elevation Angle: -14.9 Horizon Angle: +01.0 Zoom: 1.0X S463 End of day, topsoil added to banks, survey points approved MVP - S - A63</small></p>

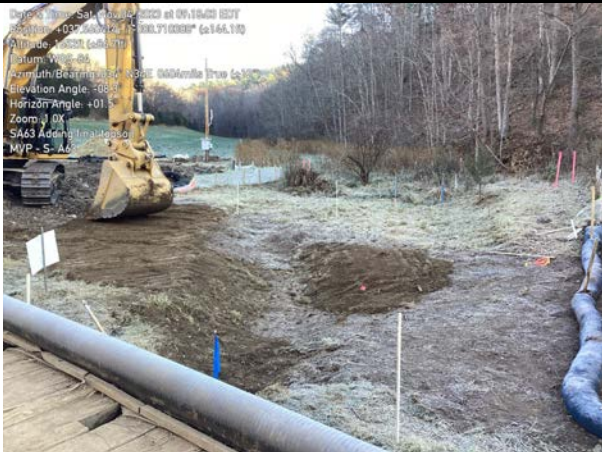
<p><small>Date & Time: Sat, Nov 03, 2023 at 09:16:03 EDT Position: +037.560437° / -080.710267° (-16.0ft) Altitude: 1622ft (-48.3ft) Datum: WGS-84 Azimuth/Bearing: 088E 088Wmils True (-12) Elevation Angle: -30.8 Horizon Angle: +01.5 Zoom: 1.0X S463 Additional topsoil MVP - S - A63</small></p>

GPS Location	See Photo	GPS Location	See Photo
Description	Photo 5: Survey staked resource. Beginning to add topsoil.	Description	Photo 6: Additional topsoil added to banks. Contouring.

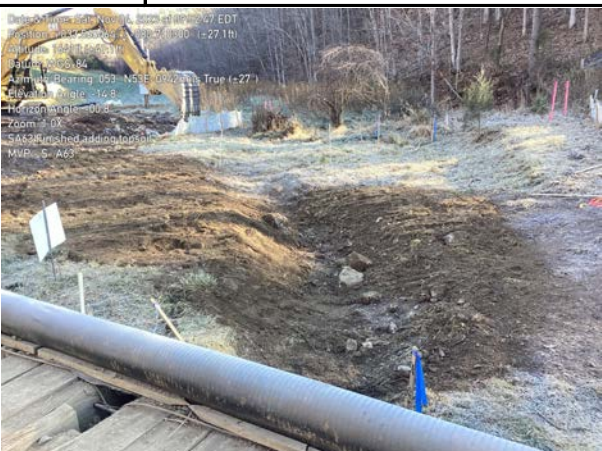
<p><small>Date & Time: Sat, Nov 03, 2023 at 16:27:07 EDT Position: +037.560437° / -080.710267° (-16.0ft) Altitude: 1633ft (-45.1ft) Datum: WGS-84 Azimuth/Bearing: 053 N53E 0762mils True (-12) Elevation Angle: -14.9 Horizon Angle: +00.6 Zoom: 1.0X S463 finished adding topsoil MVP - S - A63</small></p>		<p>Insert image here</p>	
GPS Location	See Photo	GPS Location	
Description	Photo 7: Topsoil and substrate restored.	Description
