Stream Biological Conditions EA Report

Project Name	H-600 Pipeline Spread D	AFE	124300132	Spread	H-600 Pipeline Spread D
Contractor	Precision	Report #	342		
Environmental Auditor	Scott Wessel	Date/Time	11/8/2023 7:20 AM		
Stream ID	S-A75	Crossing Start Date	11/8/2023	Crossing Completion Date	11/24/2023
Milepost	114.98	Pre-Con Assessment Date	11/8/2023	Post-Con Assessment Date	11/25/2023
Station	6070+82	Bankfull Width (ft.)	10.0	Riffle:Pool Complexes Present?	No
State	WV	Stream Classification	Perennial		
County	Nicholas	303(d) Impairment Listing	No

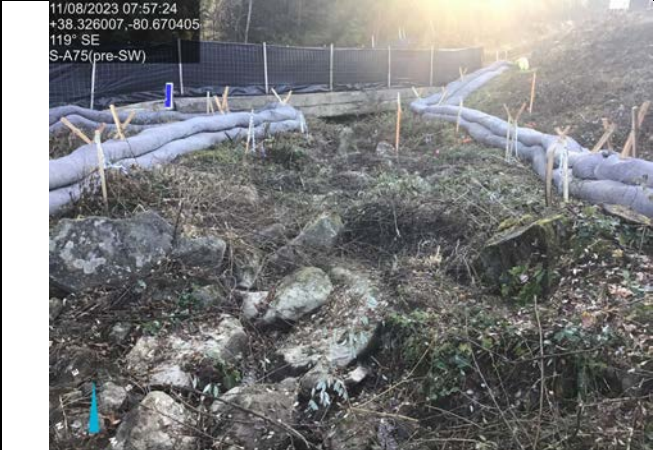
GPS Location	See coordinates in above photo.	GPS Location	See coordinates in above photo.
Description	Downstream view of permitted impact area during pre-construction assessment.	Description	Downstream view of unimpacted area during pre-construction assessment.

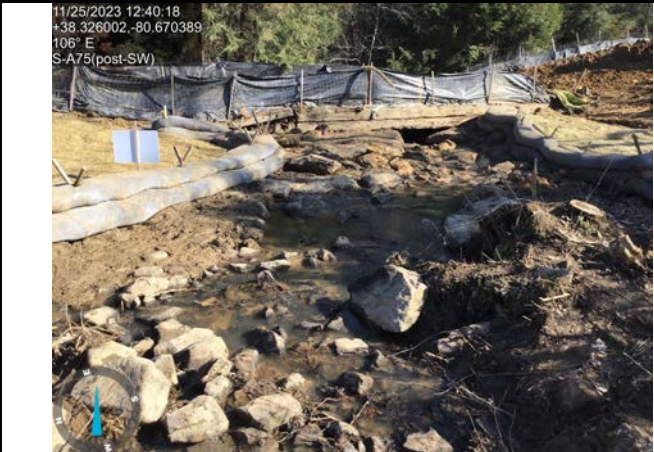
GPS Location	See coordinates in above photo.	GPS Location	See coordinates in above photo.
Description	Downstream view of permitted impact area during post-construction assessment.	Description	Downstream view of unimpacted area during post-construction assessment.

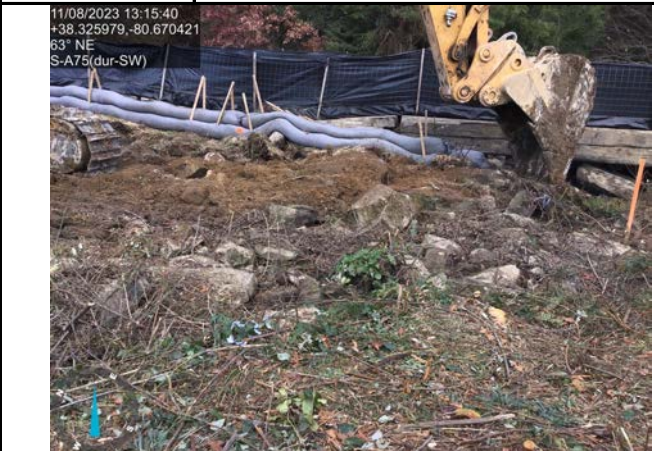
GPS Location	See coordinates in above photo.	GPS Location	See coordinates in above photo.
Description	Topsoil and large rocks from resource banks and buffer zone being removed.	Description	Substrate material being segregated on the CIS of resource crossing.

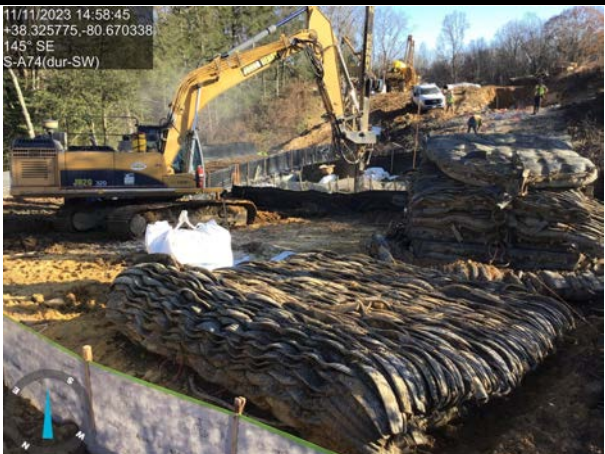
<p>11/11/2023 14:58:45 +38.325775,-80.670338 145° SE S-A74(dur-SW)</p>	  <p>11/12/2023 15:04:40 +38.326019,-80.670383 136° SE S-A75(dur-SW)</p>
GPS Location See coordinates in above photo.	GPS Location See coordinates in above photo.
Description Blasting crew drilling through rock to set charges.	Description Contractor removing subsoil on the GAS of crossing.

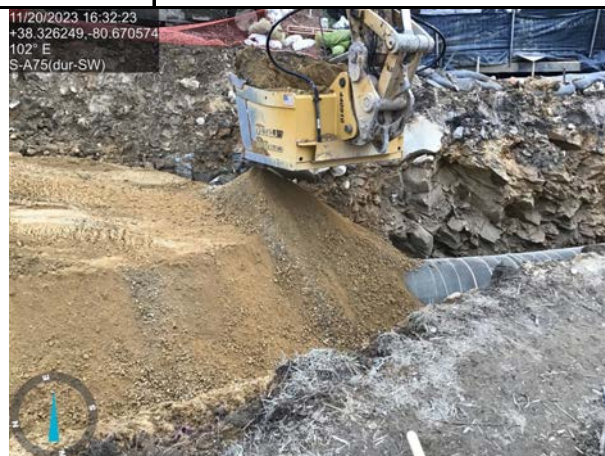
<p>11/20/2023 16:32:23 +38.326249,-80.670574 102° E S-A75(dur-SW)</p>
GPS Location See coordinates in above photo.	GPS Location See coordinates in above photo.
Description Stream section of pipe being lowered into ditch.	Description Pipe being padded before backfill starts.

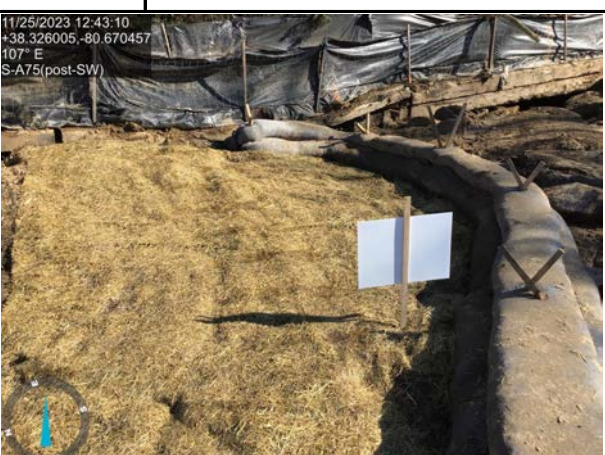
<p>11/25/2023 12:43:10 +38.326005,-80.670457 107° E S-A75(post-SW)</p>

Description Restored buffer zone area on the CIS.	Description Downstream view of stream after pump and dam was removed.
