STREAM BIOLOGICAL CONDITIONS ENVIRONMENTAL AUDITOR REPORT

Stream ID: S-B6	Crossing Start Date: 10/18/2023	Crossing Completion Date: 10/20/2023
Milepost: 297.2	Pre-Con Assessment Date: 10/16/2023	Post-Con Assessment Date: 10/20/2023
Station: 15700+40	Stream Classification: Ephemeral (Perennial, Intermittent, Ephemeral)	Bankfull Width (ft.): 10
County: Pittsylvania	303(d) Impairment Listing: Not Impaired	Riffle:Pool Complexes Present? No

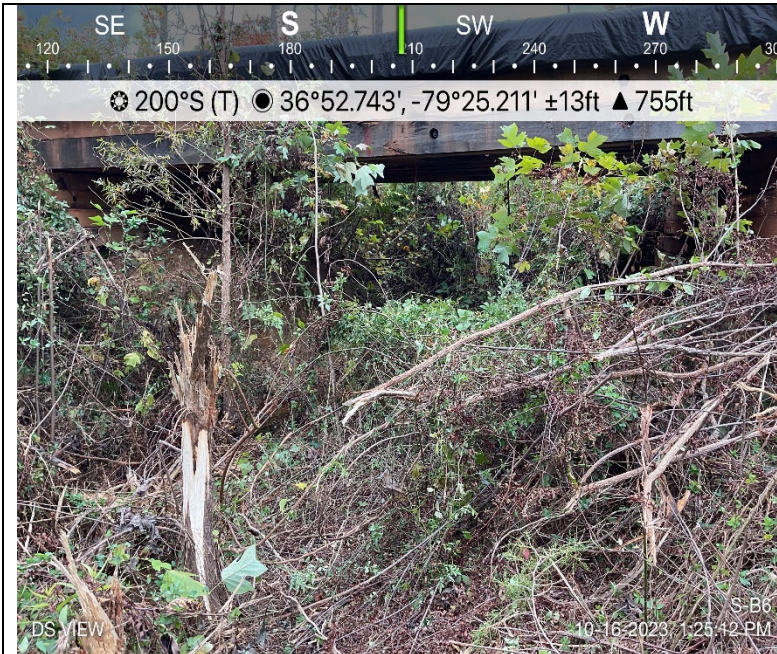
Photo Description: Downstream view of permitted impact area during pre-construction assessment.

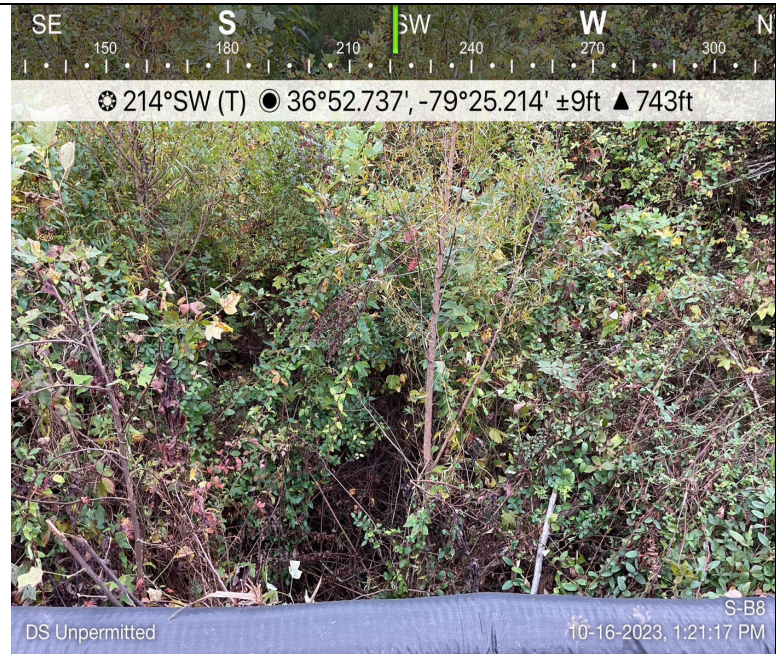
Photo Description: Conditions of the downstream area outside the ROW during pre-construction assessment.

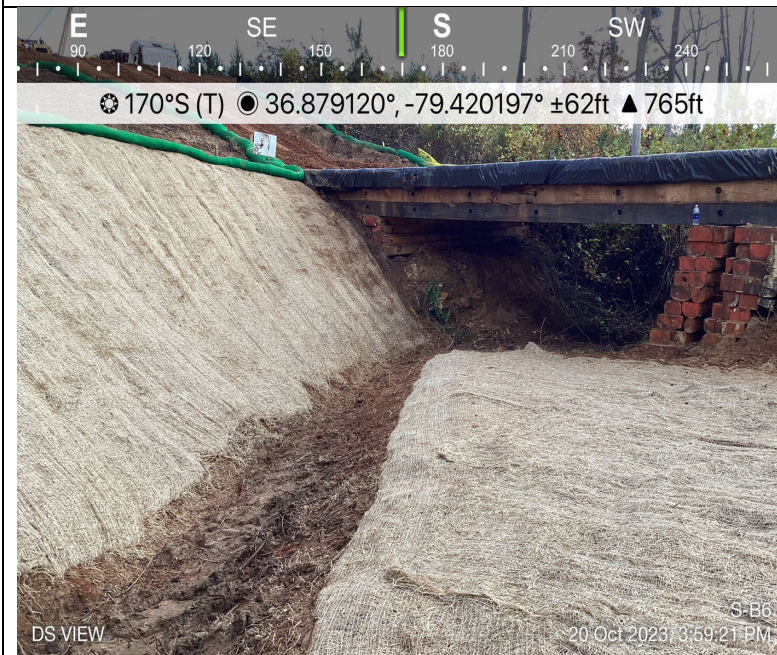
Photo Description: Downstream view of permitted impact area during post-construction assessment.

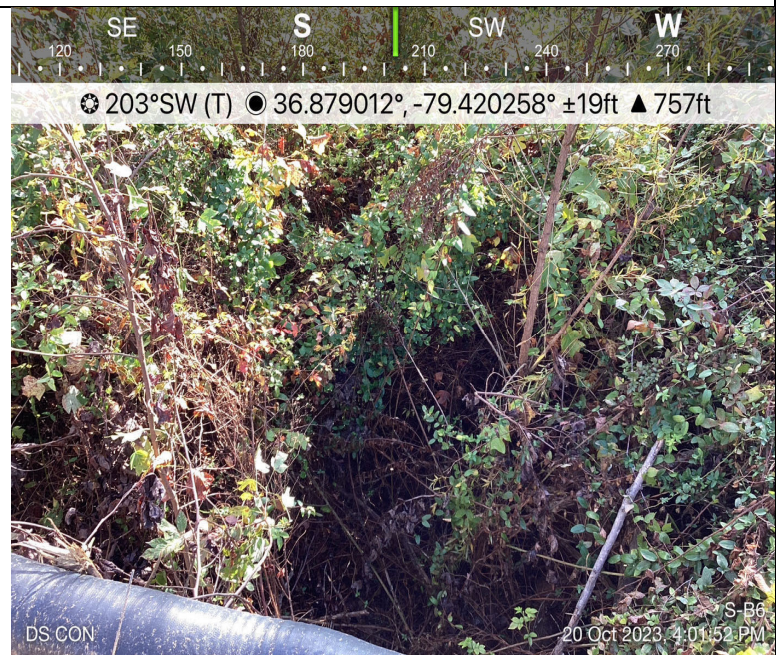
Photo Description: Conditions of the downstream area outside the ROW during post-construction assessment.

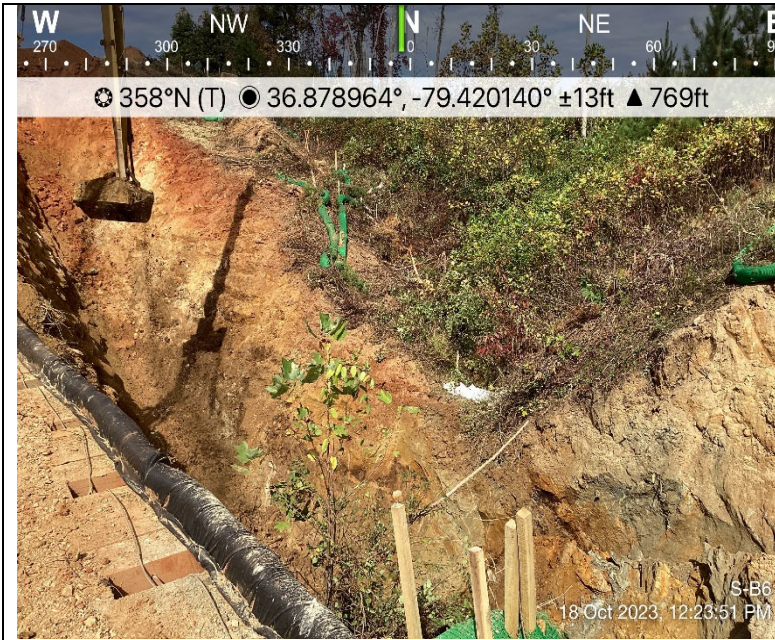
Photo Description: Excavating the trench.

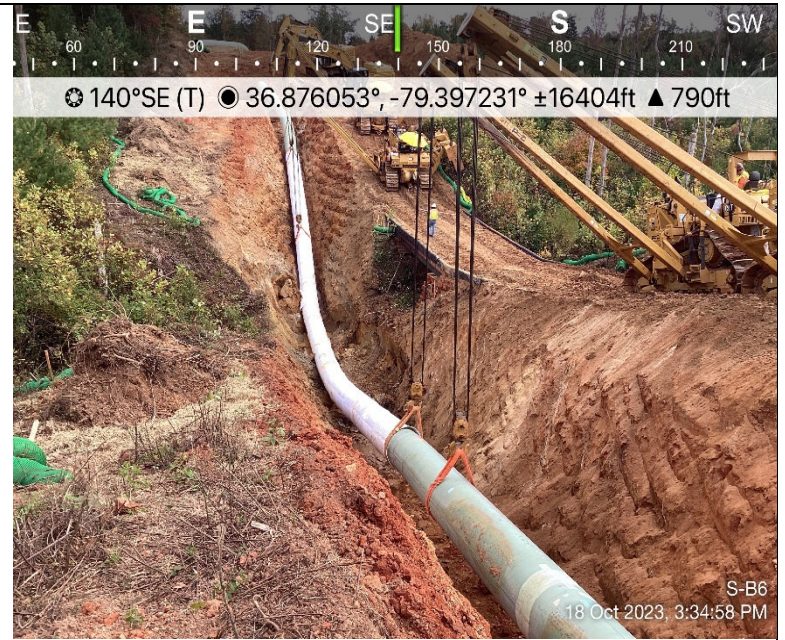
Photo Description: Pipe being lowered into the trench.

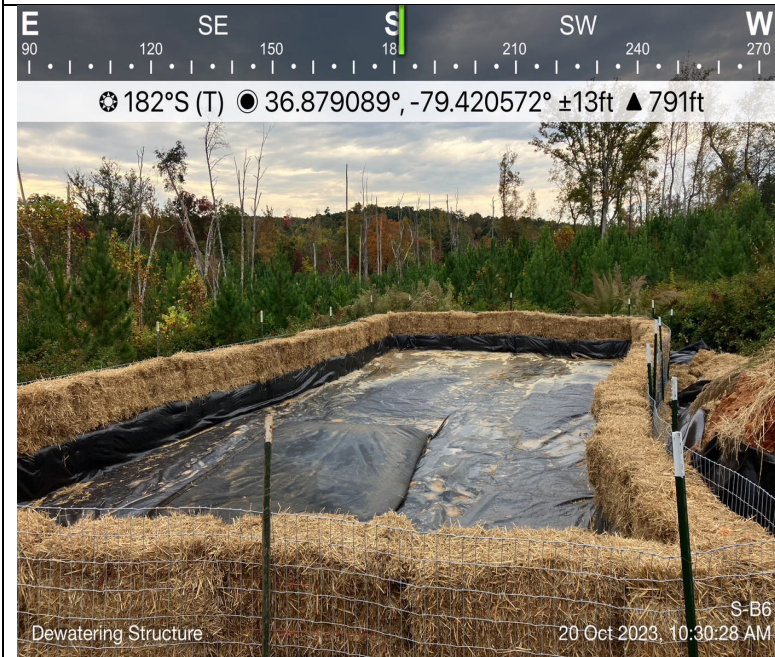
Photo Description: The dewatering structure utilized for the water in the trench.

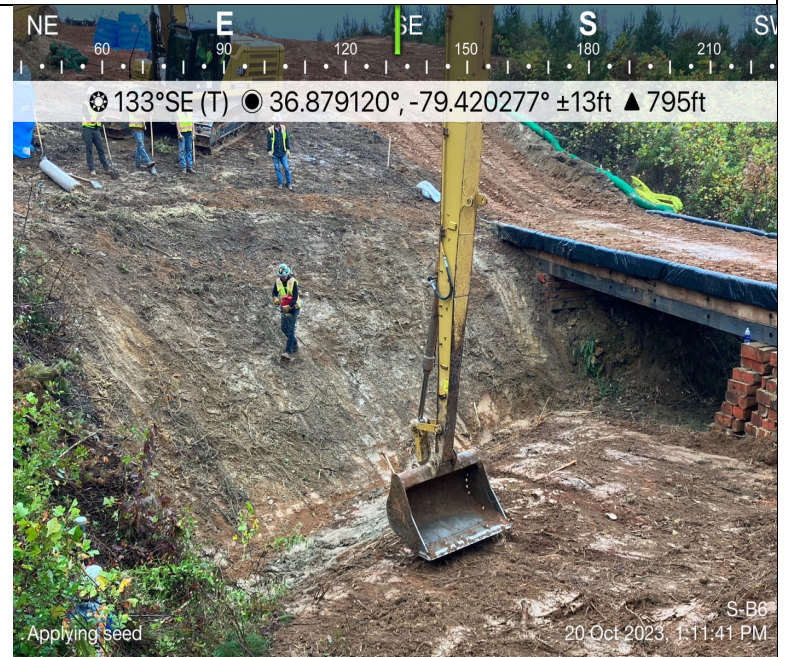
Photo Description: Restoration activities along the stream bank.
