# STREAM BIOLOGICAL CONDITIONS ENVIRONMENTAL AUDITOR REPORT

<b>Stream ID:</b> S-B8	<b>Crossing Start Date:</b> 10/23/2023	<b>Crossing Completion Date:</b> 10/28/2023
<b>Milepost:</b> 297.3	<b>Pre-Con Assessment Date:</b> 10/16/2023	<b>Post-Con Assessment Date:</b> 10/28/2023
<b>Station:</b> 15707+94	<b>Stream Classification:</b> Intermittent (Perennial, Intermittent, Ephemeral)	<b>Bankfull Width (ft.):</b> 4
<b>County:</b> Pittsylvania	<b>303(d) Impairment Listing:</b> Not Impaired	<b>Riffle:Pool Complexes Present?</b> No

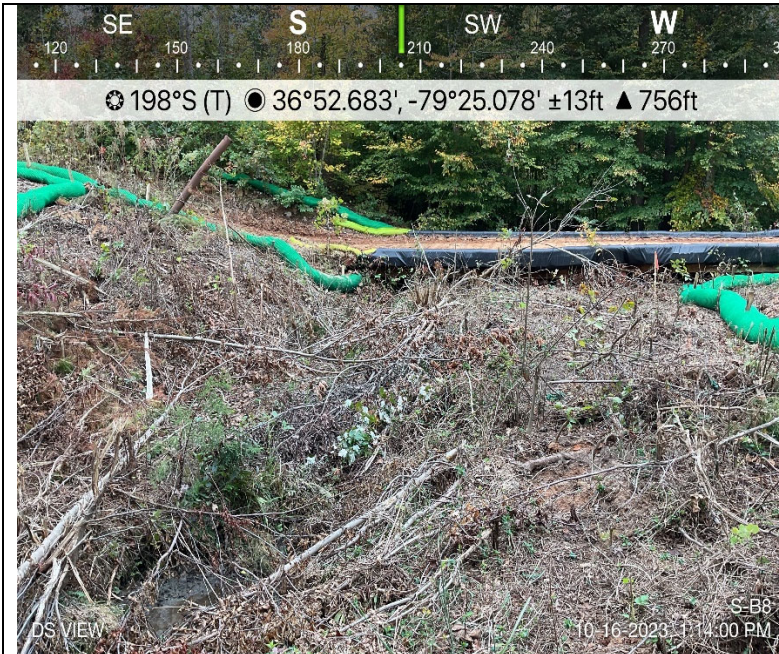
**Photo Description:** Downstream view of permitted impact area during pre-construction assessment.

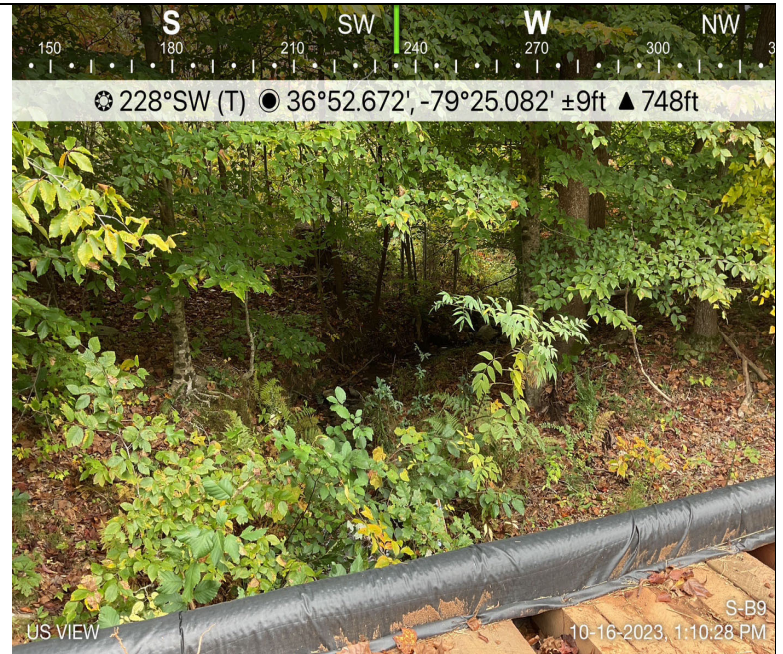
**Photo Description:** Conditions of the downstream area outside the ROW during pre-construction assessment.

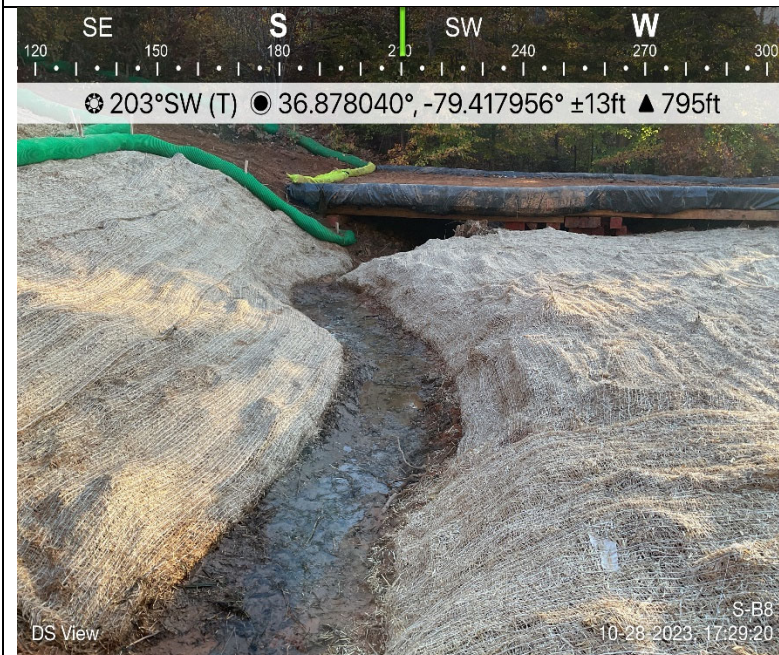
**Photo Description:** Downstream view of permitted impact area during post-construction assessment.

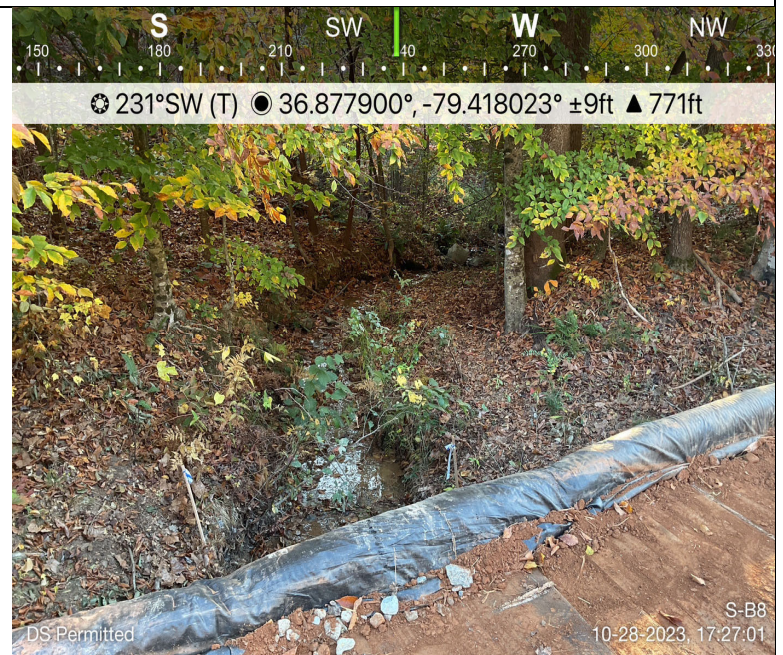
**Photo Description:** Conditions of the downstream area outside the ROW during post-construction assessment.

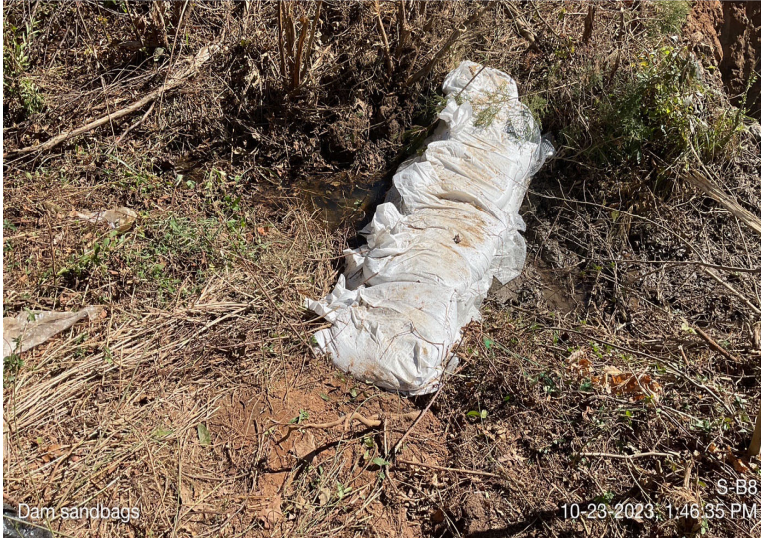
Dam sandbags

**Photo Description:** The dam constructed with sandbags to stem stream flow.

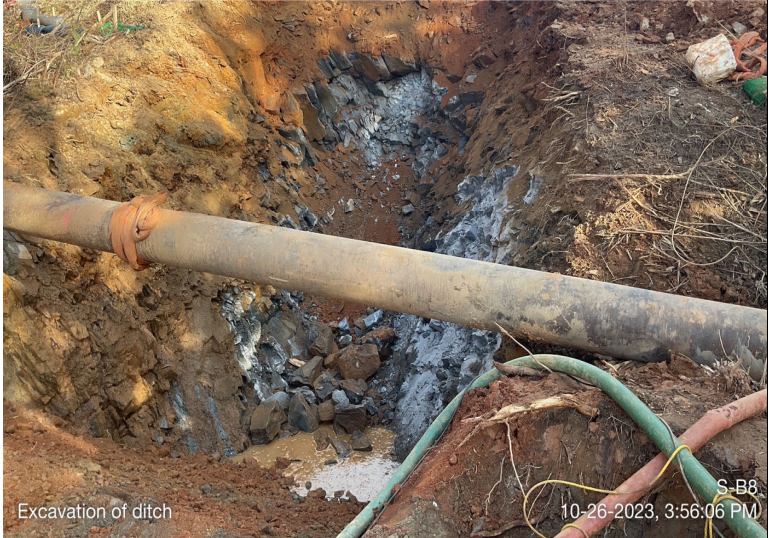
Excavation of ditch

**Photo Description:** A flume was used to allow continuous flow of the resource overnight.

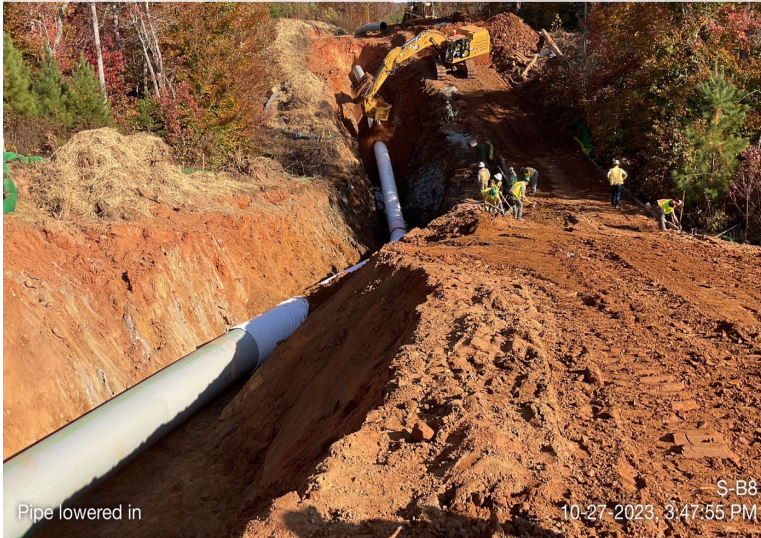
Pipe lowered in

**Photo Description:** Overview of pipe being lowered into trench.

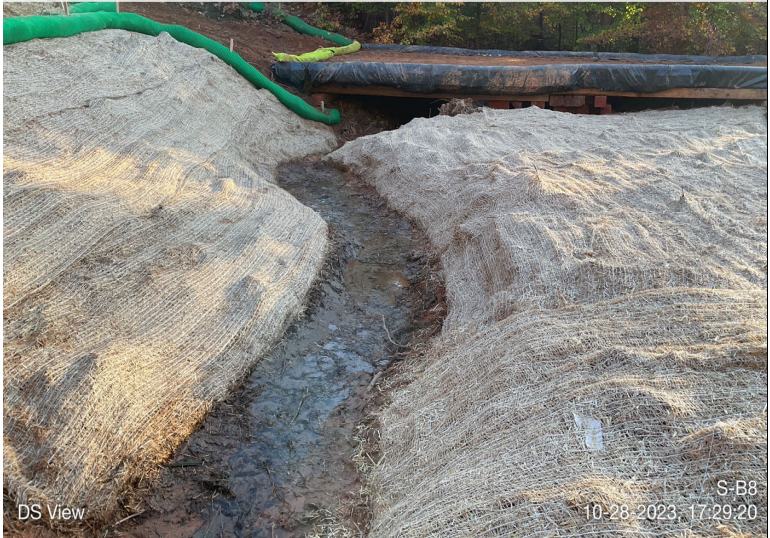
DS View

**Photo Description:** Restoration of the stream banks with erosion control matting.
